Branford Police Department

REMEDICATION PROPOSAL

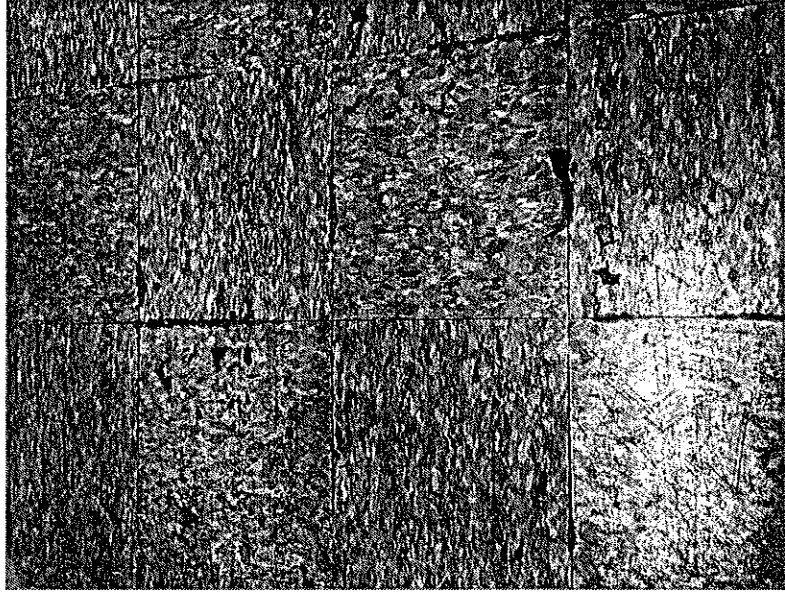
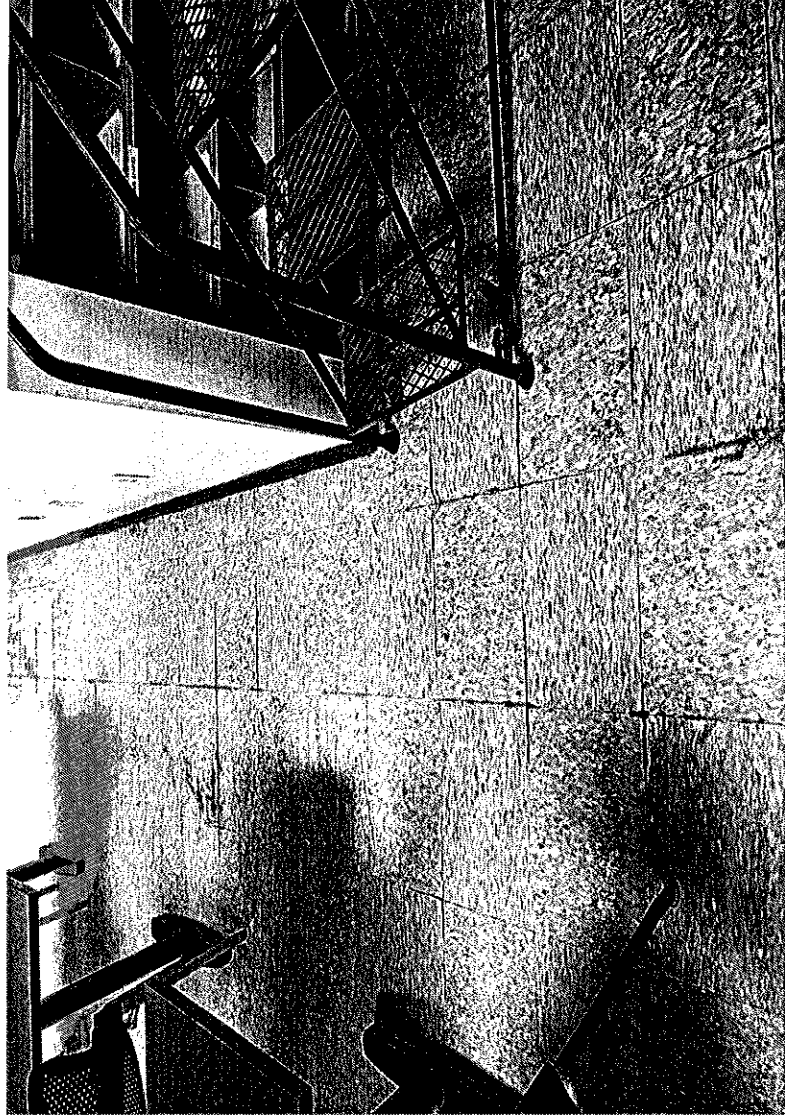
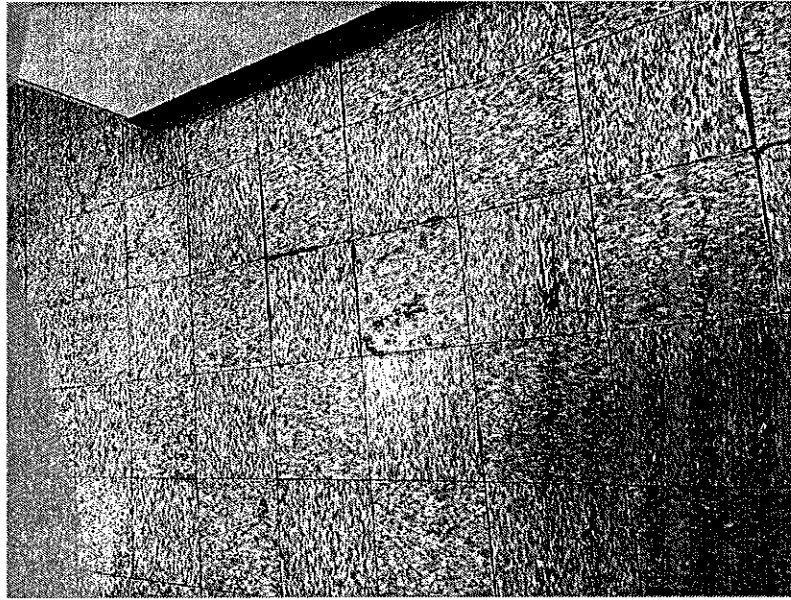
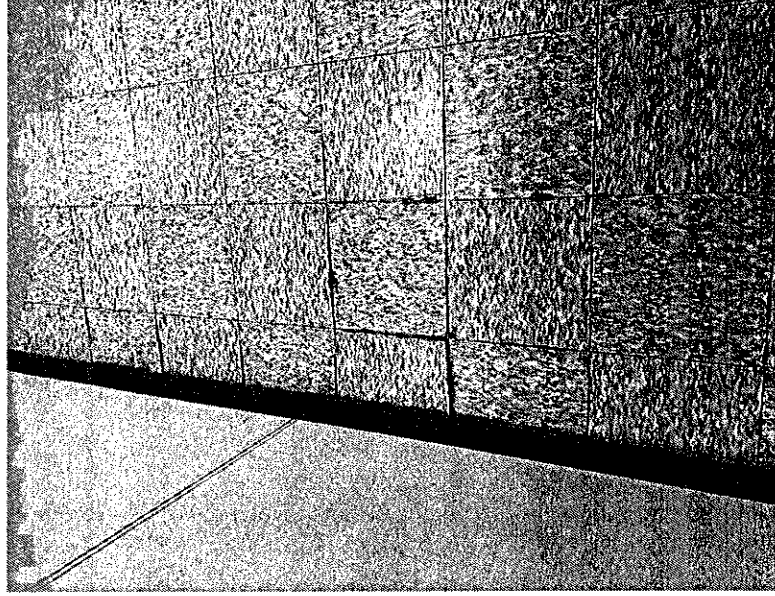
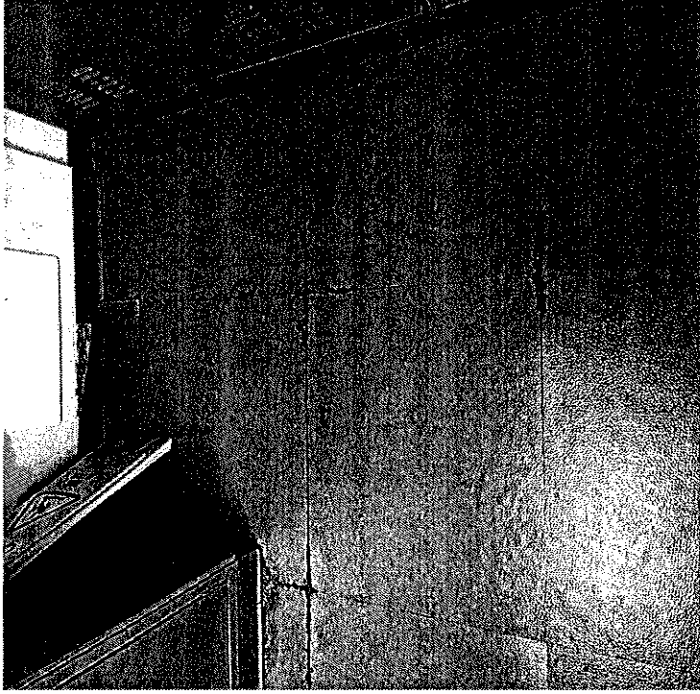
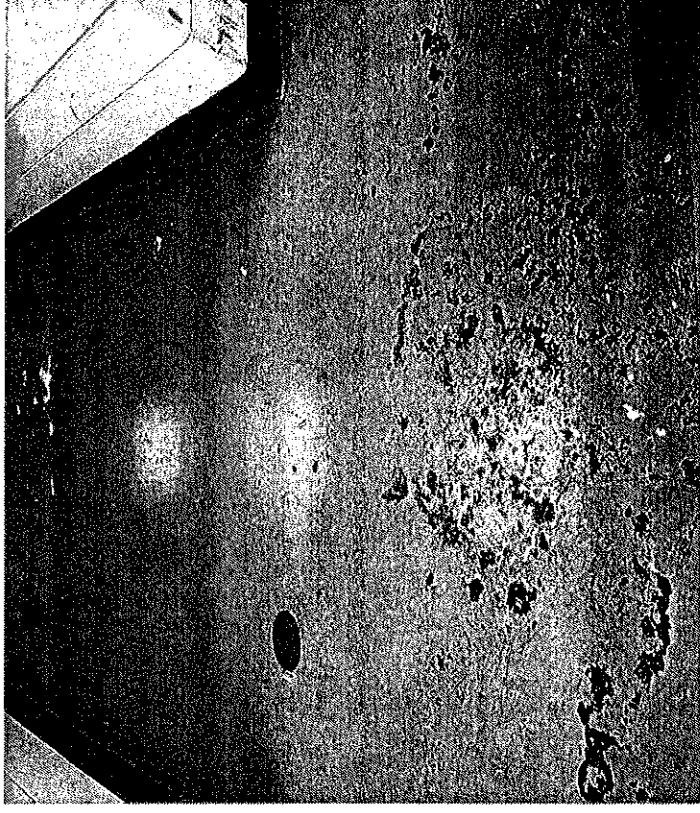
Lower Level Floors

- Report produced May 2020
- Specific tests related to concrete slab moisture were completed at selected locations throughout the lower level
- Findings – Moisture vapor transmission rate (MVER) between 8.6-13.7 pounds per 1000 square feet – As a comparison, sheet and tile manufactures don't allow their materials to be placed when MVER levels exceed 2-3 pounds per 1000 square feet.
- Typically, a vapor barrier membrane is placed on top of a compacted sub-base prior to the pouring of a concrete slab – Hoffman Architects professional opinion that the slab was cast without an effective vapor barrier – primary reason for the excessive water vapor transmission through the slab – Later determined by Downes to be the case
- The fix – “negative side waterproofing” – all flooring is removed – shot blasted – and specific coating products applied to resist specific moisture transmission rates

- High rate of vapor emissions – results in excess humidity
- Slippery floors
- Failure of flooring adhesive properties
- Mold
- Dirty duct work – HVAC

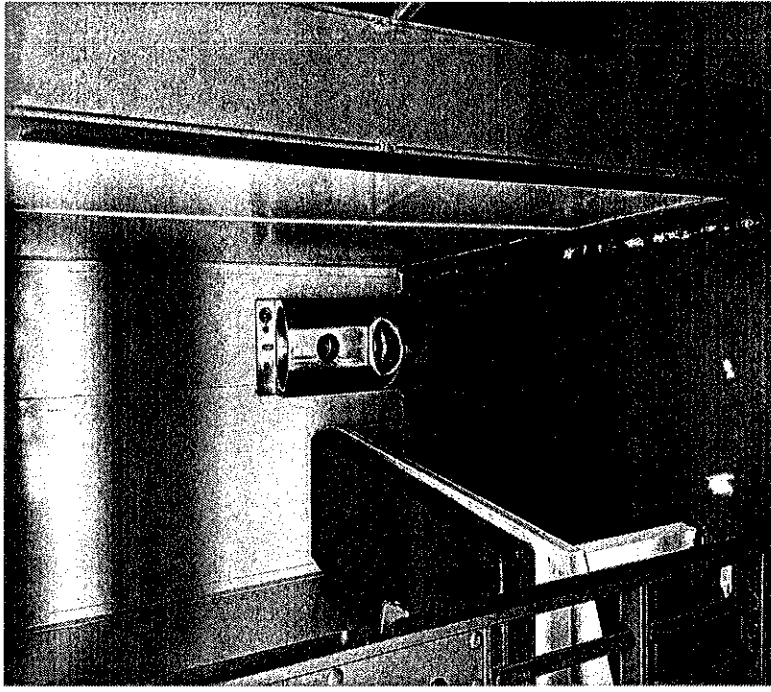
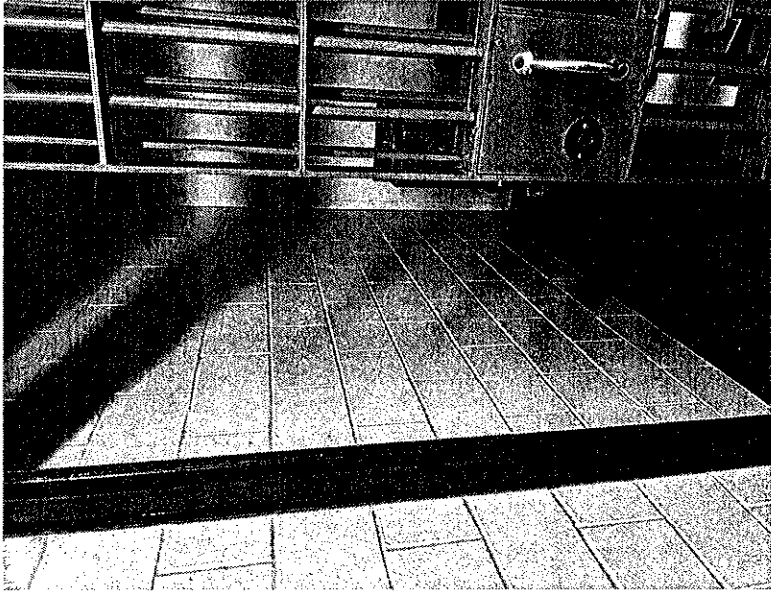
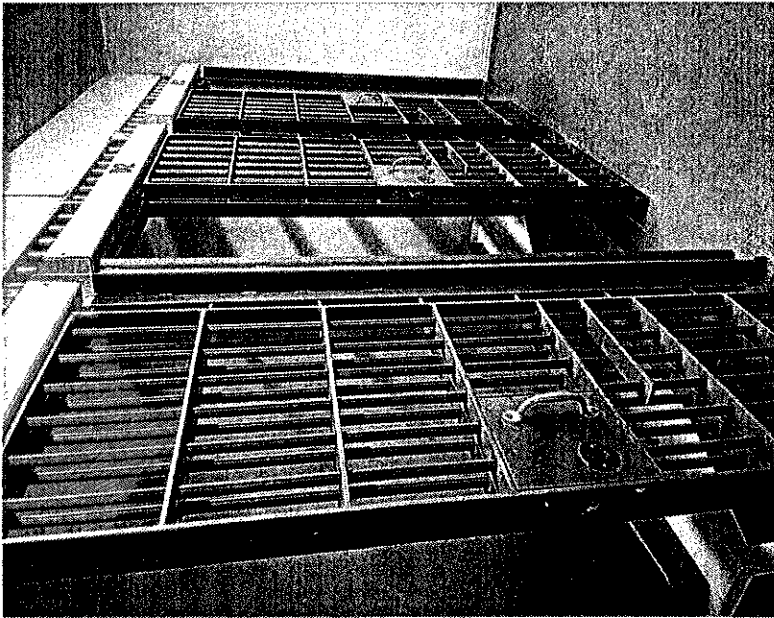
Cell Block

- Current cell blocks original to the Harrison Ave Police Department
- Old style bars – illegal in some states – need solid doors
- Susceptible to hanging – routinely have arrestees placing clothing around neck/bars
- Injuries sustained from banging head on bars
- Cells lack adequate ventilation / fresh air return
- No fire suppression
- Choke/ hanging points inside cell
- Entry/ egress – too small for extraction purposes
- 14 cells - Too many cells – wasted space
- Fixtures in cells are original to building and at end of useful life expectancy

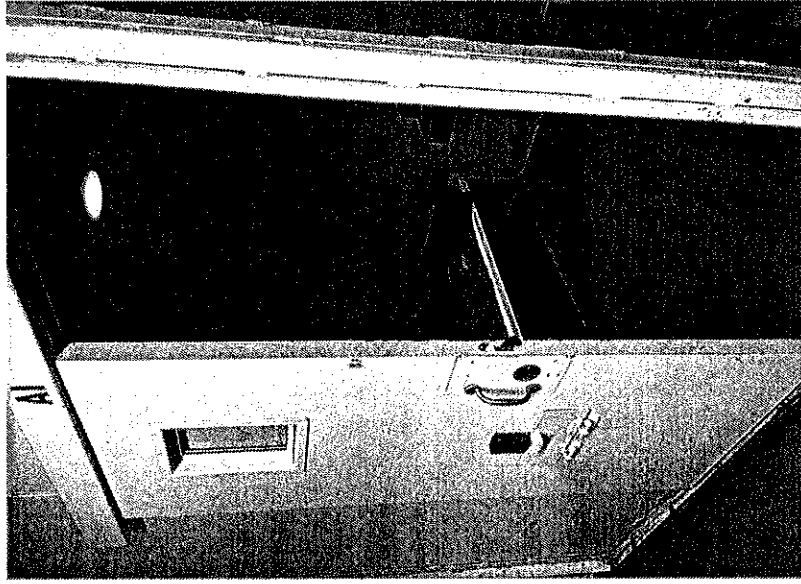
"Bio- Hazard" Cell

- 2 Bio-hazard cells
- Solid door – now utilized as our main cell block
- Wider entry
- Lacks adequate ventilation
- Lacks fire suppression
- Fixtures at end of useful life
- Older design of fixtures allows hanging/choke points

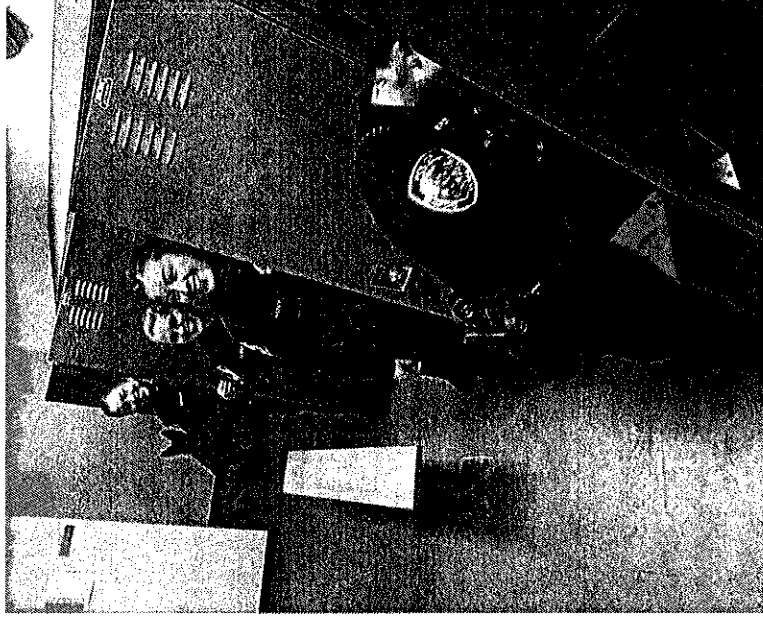
- 1995- Two female Officers – 12 lockers
- 2023- have 10 female officers – represents 20% of Officers
- Need to increase space
- Running out of space/ lockers

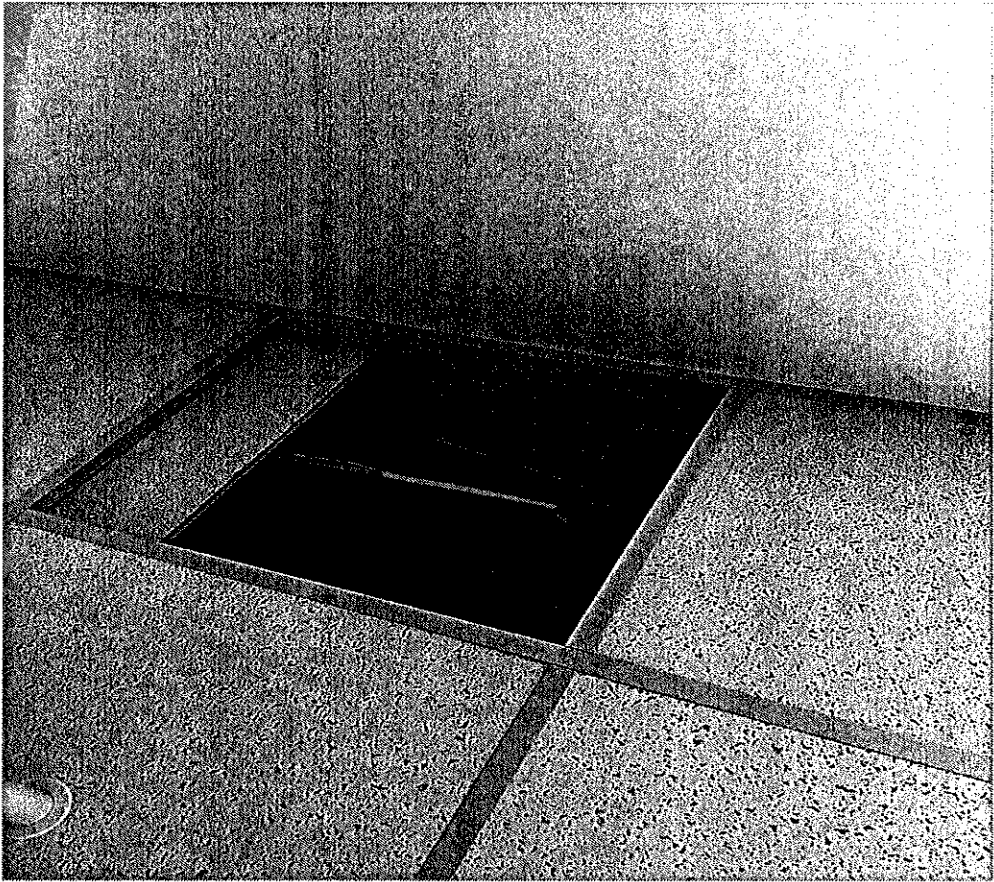
- Minor changes to the floor plan over the years have affected the balance of the HVAC
- Gas fired rooftop units currently service the building – RTUs are single zone, constant volume systems – comfort issues exist because temp control is based on the occupancy/ settings in the room that contains the thermostat (one thermostat controls multiple rooms)
- No dehumidification capabilities on current system
- Some clearance issues were identified as out of code (exhaust fans to dedicated outdoor air intake for cell block)
- Uninsulated Space above ceiling tiles

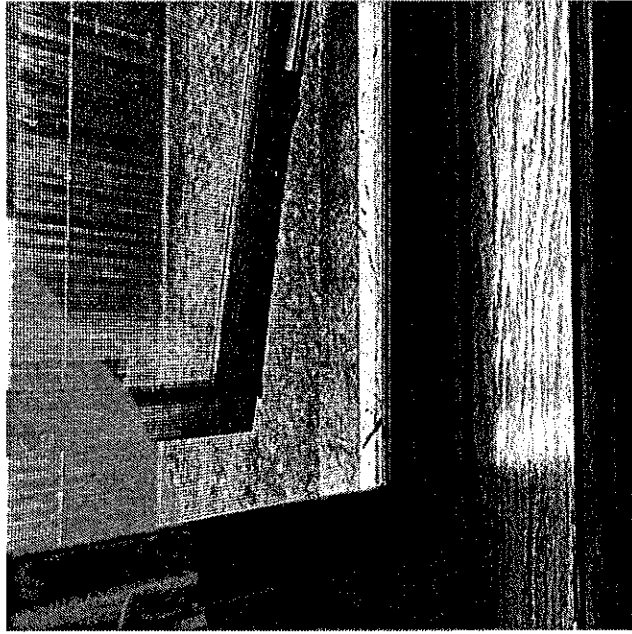
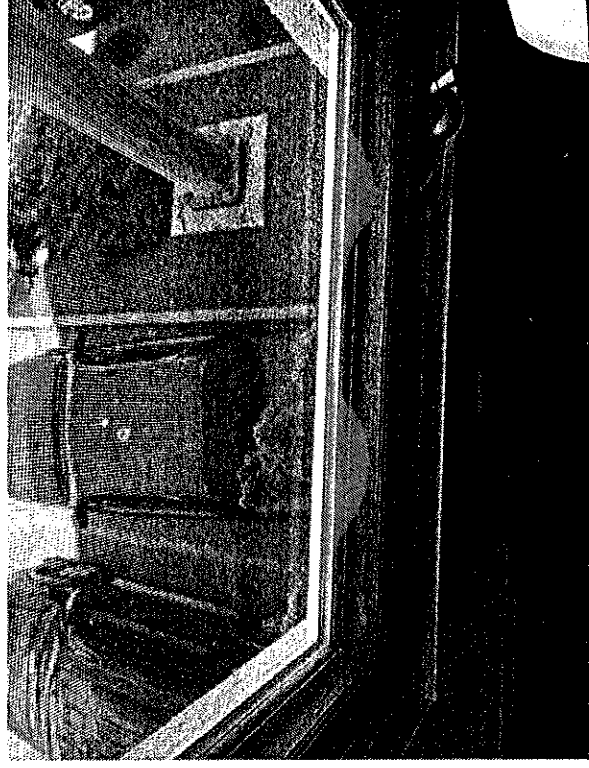
Main Floor

- Windows – original to building - residential grade

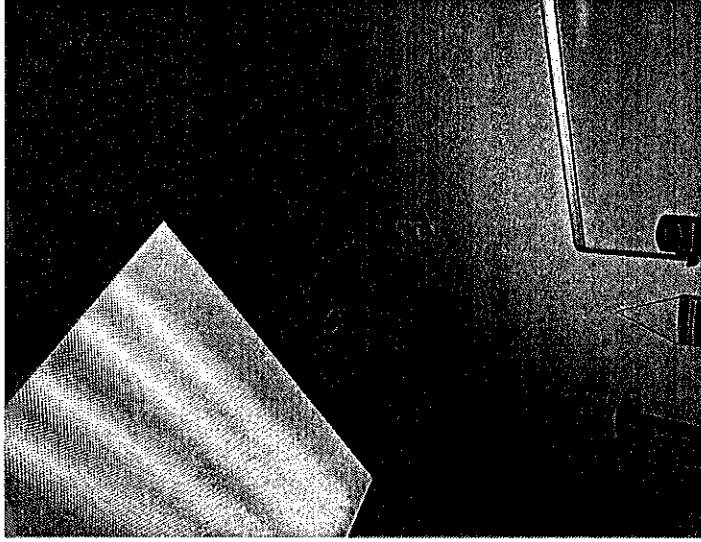
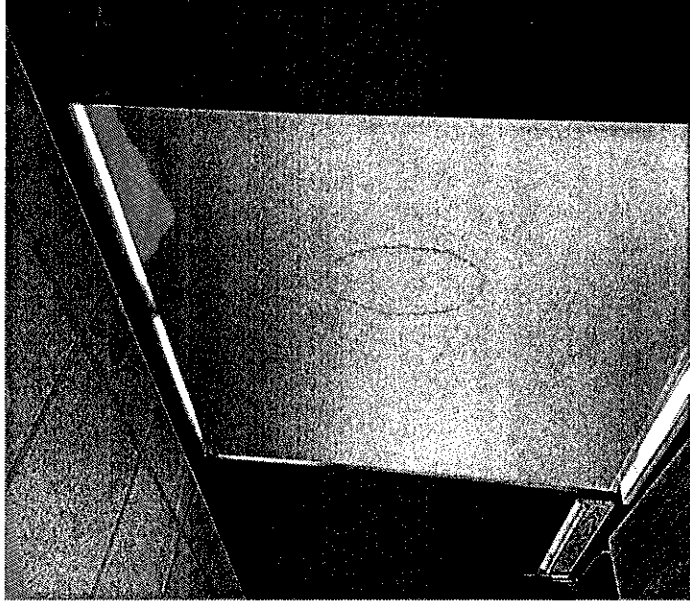
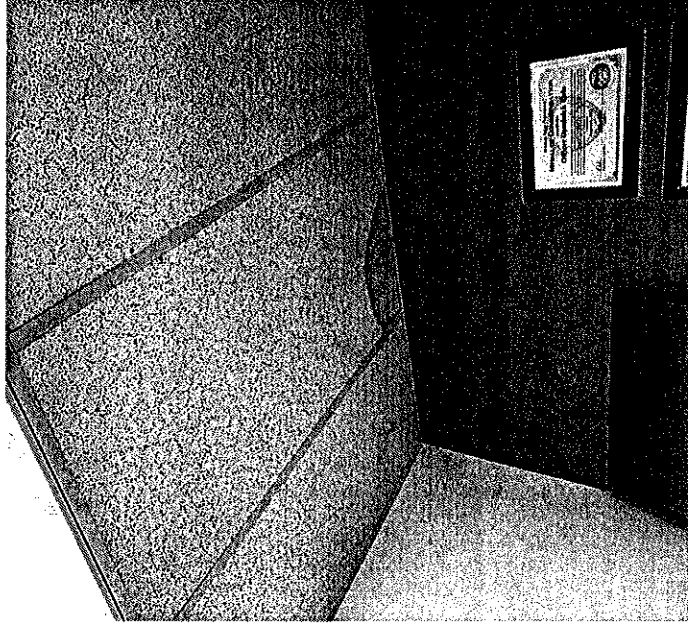
- Roof – water leaks observed throughout the building

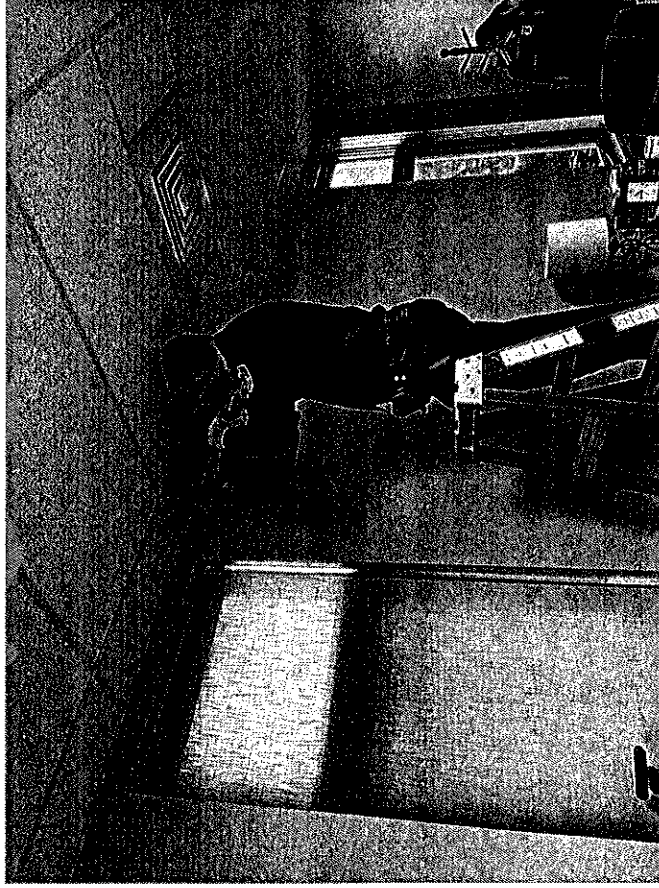
- Roof – water leaks observed throughout the building

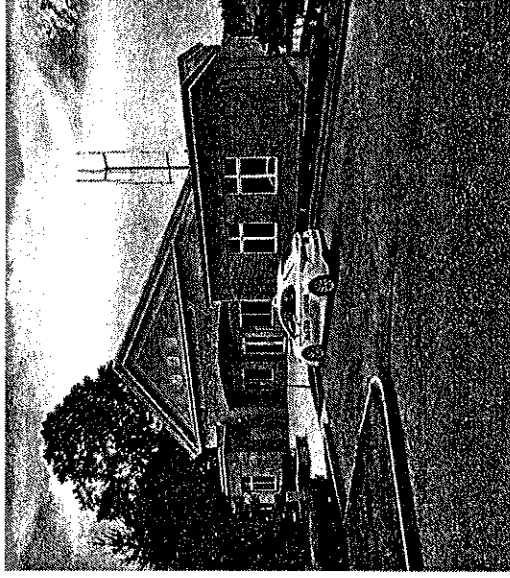
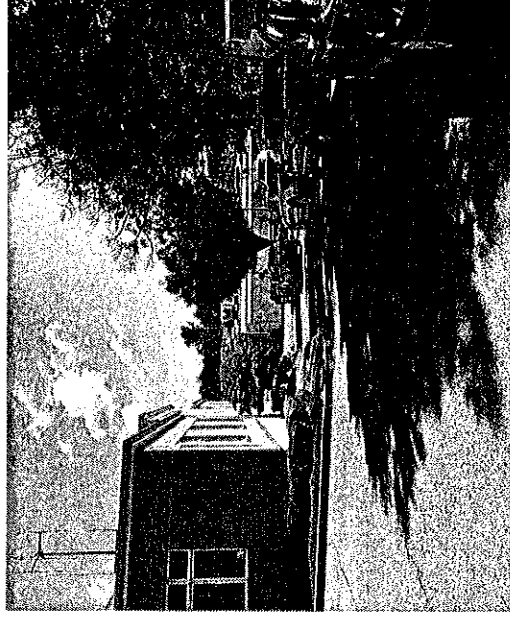
- Public Parking – currently limited three spaces / one handicapped – forces public to park in back lot and walk up the side hill
- Lack of security (stalking, 1st amendment audits, damage to private vehicles, mental health issues)
- Lack of police parking
- Risk mitigation
