**PINE GUTTER BROOK ASSESSMENT
AND RESTORATION PLAN**

FINAL DRAFT

DRAFT
March 2005
MMI #2619-01

Town of Branford
Parks and Open Space Authority
One Northford Road
Branford, CT 06405

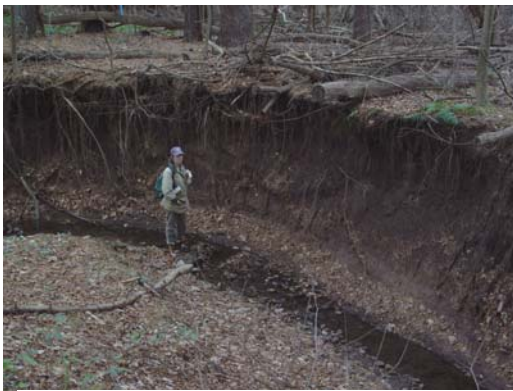
Figure 4. Example of bank "fall" in lower reaches of Pine Gutter Brook.

bank. This is the type of mechanism that occurs in the downstream reaches of Pine Gutter as shown in Figure 4. Slides occur when a mass of unconsolidated material moves along a discrete failure plane. Flows occur when material is liquefied enough to force internal deformation.

In the lower reaches of Pine Gutter Brook the failure mechanism appears to be granular flow. Debris was not observed in a fan pattern at the base of the slopes because it has been washed downstream and into the sediment basin.

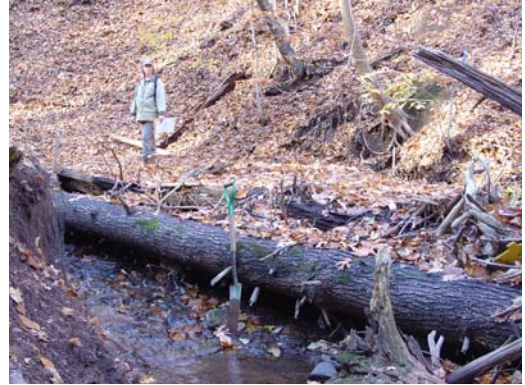
One important control process that occurs in mountain rivers is the presence of large woody debris. Inspection of Pine Gutter Brook found areas of woody debris jams as shown in Figure 5. The presence of this material is beneficial in preventing channel erosion by providing flow resistance and creating a stepped channel profile. In small streams like Pine Gutter Brook, this debris is not likely to become

Figure 5. Example of large woody debris in Pine Gutter Brook channel

mobilized in high flow events. The narrow valley walls and steep side slopes also hinder the movement of debris once it is wedged in the channel. These debris jams also provide habitat value and instream diversity, adding to the overall health of the stream corridor. One disadvantage to debris jams is that they block fish passage on perennial streams.

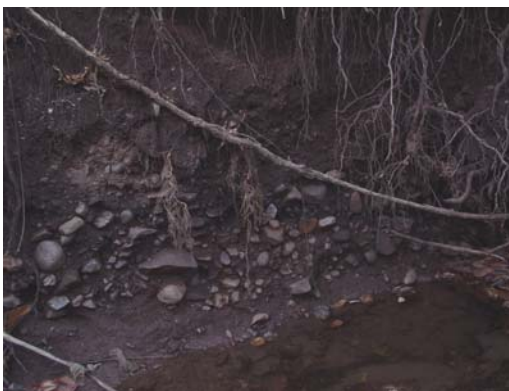
Figure 9. Channel banks in Reach 2 showed evidence of river bed cobbles, indicating previous channel bed locations and elevations.

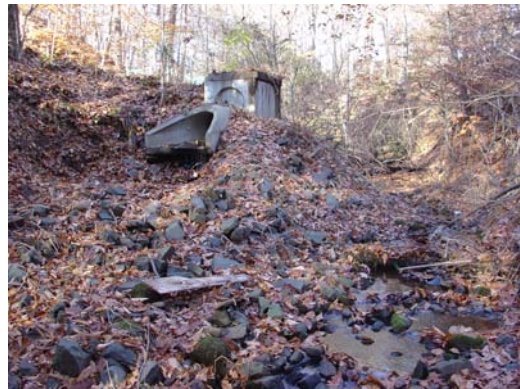
Figure 10. Perched storm drainage discharge in Reach 4.

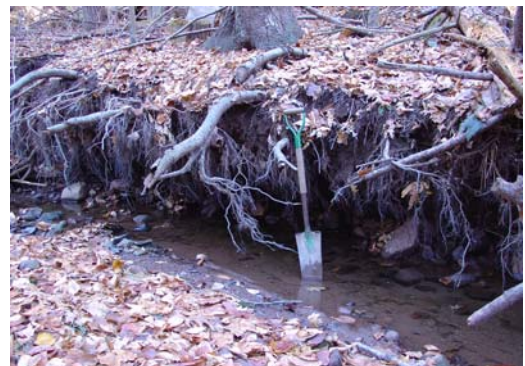
Another issue to be addressed in this reach is the undercutting of tree root systems along the bank (see Figure 15). Trees should be evaluated on a case by case basis, with earth and rock fill material placed under the tree roots to provide support. In areas where this is not possible, then the tree should be removed and the bank cut back to meet the channel width.

Figure 15. Tree root systems undercut by channel erosion. Place fill material under tree to stabilize, or remove tree and cut back bank.

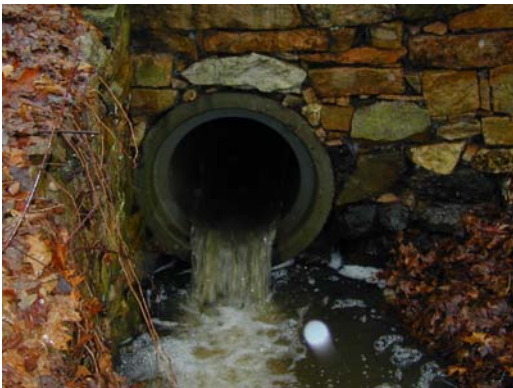
Figure 20. Culvert under Laurel Hill Road at Pine Gutter headwaters.

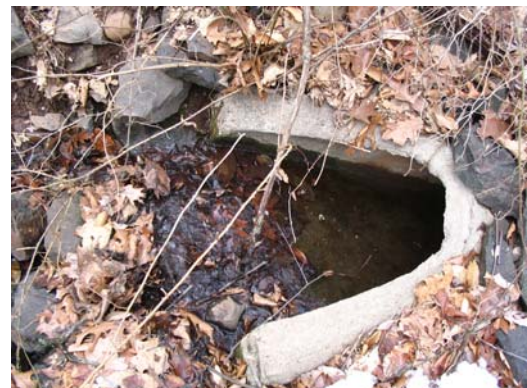
Figure 21. Discharge location of WS-20.

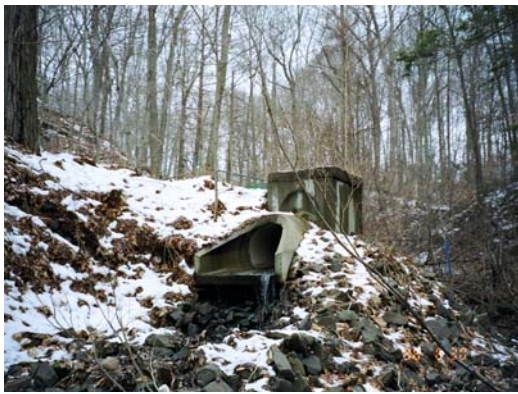
Figure 22. Discharge location of WS-30. Pipe is perched above grade.

north side of the access road to the sanitary sewer siphon. A channel carrying overland flow also enters into this catchbasin. Discharge from this catchbasin then flows to a 36-inch diameter reinforced concrete pipe with flared end section. The outlet from this pipe is perched as shown in Figure 22, with riprap at the outlet to prevent scour of the adjacent bank.

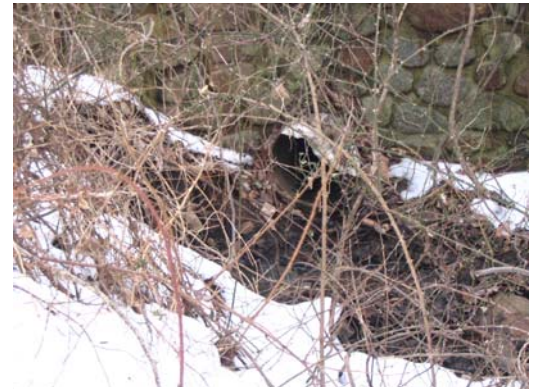
Figure 23. Discharge location of WS-40 is left of this CMP

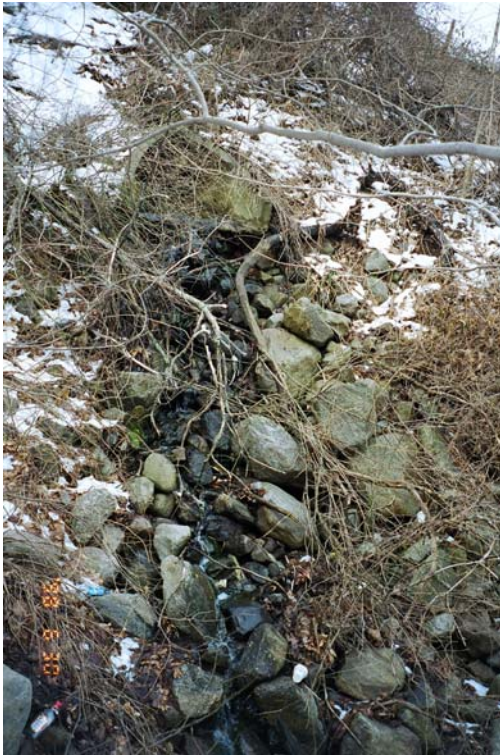
Figure 24. Discharge location of WS-50. Perched pipe discharge to gully.

Watershed 50: Watershed 50 (WS-50) consists of storm drainage network around Squire Hill and Homestead Roads. The watershed consists of single family residential development and a portion of the Squire Hill Apartment Complex. A 36-inch reinforced concrete pipe with flared end section forms the outlet of the watershed as shown in Figure 24. The discharge location is at a gully east of the existing dumpster of the Squire Hill Apartment Complex. Stormwater flows approximately 180 feet in this gully before entering Pine Gutter Brook. This gully contains household debris and garbage due to its location near the dumpster. Downstream of the outlet, the gully is severely eroded and the drainage outlet is perched above the gully bed. Bedrock was observed in the Pine Gutter Brook channel at the gully outlet,

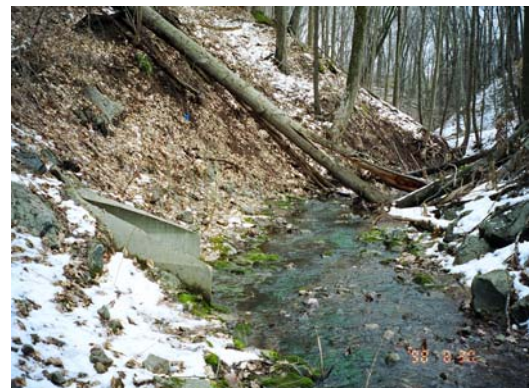
Figure 25. Discharge location of WS-60. 30" RCP with concrete and riprap bed armor.

Watershed land use consists of residential development and roadways. The outlet is a 30-inch diameter reinforced concrete pipe with flared end section in good condition. The outlet is located at elevation 66, approximately 70 feet below the elevation of Pine Hollow Road. A drop manhole structure, which serves to control velocity in the pipe system, was identified approximately 30 feet upgradient from the outlet. The channel at the outlet of the 30-inch diameter pipe has been reinforced with riprap and concrete (See figure 25), presumably to prevent scour of the channel bed.

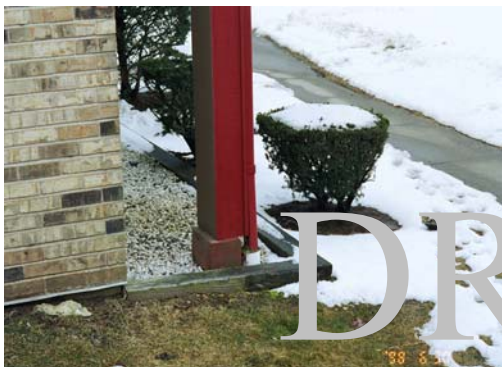
Figure 27. Downspouts at Squire Hill Apartment Complex are connected directly to the storm drainage system. This condition was observed at many residential properties in the watershed

grass areas or piped directly to the roadway drainage system. A number of properties in the Pine Gutter Brook watershed were observed to have downspouts discharging directly to nearby driveways or into the drainage system as shown in Figure 27.

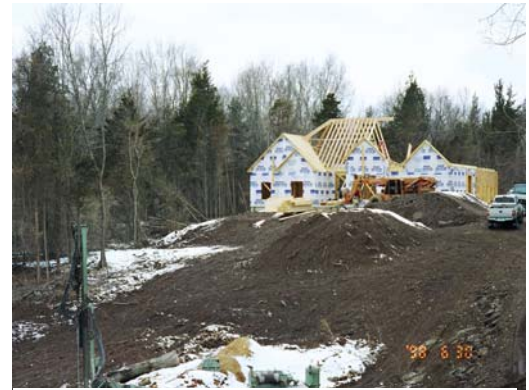
Much of the sediment collected in the sediment basin at the confluence of Pisgah Brook and Pine Gutter Brook is generated by bed and bank erosion along the channel. However, the introduction of new sediment to the river system from construction and earth moving activities should be avoided. This can be accomplished through the implementation and maintenance of proper sediment and erosion controls at construction sites. Figure 28 depicts a construction site near the north end of the Pine Gutter watershed where limited sediment and erosion controls were observed.

Figure 28. Construction site on Laurel Hill Road near watershed limit.

A sediment and erosion control plan must be developed for any site where more than one acre of disturbance is proposed. The plan should depict the location of proposed controls, a construction sequence and details of the proposed controls. The plan should comply with the requirements of the 2002 Connecticut Guidelines for Soil Erosion and Sediment Control. Development of a sediment and erosion control plan is critical to successful implementation by site contractors. Review of this plan should occur during the Planning and Zoning Site Plan review process. Based on the fact that zoning through much the Pine Gutter Brook watershed is ½-acre residential, future development is expected to be limited to single building lots associated with historic subdivisions. Sediment and erosion control at these lots should be considered carefully.
