August 31, 2023

Subject: Structural Evaluation of Trolley Bridge
Branford, Connecticut
MHAI Project No. 23-126

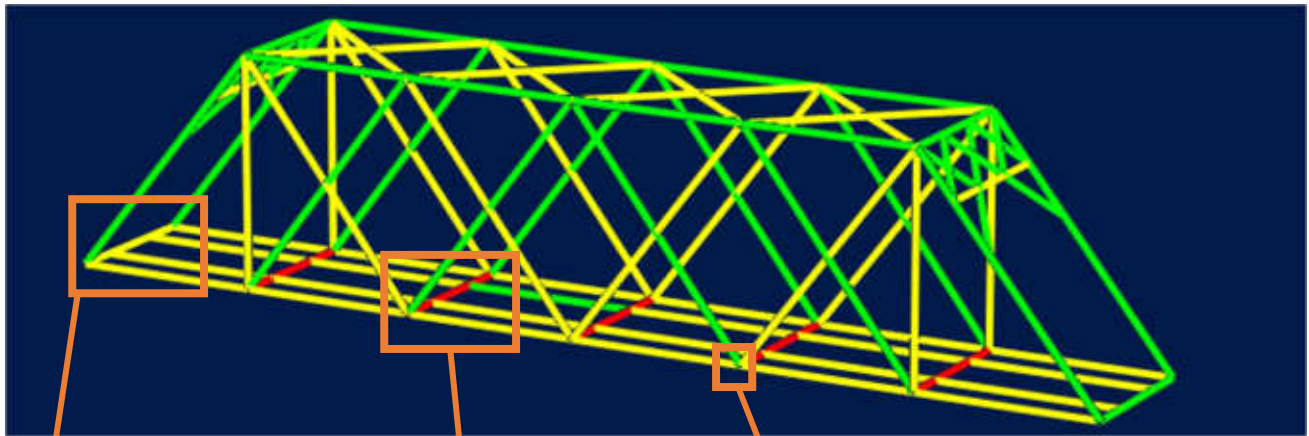
Analysis Model of Bridge - Identifying Compromised Members

Green: Adequate
Yellow: Caution
Red: Failing (for deflection only)

<p>Bridge Member Plan Base Platform</p>	<p>Repairs:</p> <ol style="list-style-type: none"> 1. Plate connection failure. 2. Beam-to-beam connection repair required. 3. Loss of section at web. 4. Loss of section at top flange. 5. Loss of section at bottom flange. 6. Web stiffener repair. 	
	<p>Repairs by member:</p> <p>B1: Repair 6. B2: Repair 5. B3: Repair 2 typical. B4: Repairs 4&5. B5: Repair 4. B6: Repair 2 typical. B7: Repair 2 typical. B8: No repairs required. B9: Repair 1 @ B10. Repair 2. B10: Repair 1 @ B9 & B11. B11: Repair 1 @ B10 & B12. B12: Repair 1 @ B11. B13: Repairs 1 & 5. B14: Repair 2 typical. B15: Repair 2 typical. B16: Repair 2 typical. B17: Repair 2 typical. Repair 4. B18: Repair 2 typical. Repair 4. B19: Repair 2 typical. B20: Repair 2 typical. Repairs 5&6. B21: Repair 2 typical. Repair 5. B22: Repair 2 typical. Repair 5. B23: Repair 2 typical. Repair 5. B24: Repair 2 typical. Repair 5. B25: Repair 2 typical. B26: No repairs required.</p>	<p>B27: Repair 1 @ B28. B28: Repair 1 @ B27 & B29. B29: Repair 1 @ B28. B30: Repair 1 @ B31. B31: Repair 1 @ both ends.</p> <p>Repair work at the truss web members and at the horizontal bracing between top chords of the truss, is limited to the replacement of approximately (50) - 2"x5/16"x25" plates. <i>Refer to Photograph Exhibit #11.</i></p>

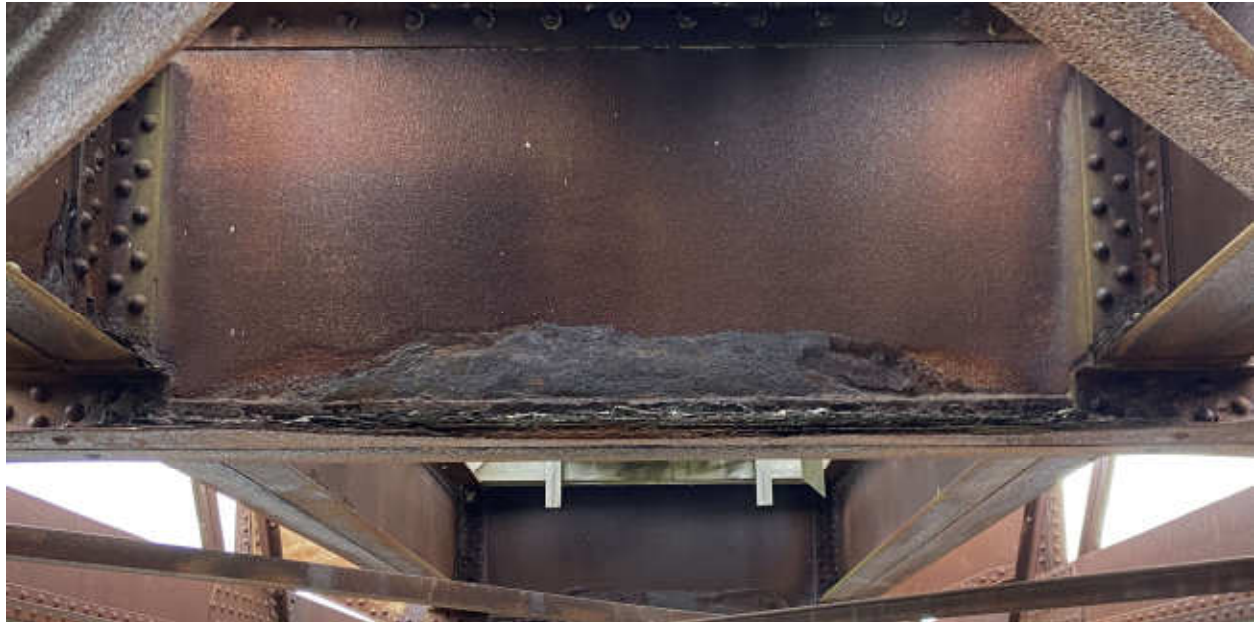
Photograph #1

Beam Photos:
1, 2, 5, 6, 8, 9, 10

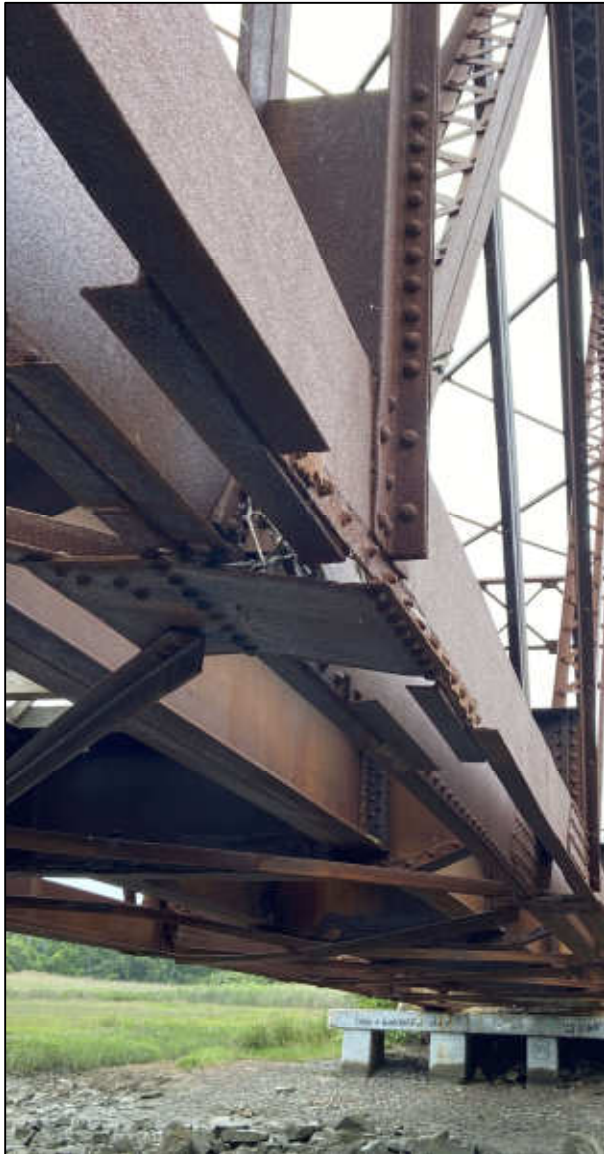
Photograph #3

Plate Connection
Photos: 3, 4, 5

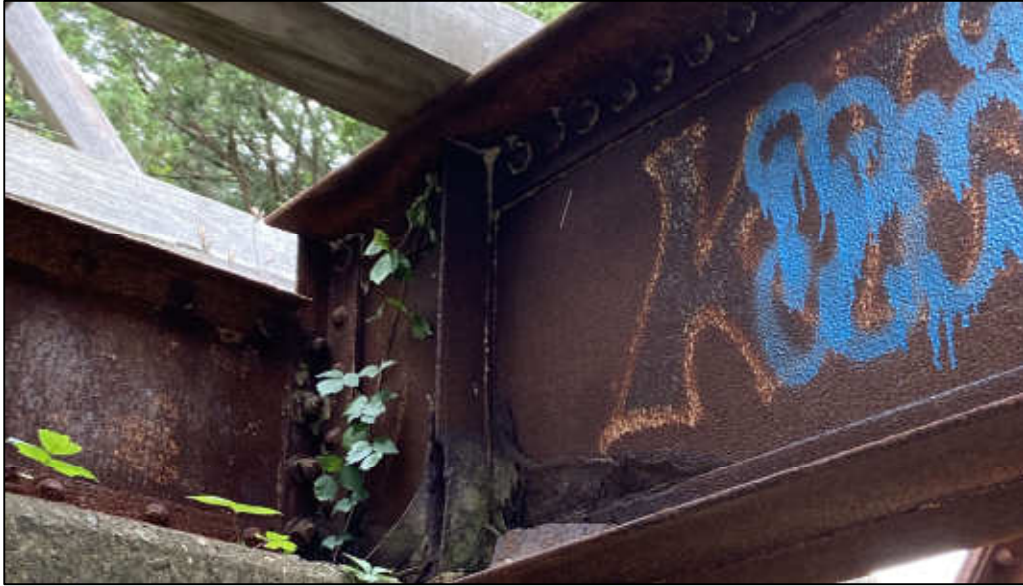
Photograph #7

Web Stiffener
Photos: 7
