Slab Moisture Investigation

Branford Police Department Branford, CT

Architect's Project No. 220030

7 May 2020

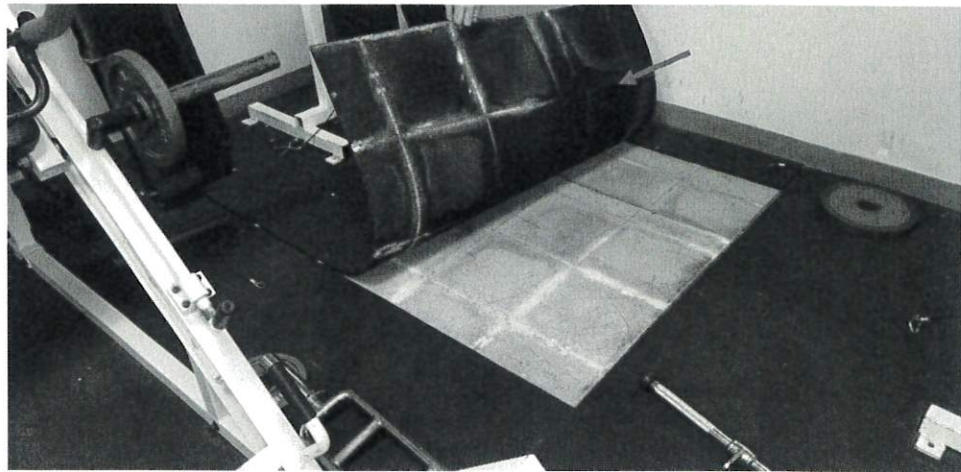
In February 2019, Hoffmann Architects made the following general observations while on site discussing the project with Branford officials. In the workout room, we lifted a loose-laid, resilient floor tile and discovered VCT underneath. On the underside of the resilient flooring (rubber), moisture was present.

Photo 1 - View of resilient floor, lifted. Note: moisture present on underside.

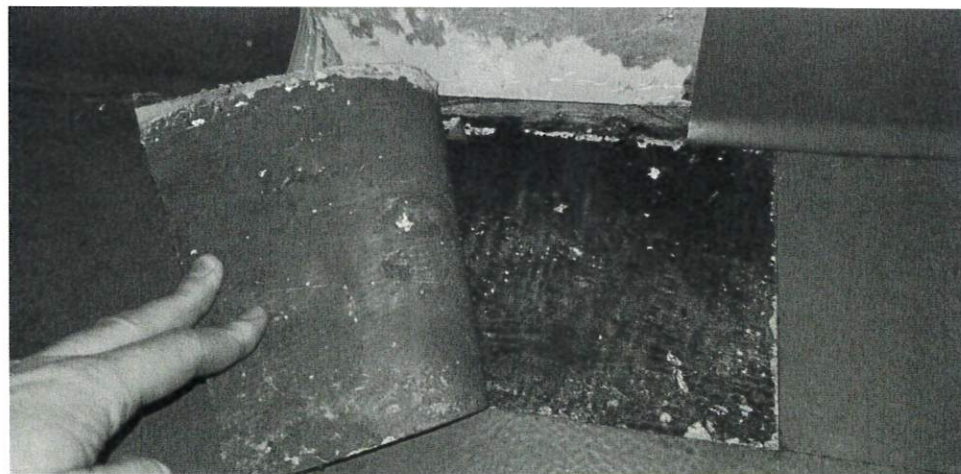
In the men's locker room, the finish flooring is a gray solid vinyl tile. This tile is applied over a blue membrane material. We were able to easily remove one small tile and noticed that there was little to no adhesion of the tile to the substrate.

Photo 2 - View of solid vinyl tile, lifted. Note: blue membrane underneath.

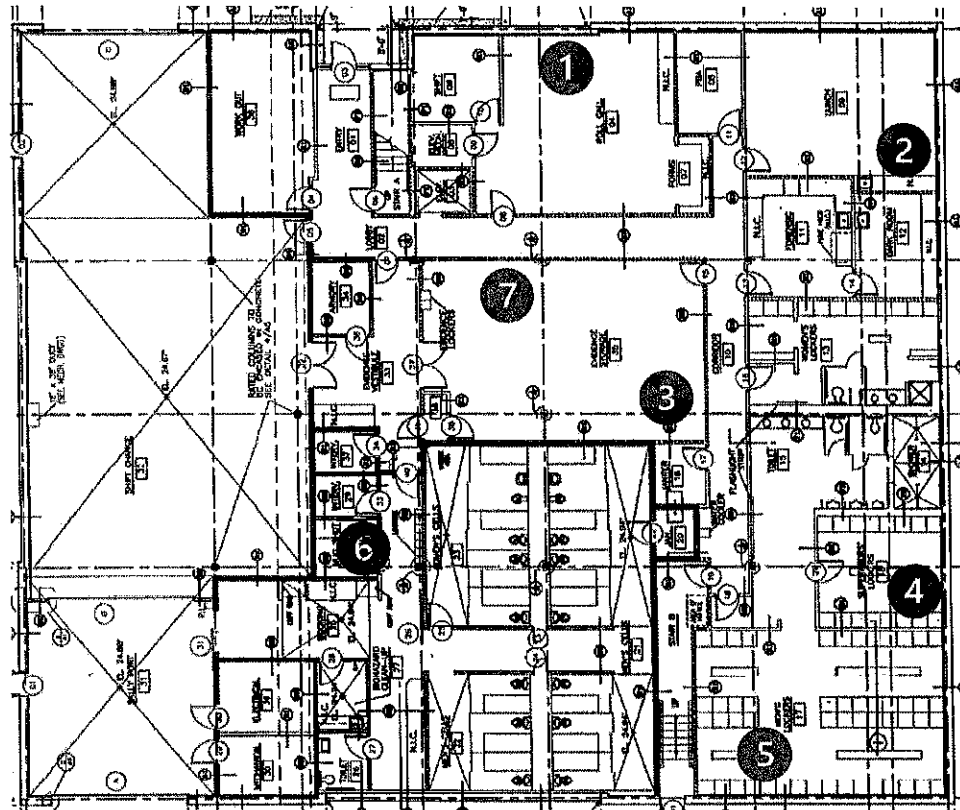
Photo 5 - Ground floor plan. Yellow shaded area is not part of test area. Red dots indicate test locations.

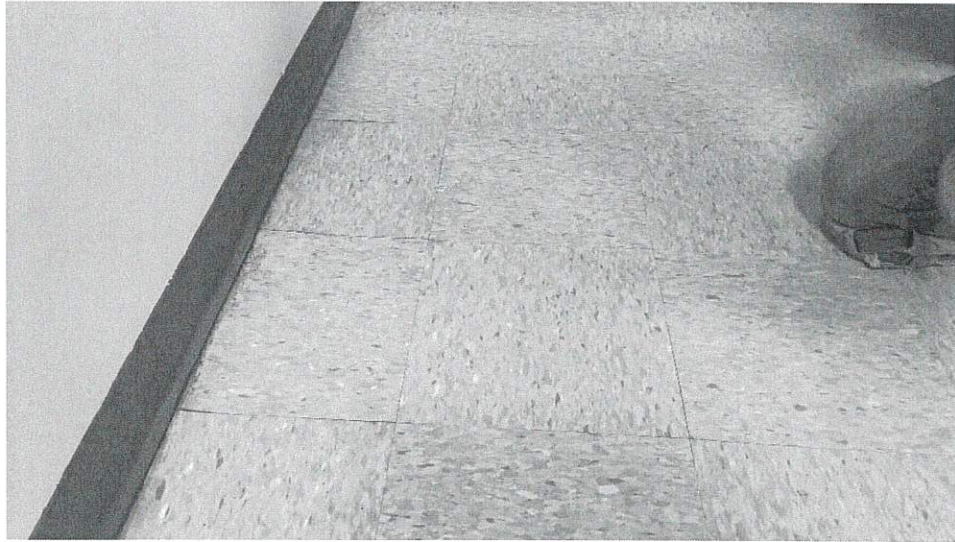
Three vinyl composition tiles were removed by IFTI and the concrete slab was prepared for moisture testing. The adhesive that bonds the VCT to the concrete slab was wet. Tiles were not securely bonded.

Photo 6 - View of VCT flooring in roll call room.

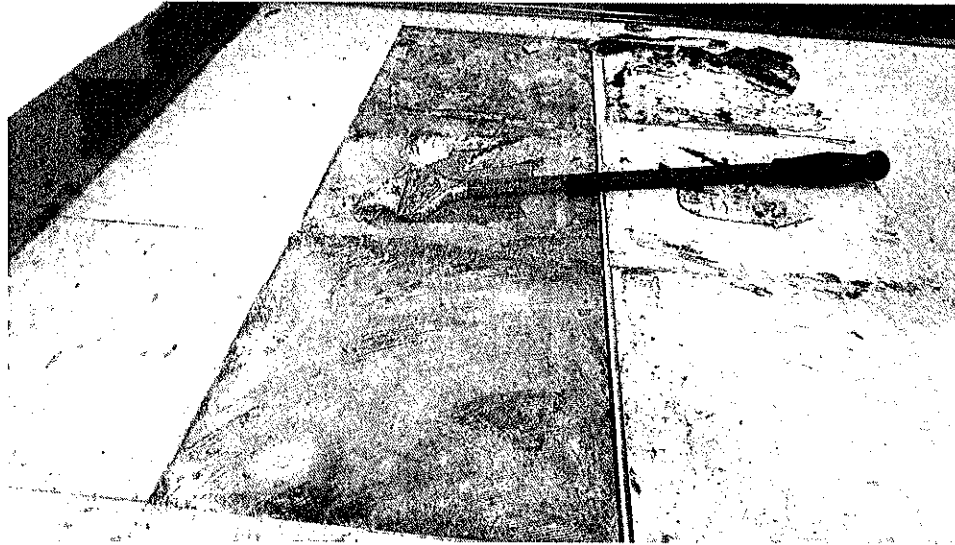
Photo 7 - Three tiles removed in roll call room. A scraper was used to remove the VCT adhesive.

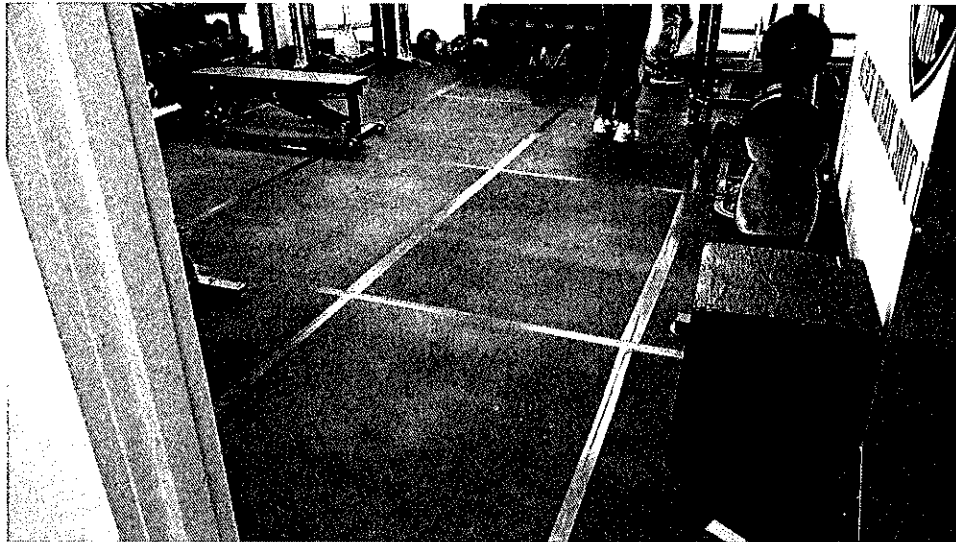
A section of resilient rubber flooring was rolled back, and eight vinyl composition tiles were removed by IFTI. The concrete slab was prepared for moisture testing. The adhesive that bonds the VCT to the concrete slab was wet. Tiles were securely bonded in this room. However, the VCT adhesive was wet and re-emulsified.

Photo 9 - View of resilient rubber flooring at gym.

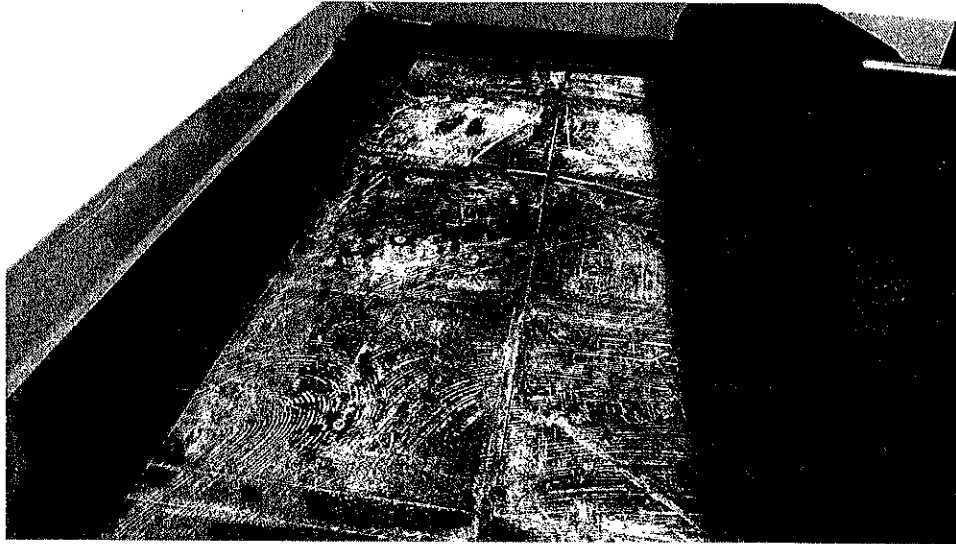
Photo 10 - View of resilient rubber floor rolled back to expose VCT.

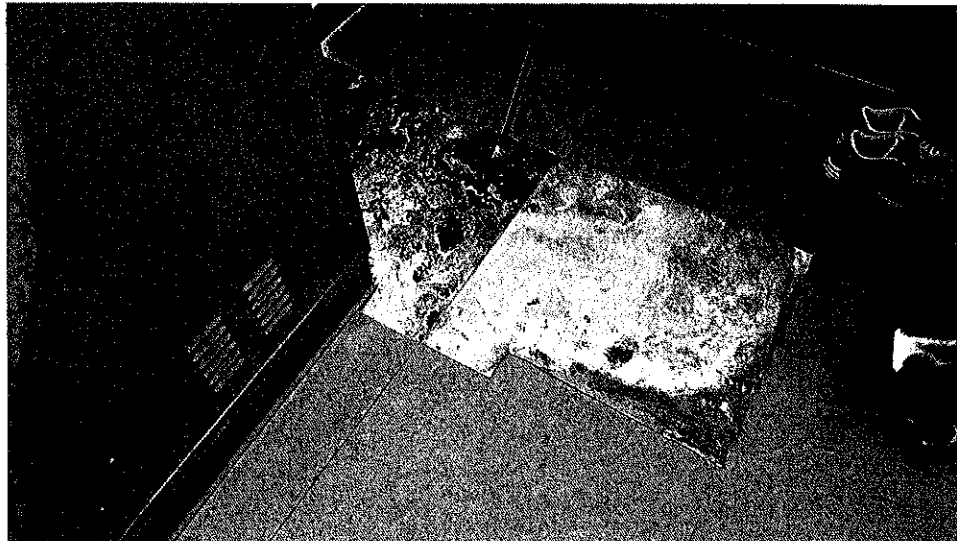
Four vinyl tiles were removed by IFTI and the concrete slab was prepared for moisture testing. The adhesive that bonds the vinyl tile to the blue coating on the concrete slab was wet and re-emulsified. Tiles were not securely bonded.

Photo 13 - Vinyl tiles removed in supervisor's locker room. Note: blue coating on slab.

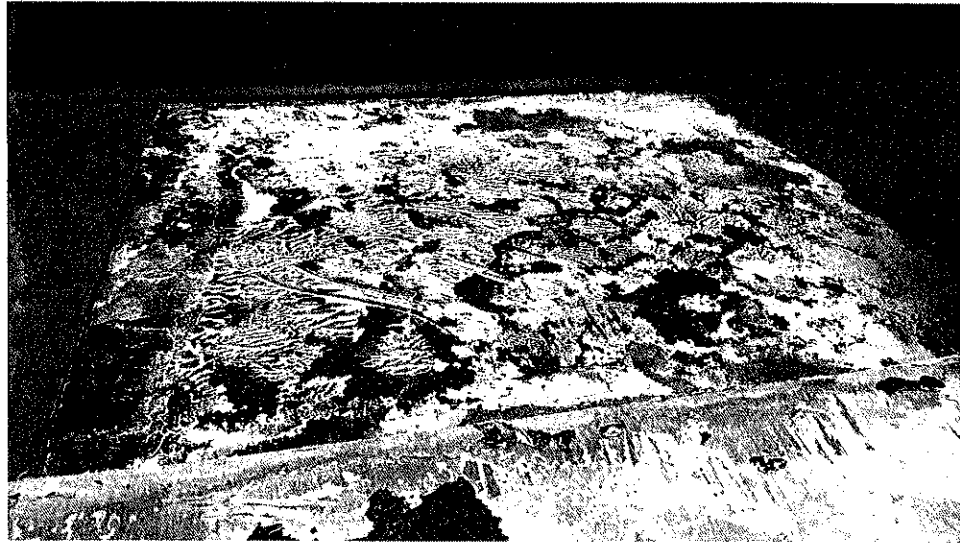
Four vinyl tiles were removed by IFTI and the concrete slab was prepared for moisture testing. The adhesive that bonds the vinyl tile to the blue coating on the concrete slab was wet and re-emulsified. Tiles were not securely bonded.

Photo 15 - View of vinyl tile removed in men's locker room.

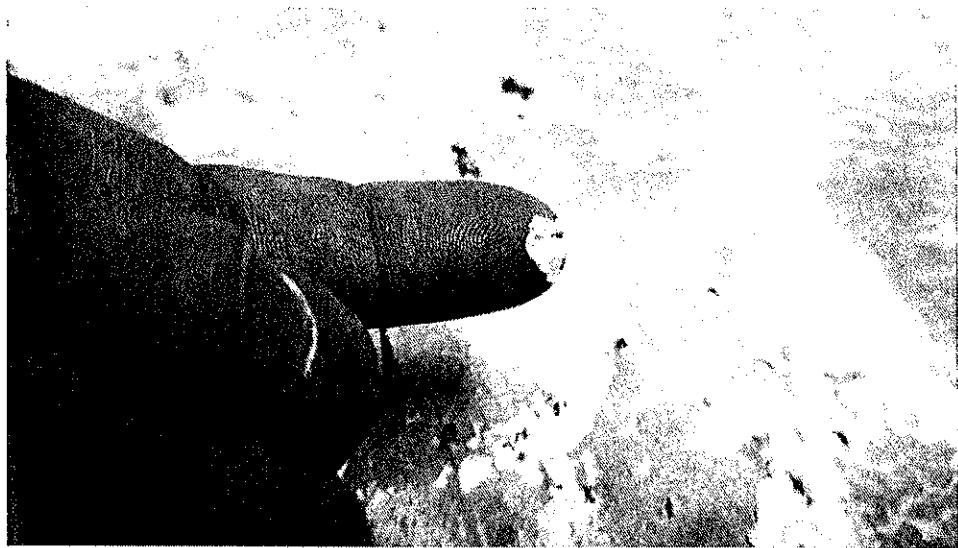
Photo 16 - Adhesive bonding vinyl tiles to blue coating was wet, deteriorated, and paste consistency.

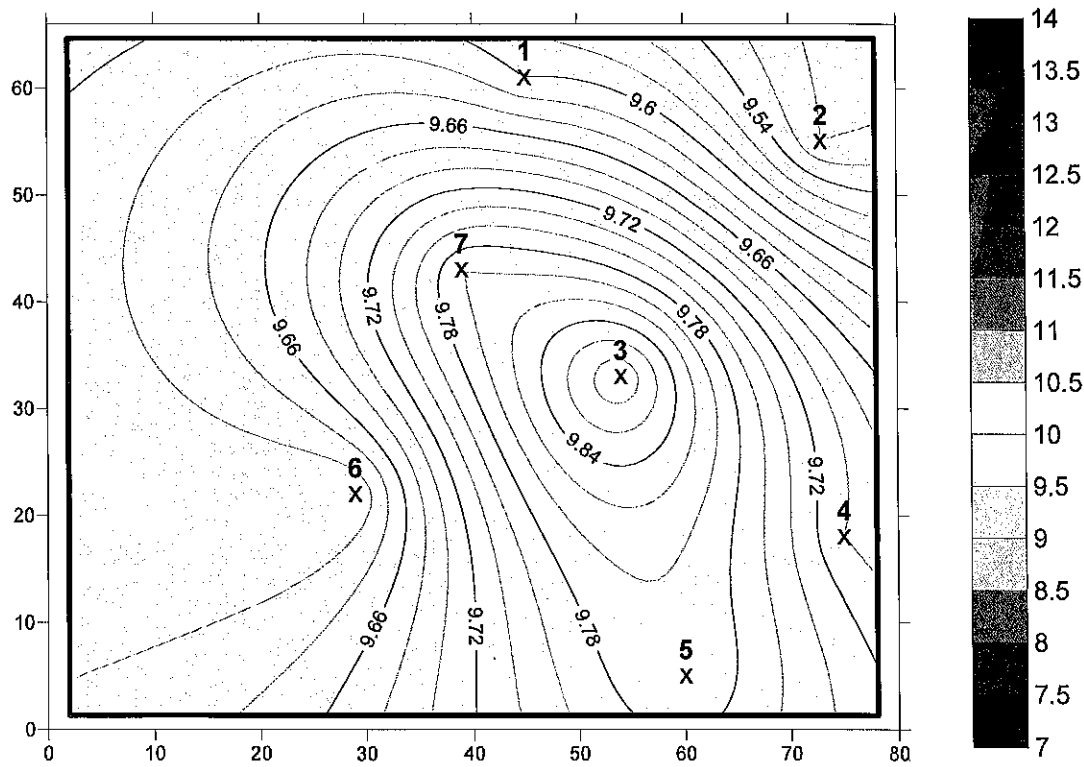
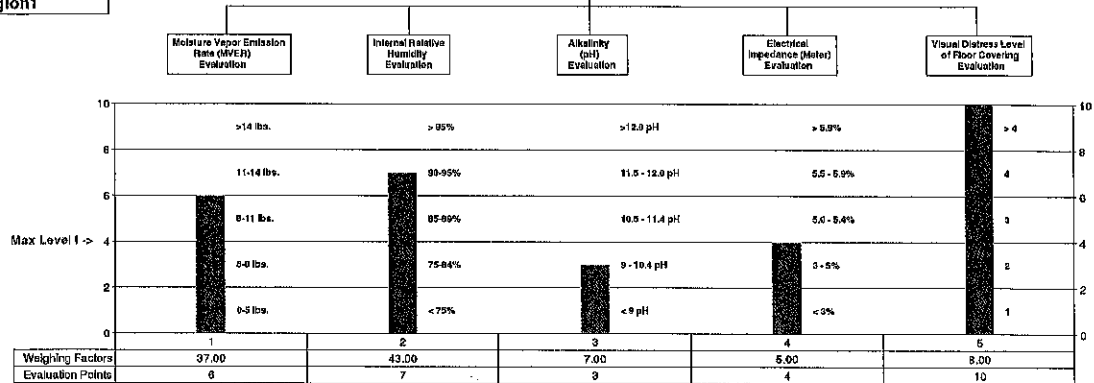
IFTI's Risk Assessment & Repair Option Chart

- In summary, the Risk Assessment is showing that overall; a "Moderate to High Risk Condition" exists.
