# **A Biosocial Analysis of the Pisgah Brook Watershed**

**Philip B. Huffman  
Nathan M. Frohling  
Derek C. Denniston  
Miel R. Corbett**

**Yale University  
School of Forestry and Environmental Studies**

**FES 740: Ecosystem Management  
Professor William R. Burch Jr.  
May 1996**

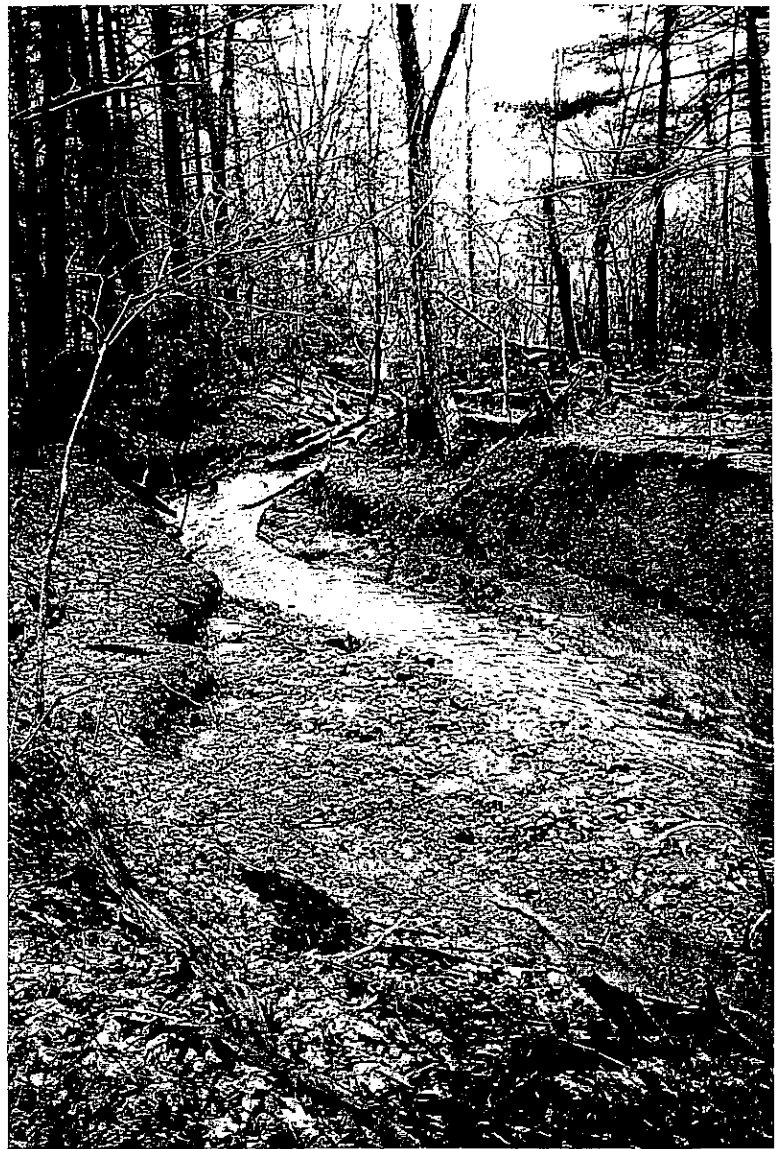
**Pine Gutter Brook Erosion**

There is a serious erosion problem in Pine Gutter Brook. The original stream channel has been swept away by the huge force of storm water discharging from upper elevations of this sub-watershed. These extreme storm water volumes and energy are due to human developments and drainage systems. Not only does the undermining of the river corridor degrade the associated riverine habitat, take out upland vegetation and leave raw, unconsolidated soils exposed in many locations on huge embankments, but it contributes a continuous source of heavy sediment loading to both Pine Gutter and Pisgah Brooks, and therefore to the Branford Supply Ponds which are located immediately downstream. This sediment is highly damaging to ecosystem structure and function, as well as to the highly prized recreational and scenic values of Pisgah Brook and the Supply Ponds. Sediment loading clogs fish gills, destroys fish and aquatic organism habitat, interferes with the normal functioning of aquatic life (e.g., predators being able to see their prey), and disturbs the normal level of photosynthetic activity to which a balanced system is accustomed. Sediments also carry excessive nutrients into the water column, leading to additional water quality problems and accelerated eutrophication. (Noss & Cooperrider 1994) In addition, downstream wetlands and ponds may be physically inundated with sediment. In short, the ecological and recreational damage from erosion in the Pine Gutter Brook drainage is serious and has caused substantial degradation of the Pisgah Brook watershed's otherwise high quality. This damage is not likely to be restored for the foreseeable future because both the driving forces and vulnerable conditions remain. As we will see below, efforts have been made to solve the problem, but these have failed. The Pine Gutter Brook erosion problem represents a clear and measurable indicator of the connection between people and the biophysical system. It shows us the natural response of the ecosystem to human perturbation. It also reveals one of the ways humans have related and

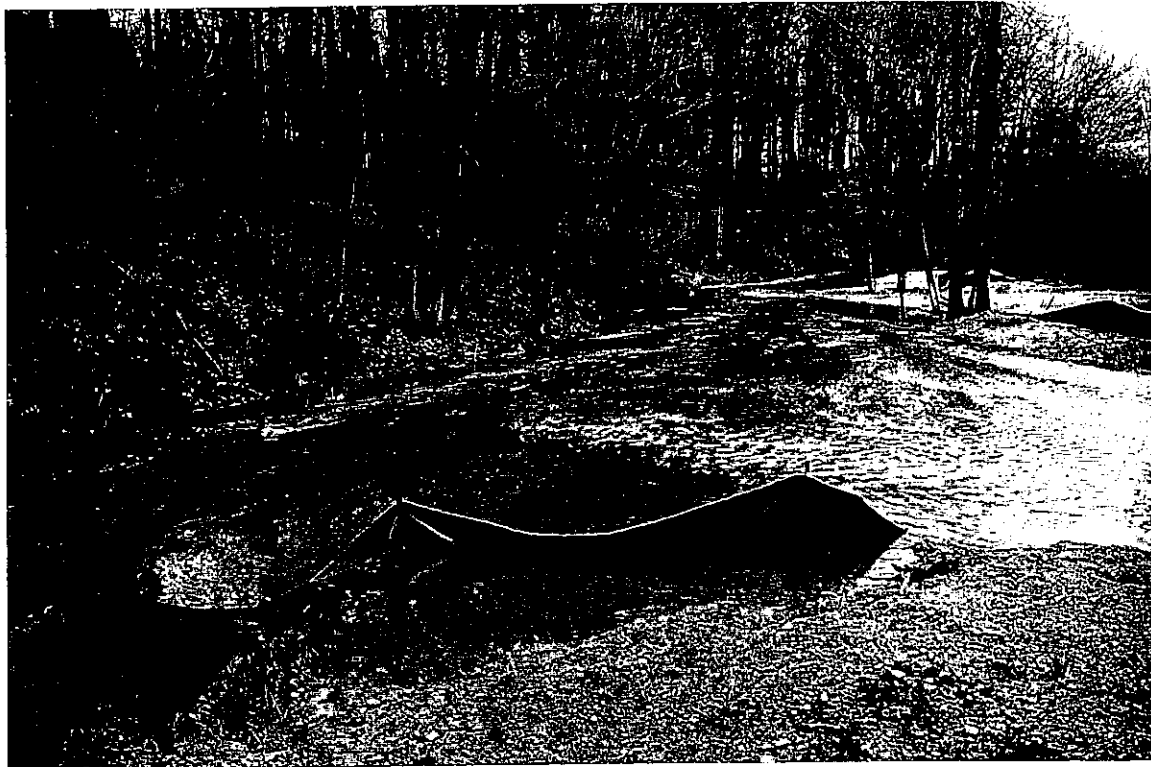
### **Confluence of Pisgah Brook & Pine Gutter Brook**

*Note contrast of sediment laden water from Pine Gutter Brook entering relatively clear Pisgah Brook during April 15-16 storm.*

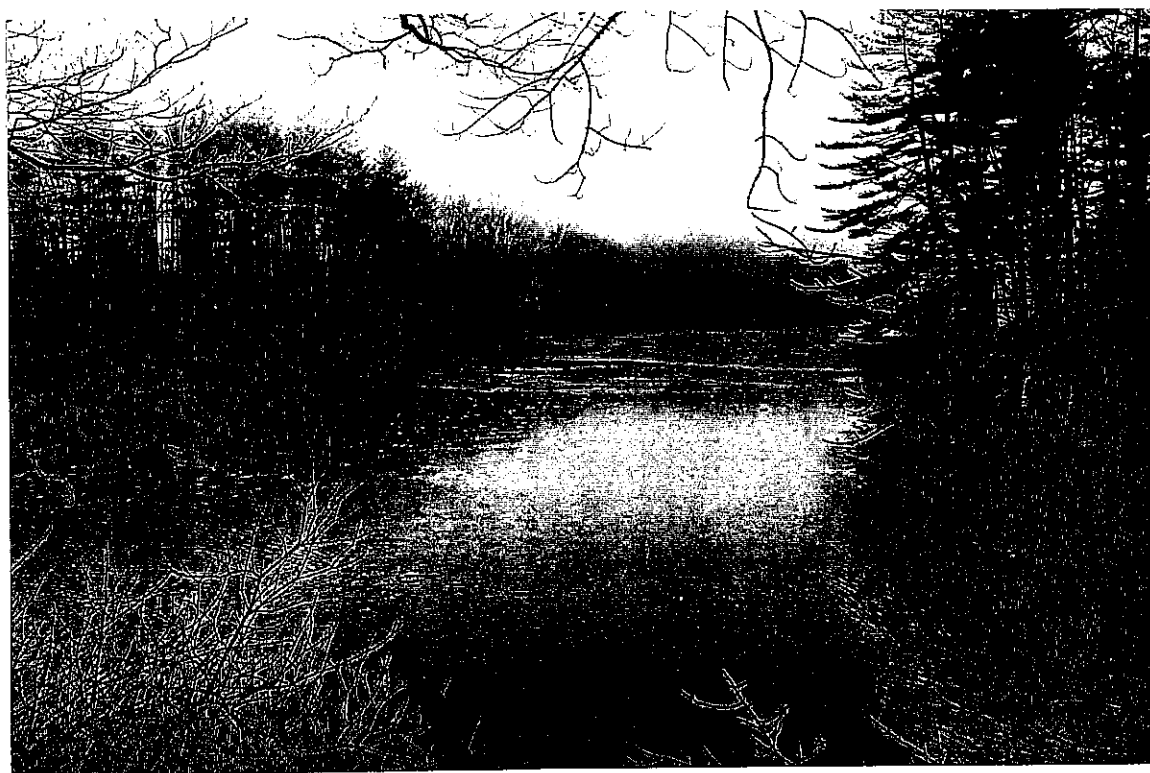
### **Storm Impact to Supply Ponds**

*April 15-16 storm with visible sedimentation impacts from Pine Gutter Brook. An isolated cove shown in middle/right of photo escaped the flow of turbid water*

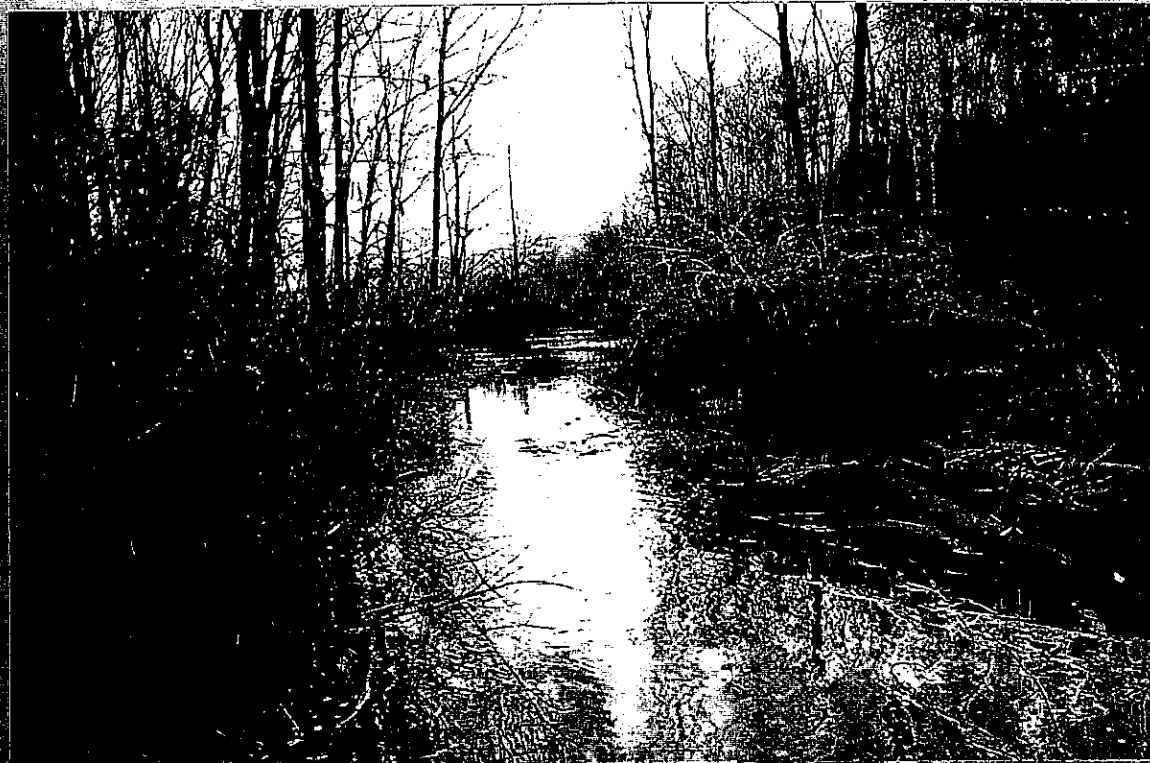
### **Wetlands During April 15-16 Storm Event**

*Just upstream of Pine Gutter Brook showing the natural, undisturbed system's ability to maintain water quality - even during storm events*

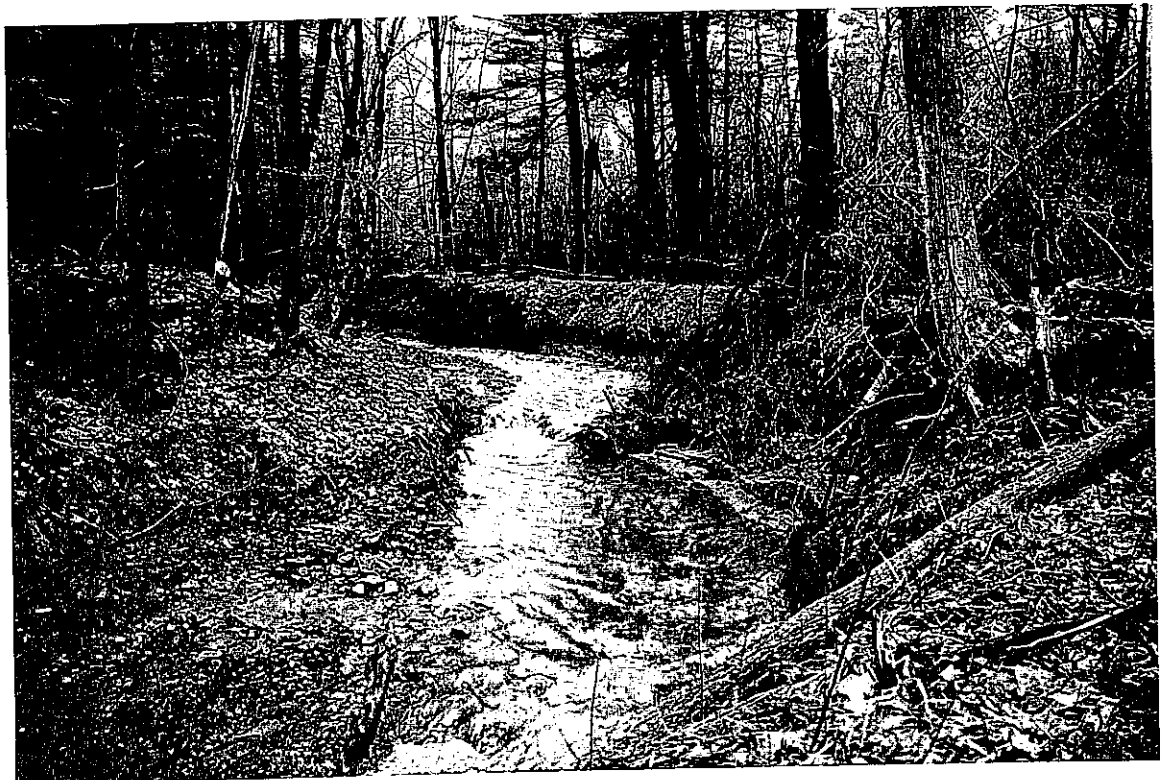
**Pine Gutter Brook Erosion**

Our calculations indicate that approximately 95,600 cubic feet of earth have been eroded and lost downstream. This is the equivalent of 3,540 cubic yards or 590 truck loads (using a standard 6-cubic yard, 6-wheeled dump truck). This is a huge figure for a brook that probably used to be on average about 8 feet wide from bank to bank and less than one foot deep in most places. Now, it is not uncommon to find the channel on the order of 25 feet wide and 5 feet or more deep. The volume of the original stream channel is estimated at 7,419 cubic feet—nearly 13 times less than the current one. (See Appendix A for further discussion.)

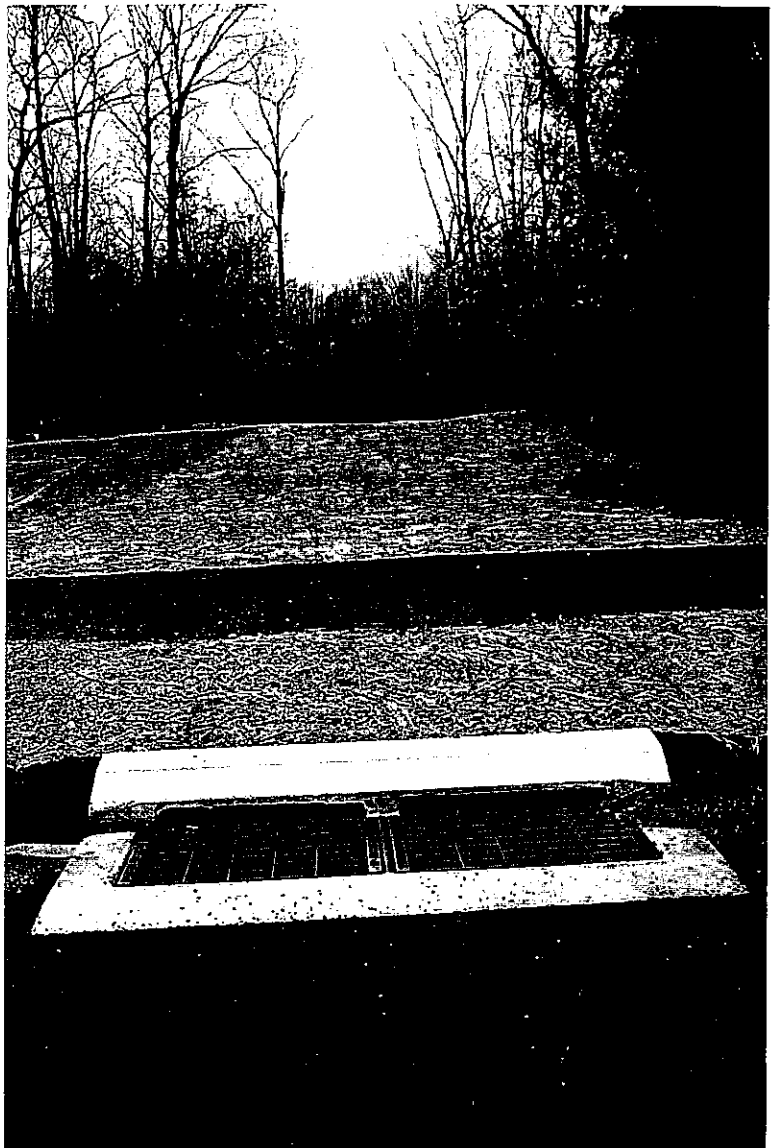
**Pine Gutter Brook  
Storm Water Drainage**

*Drain grating leading to outlet  
on Pine Hollow Road off Red Rock Road.*

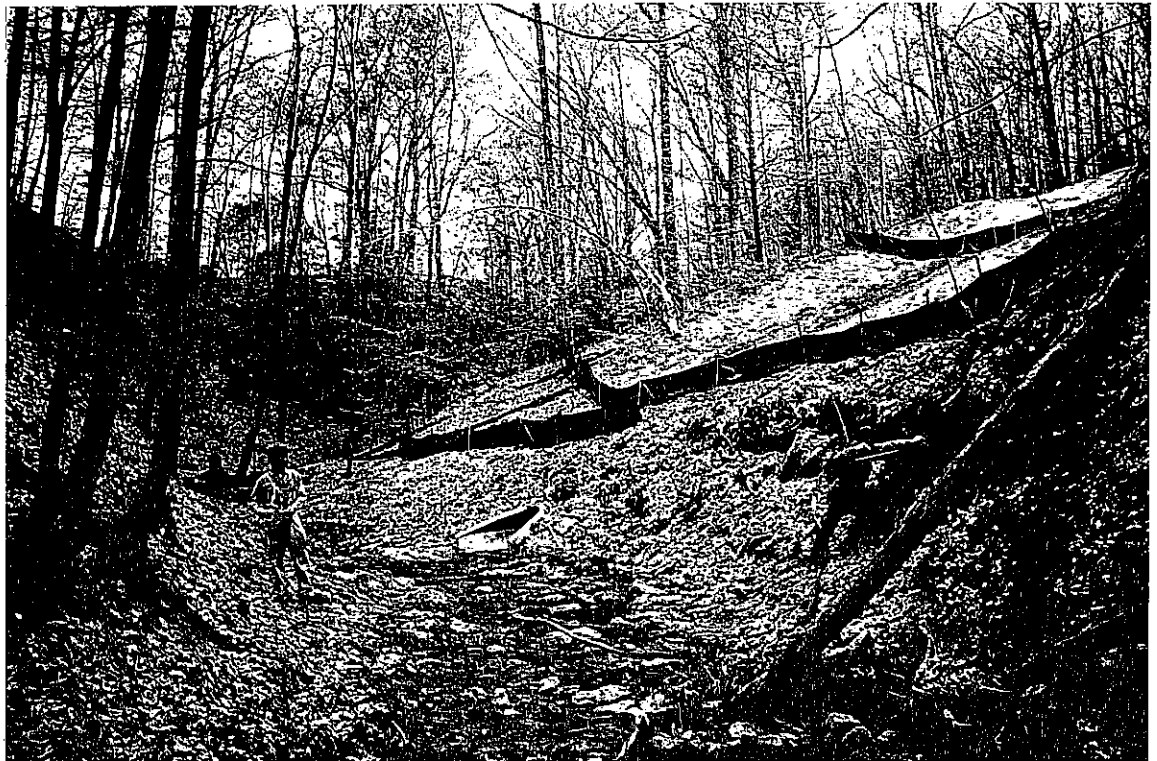
**Pine Gutter Brook  
Storm Water Outfall**

*Outfall draining Pine Hollow,  
Bear Path, and a portion of  
Red Rock Roads.*

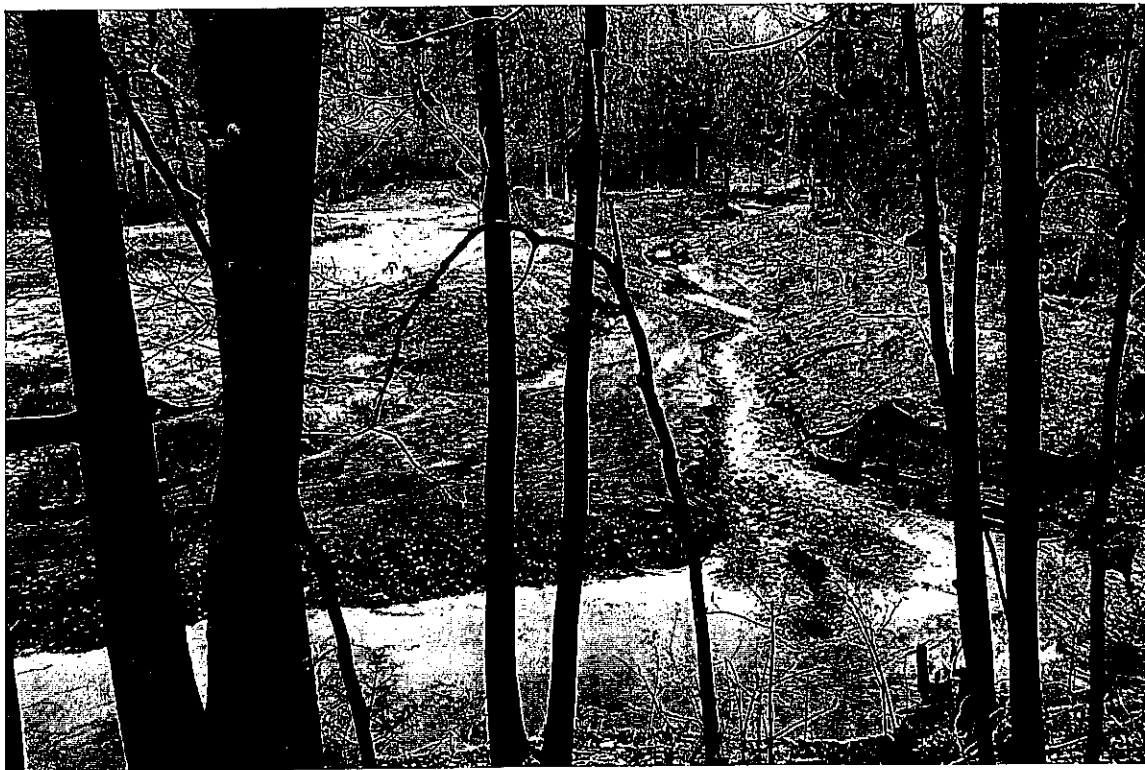
**Pine Gutter Brook Restoration Project**  
*Mouth of Pine Gutter Brook and Pisgah Brook*

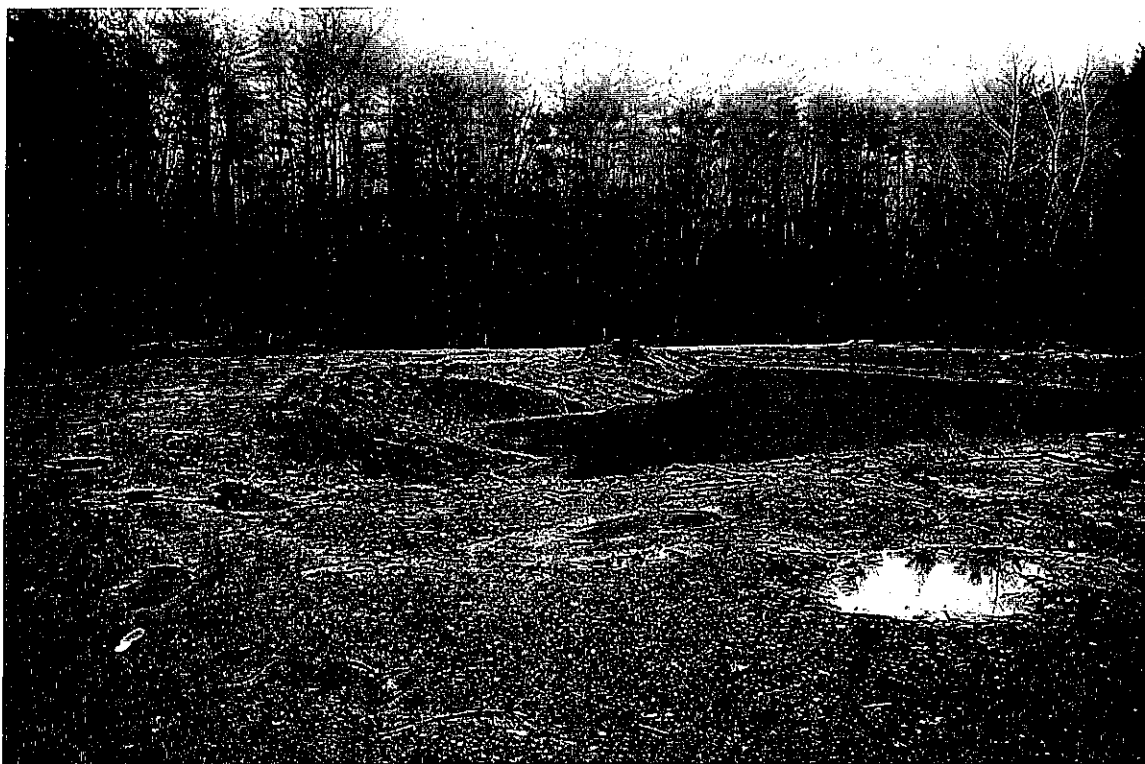
A restoration project has been pursued at the mouth of Pine Gutter Brook in an attempt to reduce the amount of sediment flowing into Pisgah Brook. This project had been pursued by the town in an apparently good faith attempt to address the problem. However, the project has failed. Instead of capturing the sediment, the project has exposed almost an acre of earth, which has remained barren and vulnerable to erosion from the fall of 1995 through the winter and into the spring of 1996. A settling pond was dug, and a log dam was built to raise the water elevation enough to enable the stream to flow into the settling pond, but the two components were never connected. During the major April 15-16, 1996 storm event, the base of the dam was blown out by the high volume and force of sediment-laden water in the brook. This resulted in further erosion of the stream channel and exposed banks below the dam, causing further degradation of water quality in Pisgah Brook and the Supply Ponds. A further impact on the local environment resulted from the fact that in order to get to the site, a bulldozer graded a half-mile path through the woods and across a culverted wetland, exposing additional soil to further erosion. We were unable to clarify the cause of such blatant project failure, but we suspect that time pressures, weaknesses in contract requirements, inadequate site design, and lack of oversight by the town were all involved.

**Pine Gutter Brook Restoration Project**  
*Showing pond intended as sediment basin*

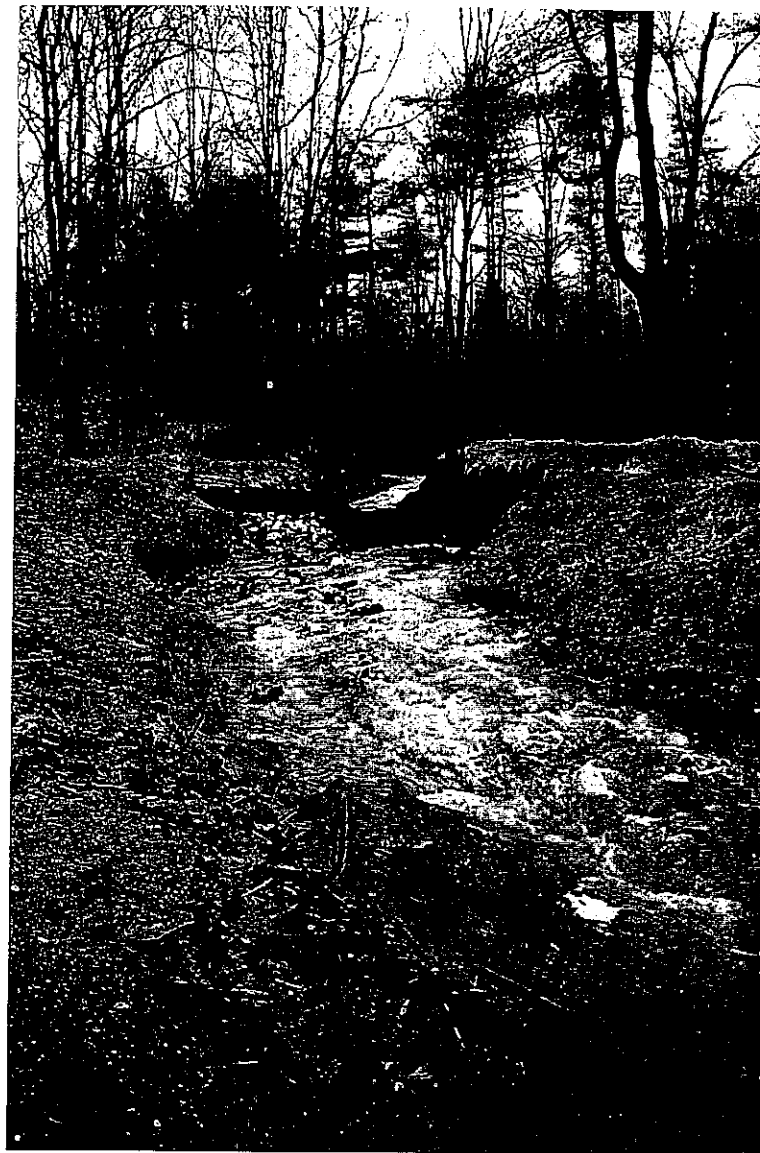
**Pine Gutter Brook Restoration Project**

*Showing undermined dam during this April 15-16 storm*

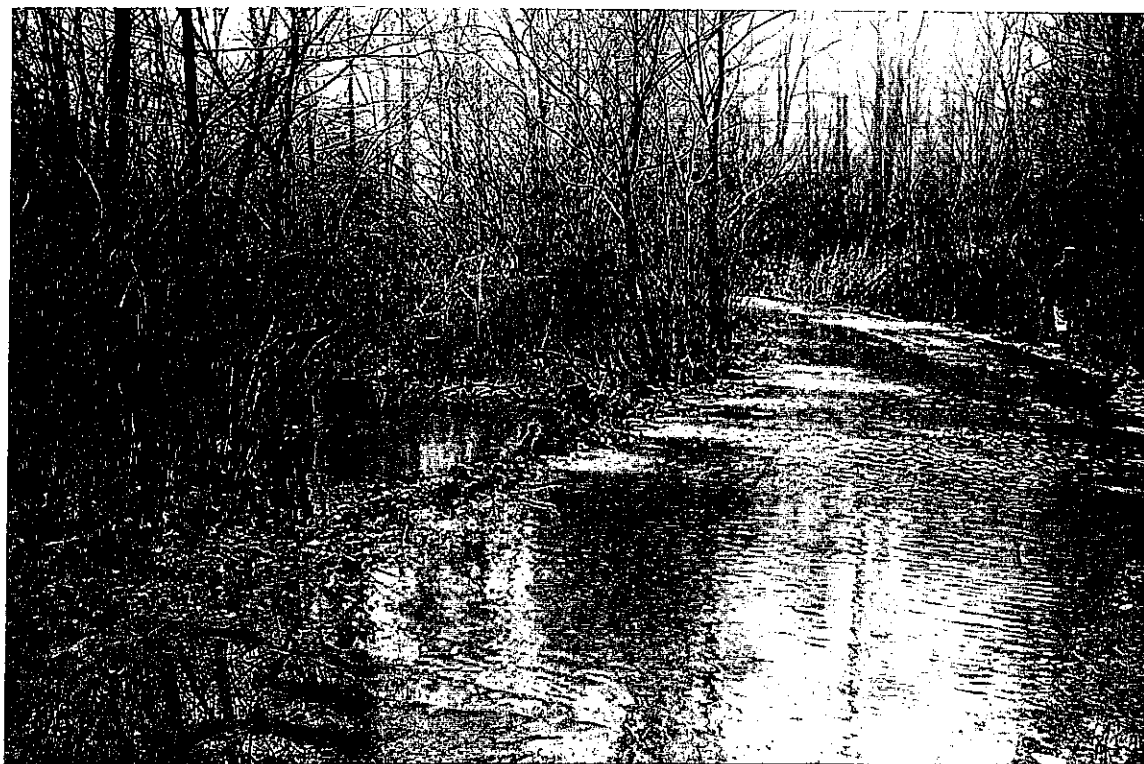
**Pine Gutter Brook Restoration Project**

*2500' access road into project site with visible erosion during April 15-16 storm*
