BRANFORD

Community Facilities Evaluation

Phase 1 - February 2012

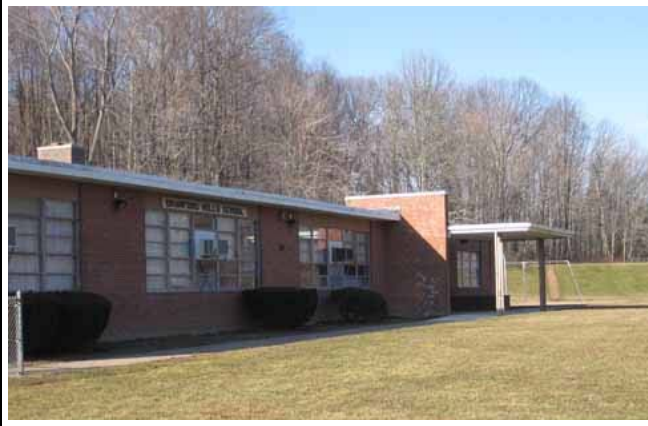
Photograph

Physical Condition	
Roof:	
Fair	
Exterior Walls / Windows:	
Good	
Interior Condition:	
Good	
Signs of Water Damage?	Yes

Building
<p>Property in flood plain but building is not.</p> <p>CIP - \$200,000 for carpet / floor work (2012-16)</p> <p>CIP - \$75,000 for brick wall / sidewalk work (2012-16)</p> <p>CIP - \$101,000 for door / entry replacements (2013-15)</p> <p>CIP - \$210,000 for energy management system (2014)</p> <p>CIP - \$130,000 for conversion to HW in Shop area (2014)</p> <p>CIP - \$125,000 for fire notification system (2014)</p>

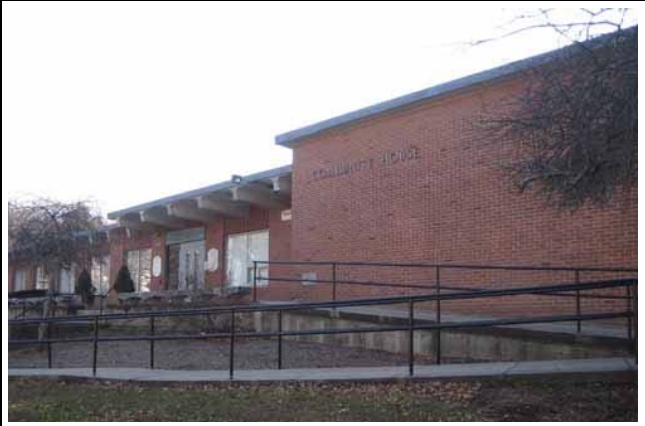
Photograph

Physical Condition	
Roof: Good	Roof replaced two years ago, occasional leaking in computer lab
Exterior Walls / Windows: Fair	Columns are rotting, paint peeling
Interior Condition: Fair	Finish worn off of wood floors, carpet buckling & stained, bathrooms need updating.
Signs of Water Damage?	Yes

ADA Compliance	
Building Interior: Fair	May need elevator eventually fir Senior Center use
Building Access: Poor	Ramp not ADA compliant and pitch / length is very difficult for elderly. Cement cracks and crumbles constantly on ramp & stairs
Route To Parking Area: Poor	Via long walkway & steep lengthy pre-ADA ramp. Cement cracking and ice accumulatin are major ongoing issues
Parking Area: Fair	Limited handicapped parking

Building
<p>CIP – Requested \$4,800,000 for renovation / use as BOE offices with Senior Center relocation elsewhere – not funded by BOF</p> <p>Some part of the building may be connected to a septic tank</p> <p>Possible hazardous materials in building.</p>
