Branford Police Department

REMEDIATION PROPOSAL

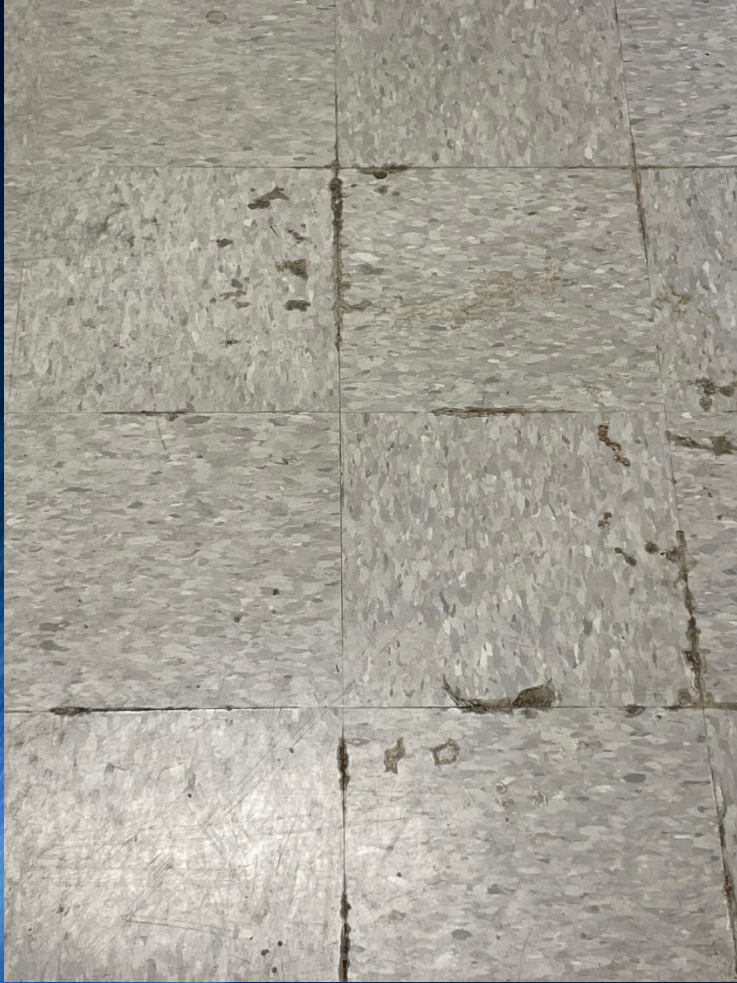
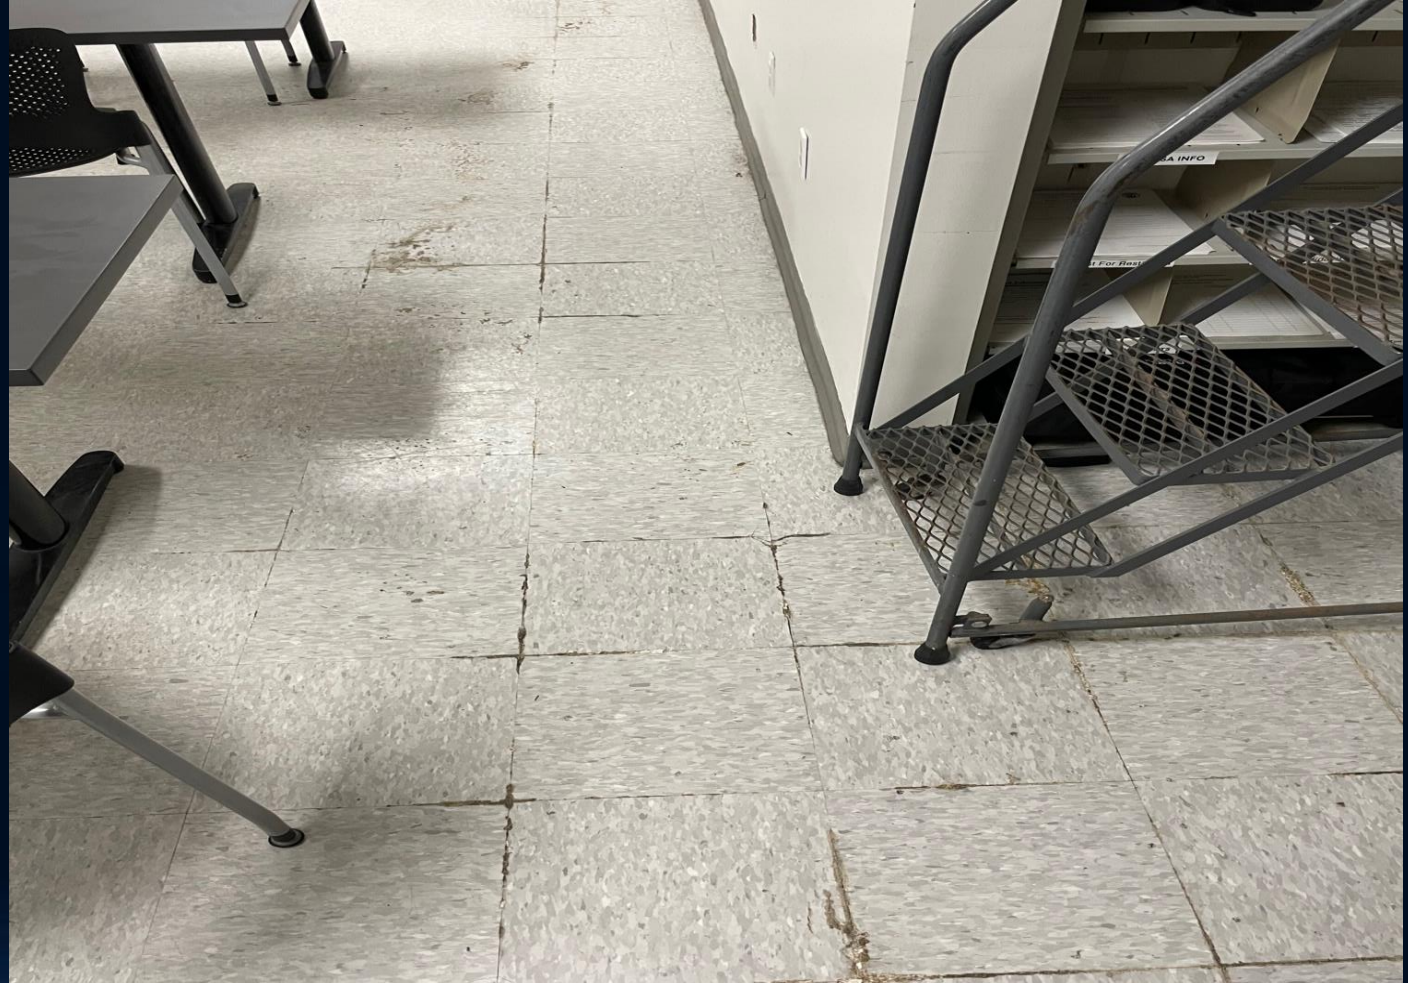
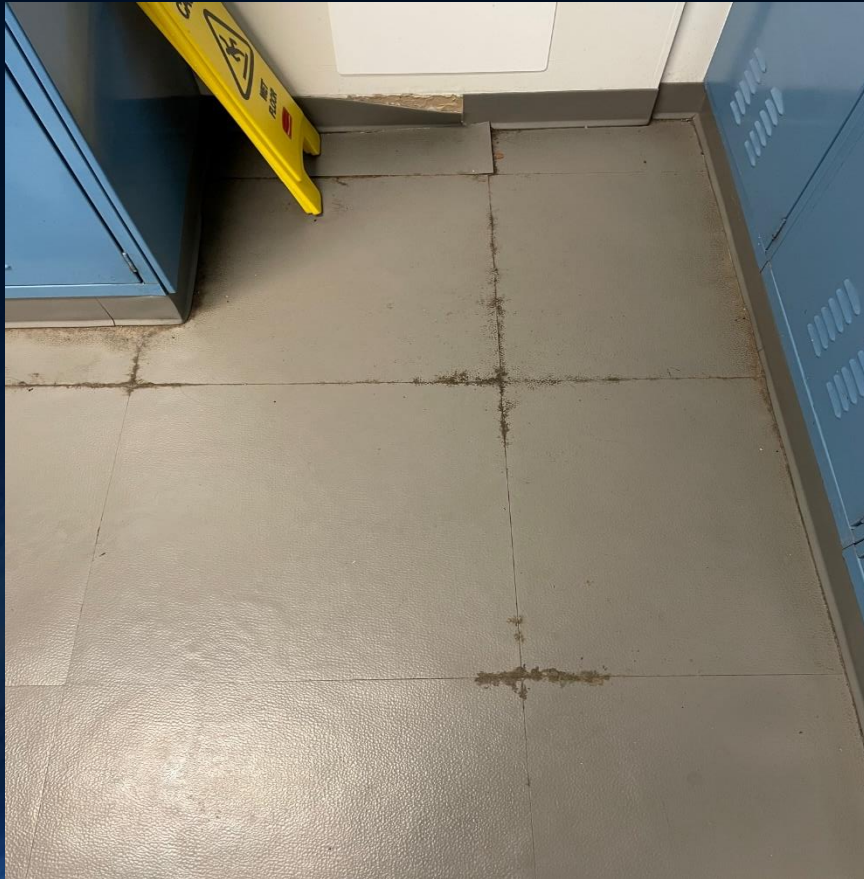
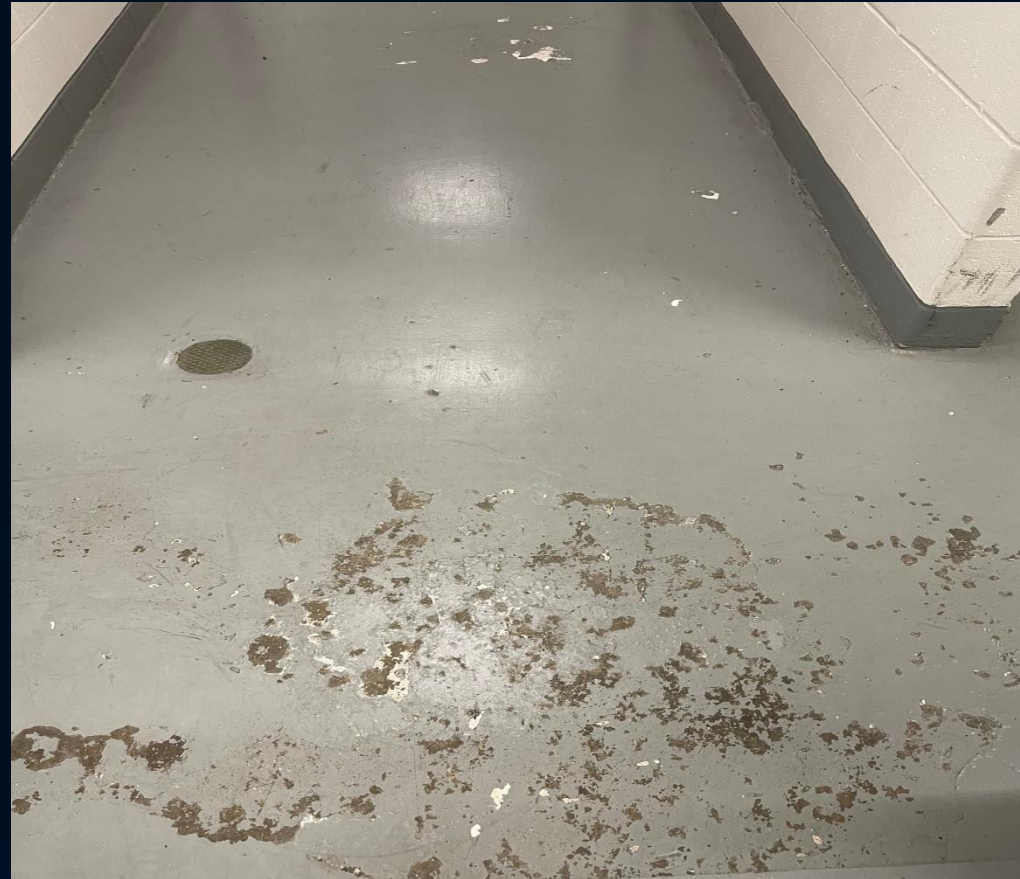
Lower Level Floors

- Historically, very high level of moisture within the building especially on lower level
- Short term attempts/ solutions to rectify moisture in lower level, to include running fans, and portable de-humidifiers.
- High levels of humidity resulted in lack of adhesion of flooring tiles to slab, bubbles, blisters and crack on areas that have epoxy coated floors, rust to lockers, rust on equipment stored inside (guns, cuffs, batons); moisture can compromise the integrity of the Officer's bullet proof vests; mold discovered underneath flooring; dirty duct work throughout building

- Report produced May 2020
- Specific tests related to concrete slab moisture were completed at selected locations throughout the lower level
- Findings – Moisture vapor transmission rate (MVER) between 8.6-13.7 pounds per 1000 square feet – As a comparison, sheet and tile manufactures don't allow their materials to be placed when MVER levels exceed 2-3 pounds per 1000 square feet.
- Typically, a vapor barrier membrane is placed on top of a compacted sub-base prior to the pouring of a concrete slab – Hoffman Architects professional opinion that the slab was cast without an effective vapor barrier – primary reason for the excessive water vapor transmission through the slab
- The fix – “negative side waterproofing” – all flooring is removed – shot blasted – and specific coating products applied to resist specific moisture transmission rates

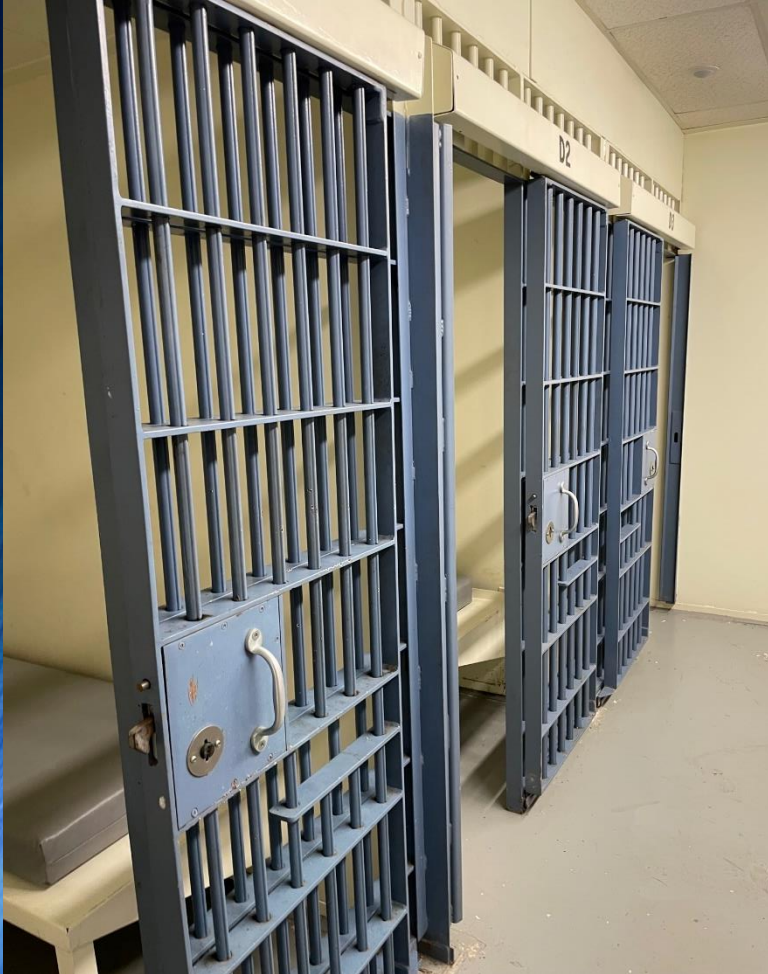
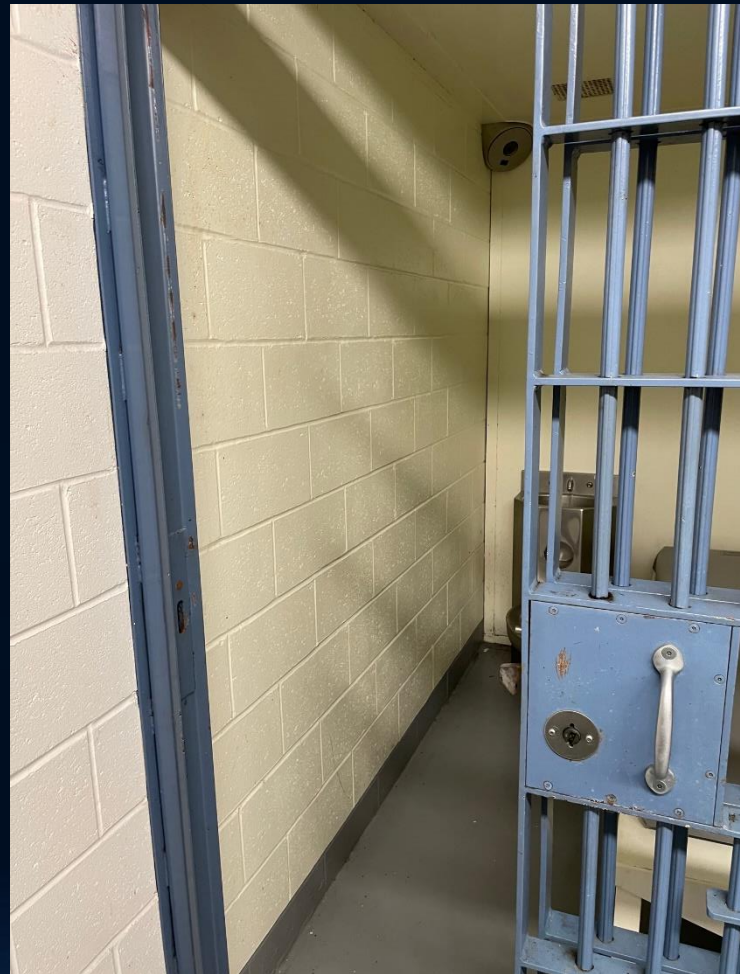
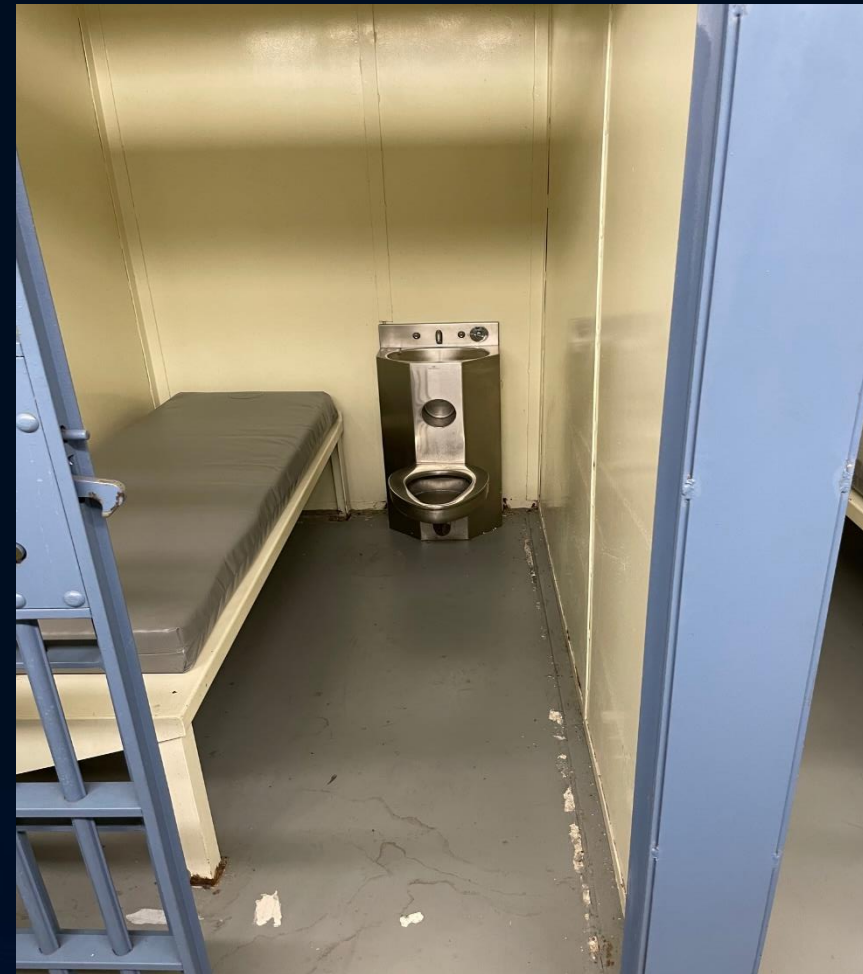
Cell Block

- Current cell blocks original to the Harrison Ave Police Department
- Old style bars – illegal in some states – need solid doors
- Susceptible to hanging – routinely have arrestees placing clothing around neck/bars
- Injuries sustained from banging head on bars
- Cells lack adequate ventilation / fresh air return
- No fire suppression
- Choke/ hanging points inside cell
- Entry/ egress – too small for extraction purposes
- 14 cells - Too many cells – wasted space
- Fixtures in cells are original to building and at end of useful life expectancy

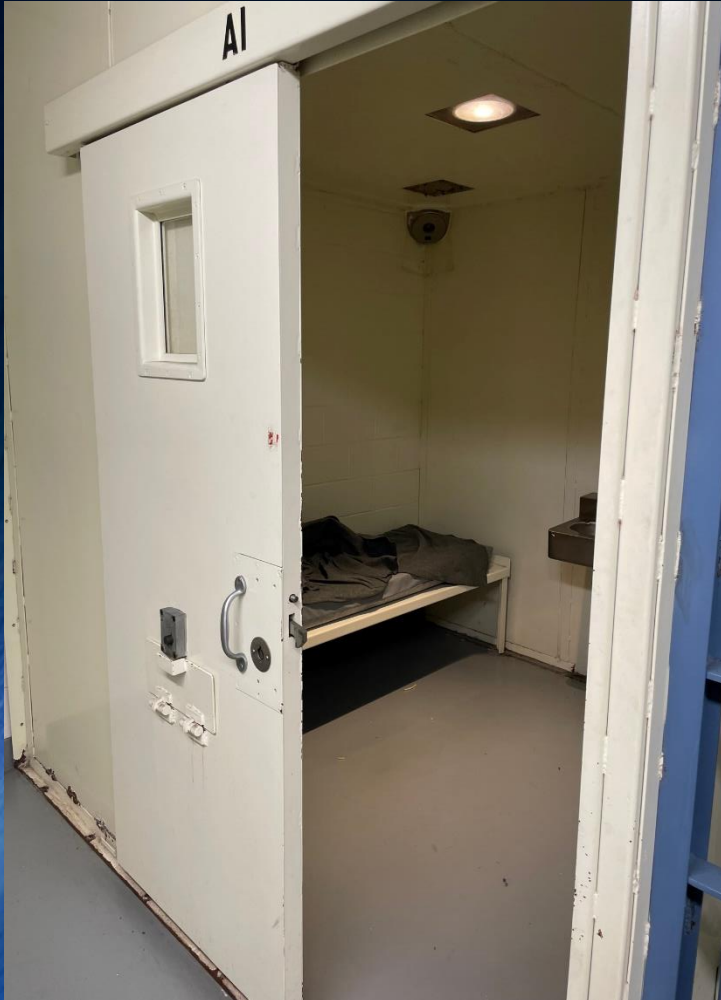
“Bio- Hazard” Cell

- 2 Bio-hazard cells
- Solid door – now utilized as our main cell block
- Wider entry
- Lacks adequate ventilation
- Lacks fire suppression
- Fixtures at end of useful life
- Older design of fixtures allows hanging/choke points

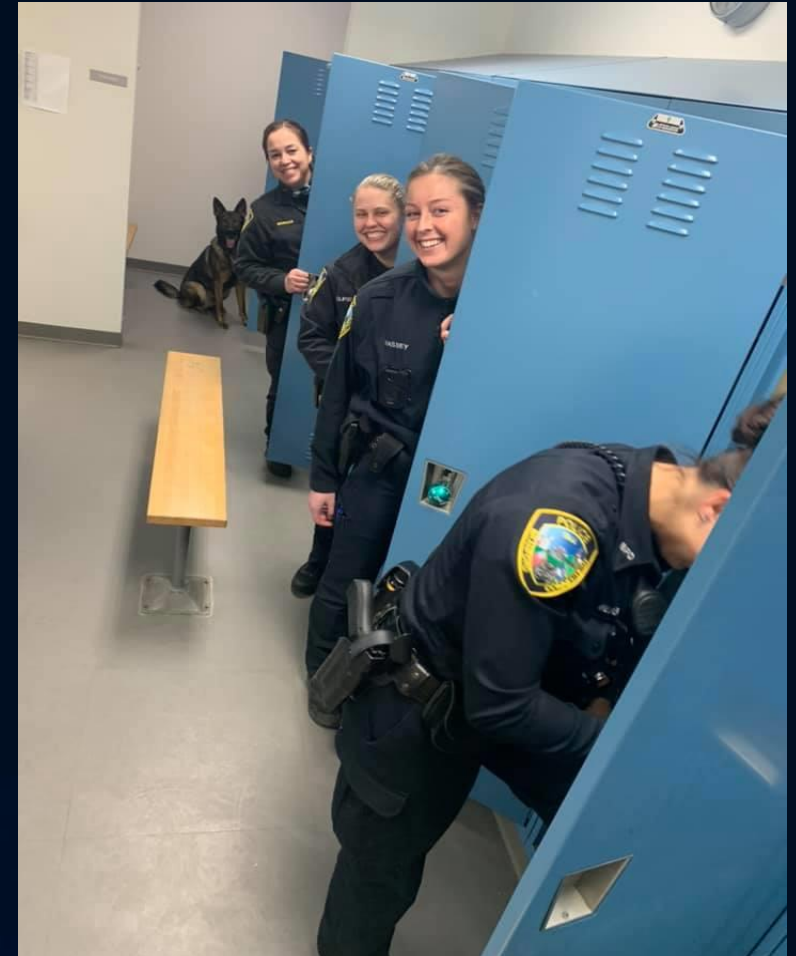
Female Locker Room – Space needs

- 1995- Two female Officers – 12 lockers
- 2022- have 10 female officers – represents 20% of Officers
- Need to increase space
- Running out of space/ lockers

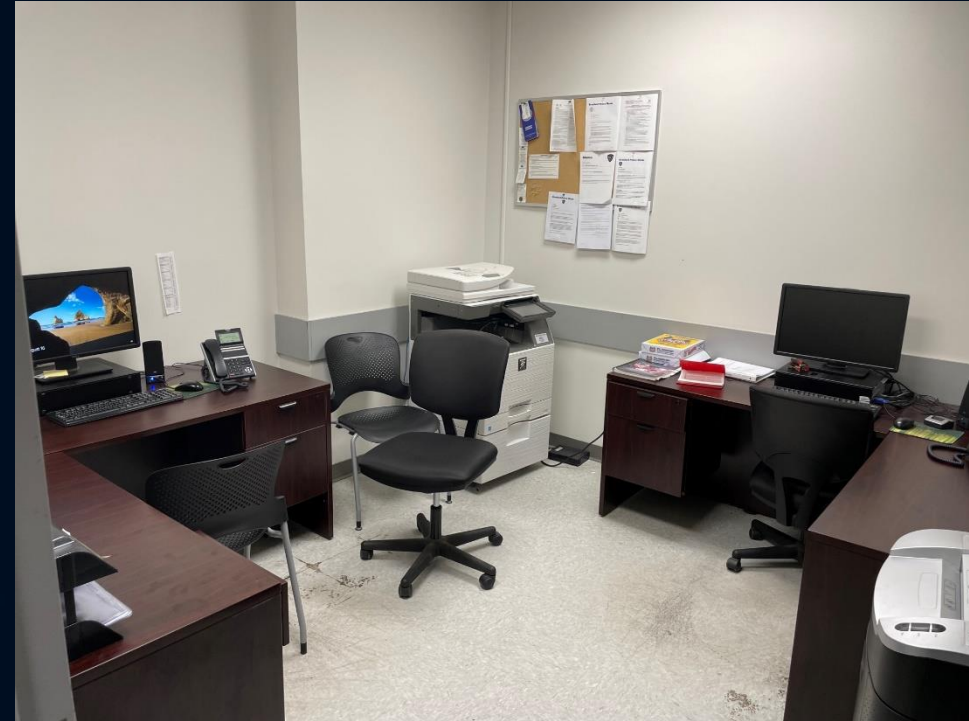
Report Writing –space needs

- Major increase in modern day policing in terms of reporting
- Small room with two stations serves the entire Patrol Division – 65% of Agency
- Often both stations are occupied

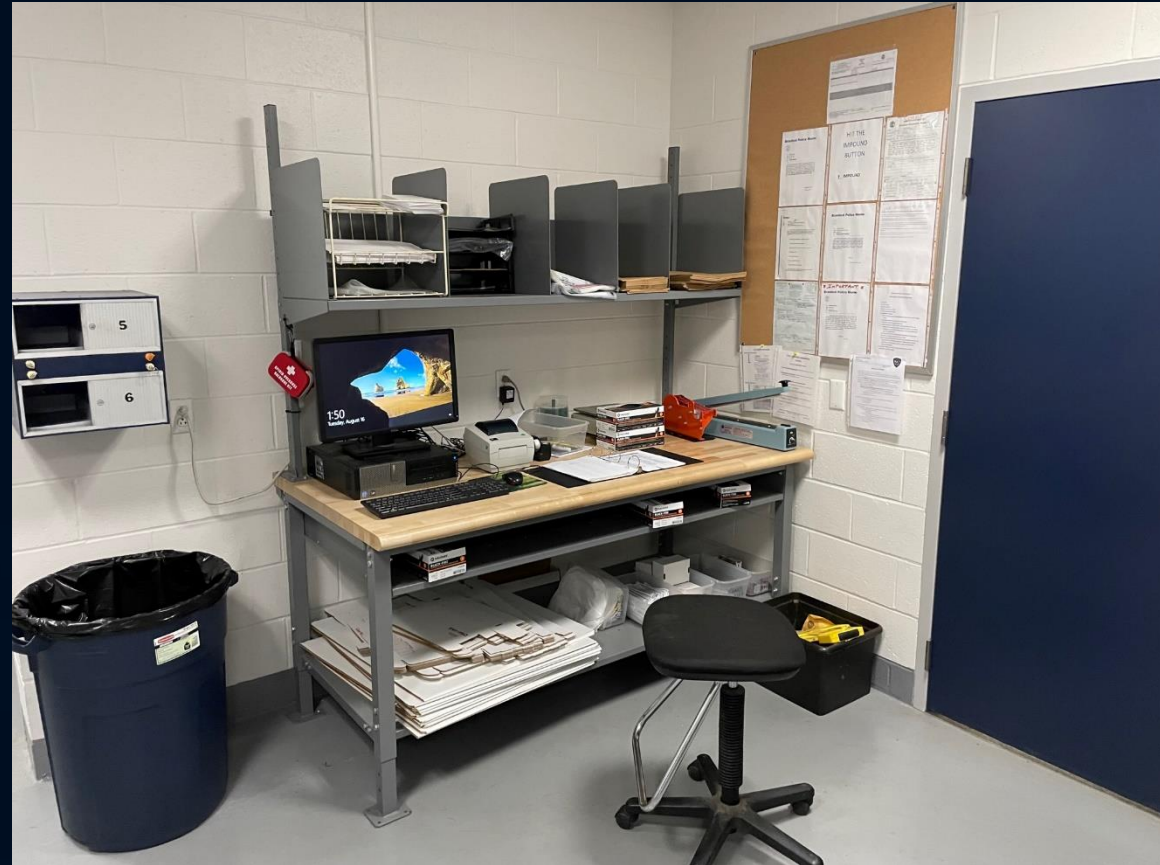
Evidence processing – space needs

- Area serves entire patrol division and detectives.
- Better utilization/ allocation of space in our proposal

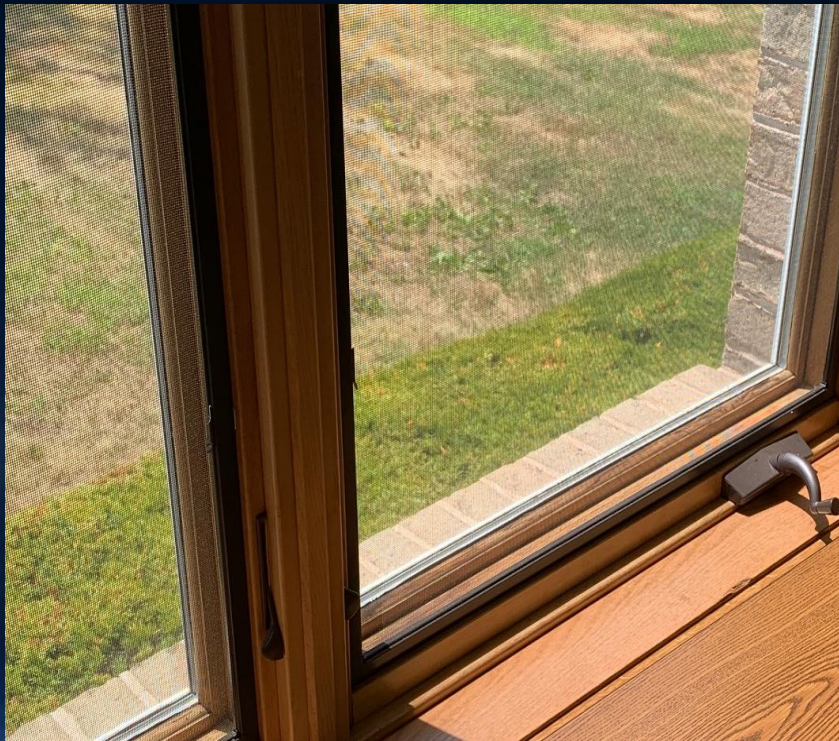
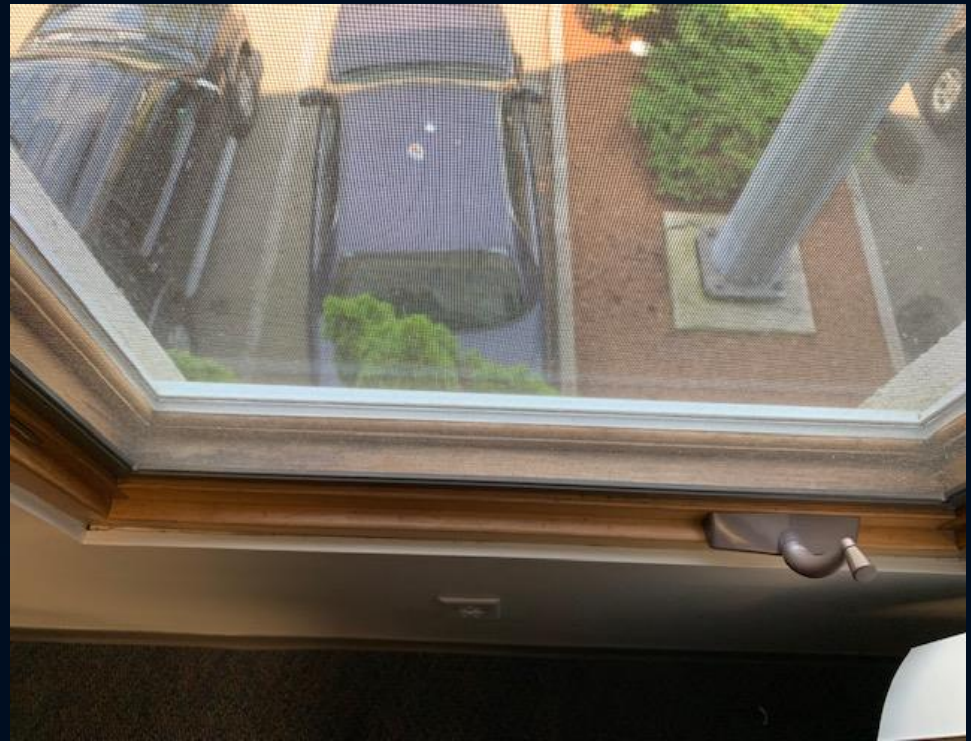
Main Floor

- Windows – original to building

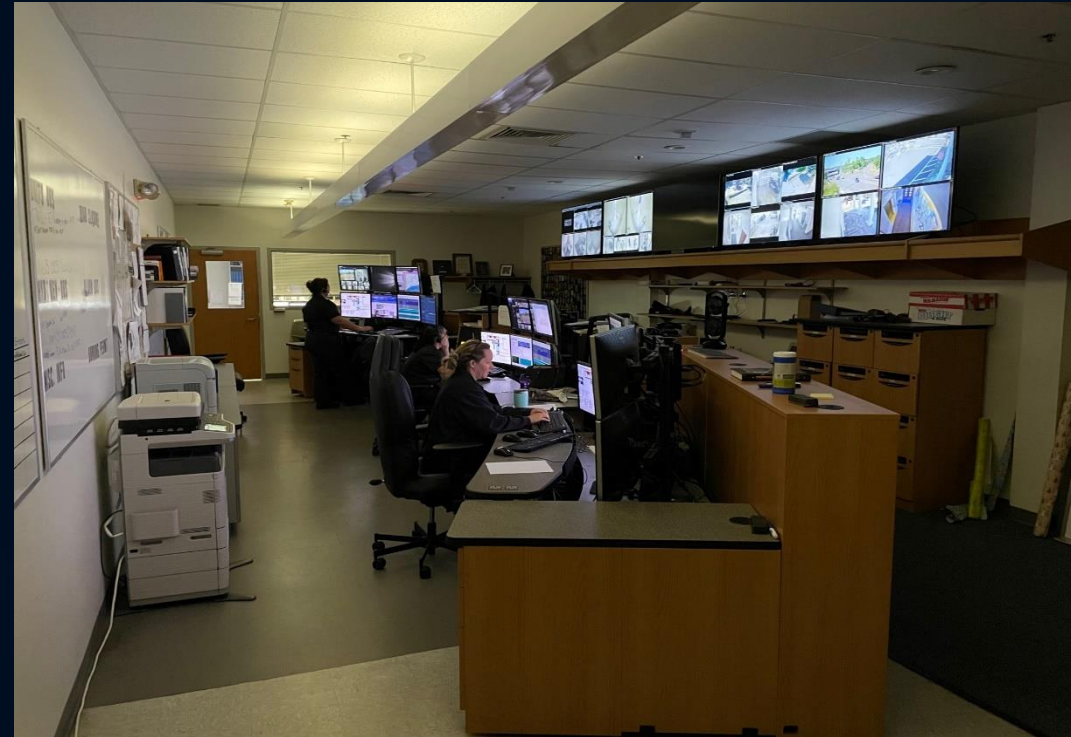
Dispatch – space needs

- 24/7/365 – operation
- Dispatchers are confined to the space during their shift
- Increase in technologies to monitor requiring more space
- Comforts needed – locker space/food storage
- Direct access to restrooms

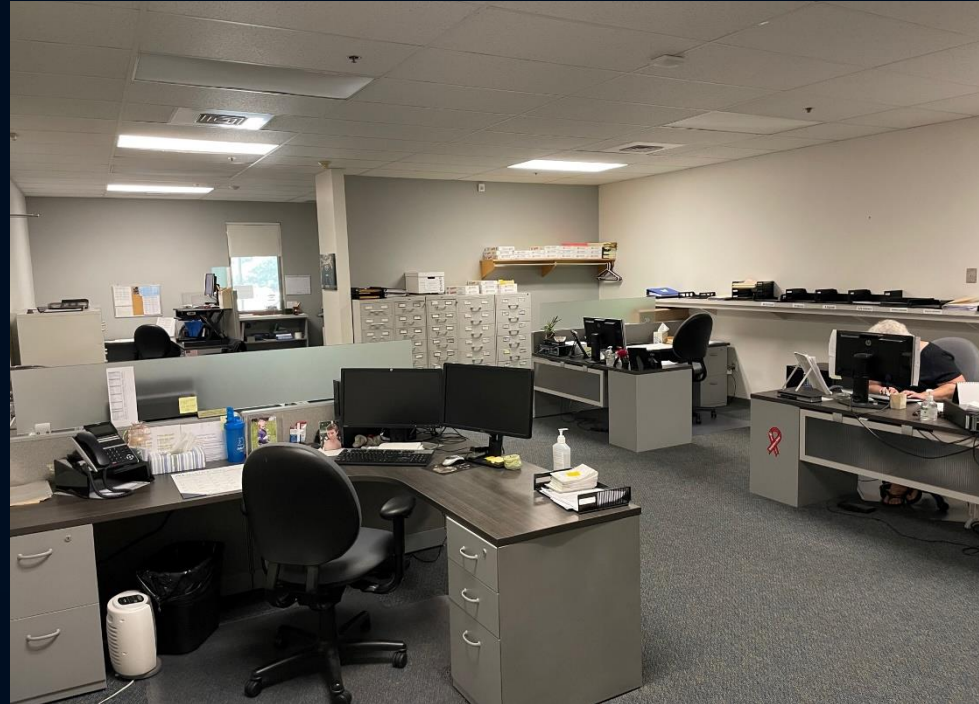
Records – space needs

- Too much space currently allocated to records
- One full time clerk
- 3 part time staff
- Records increasingly becoming digital
- Officers type reports/ complete most records

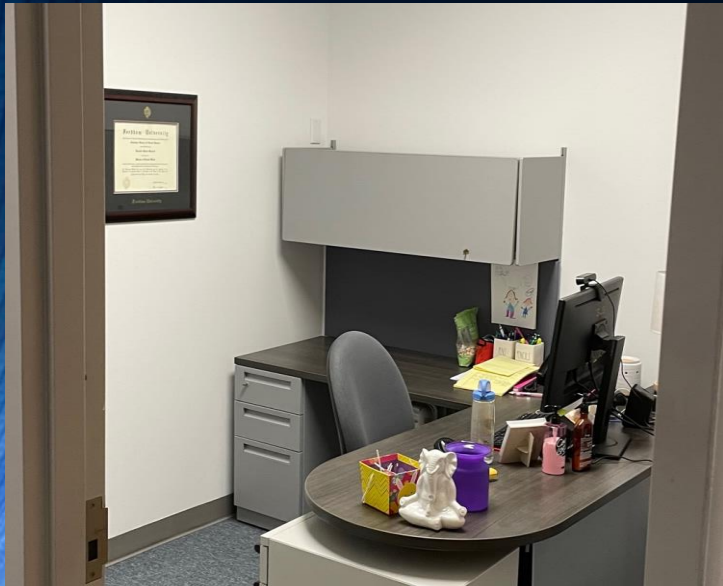
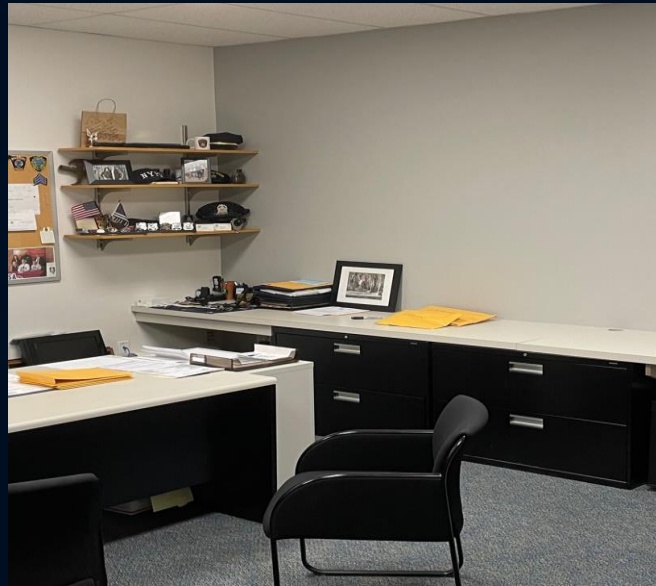
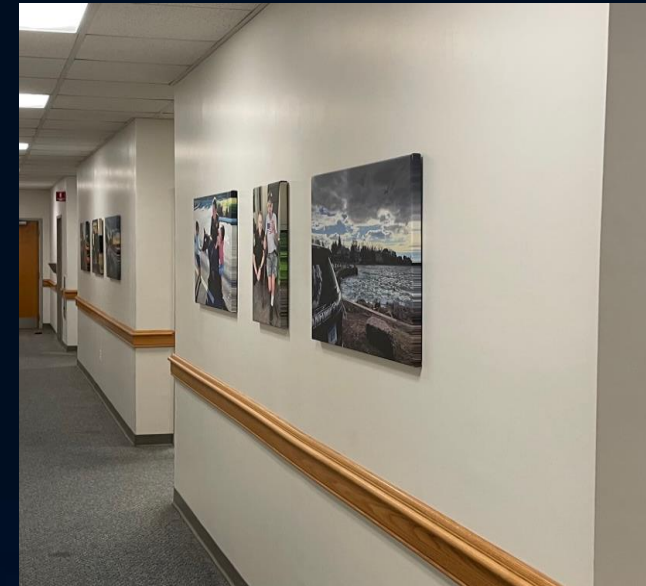
Offices - Main Floor – space needs

- Re-allocation (re-organization) of square footage is needed
 - Over the years, closets have been built, offices/walls added – HVAC balance
 - Growth -Police social worker = closet / 2 employees from I.T/ Crime Analyst

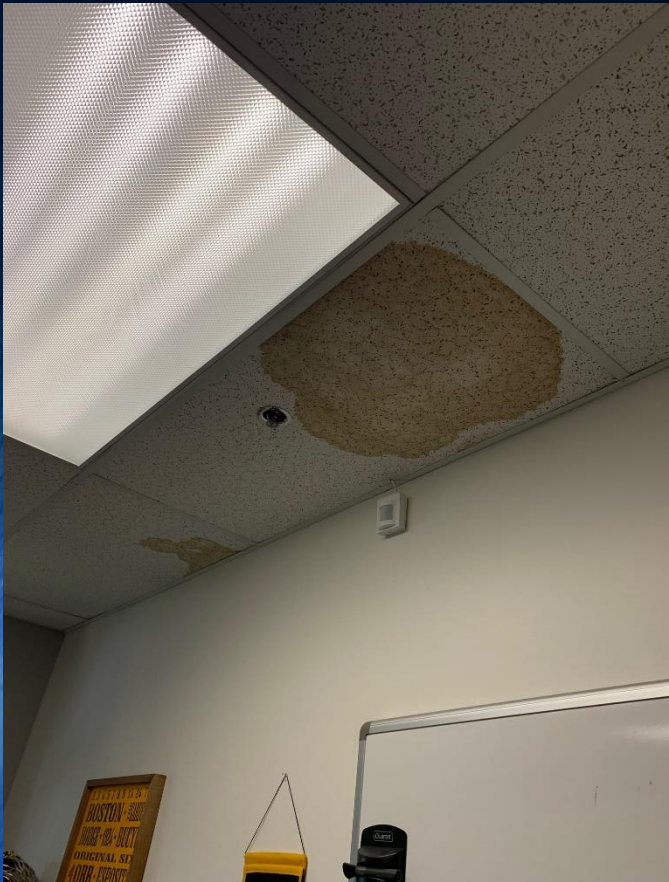
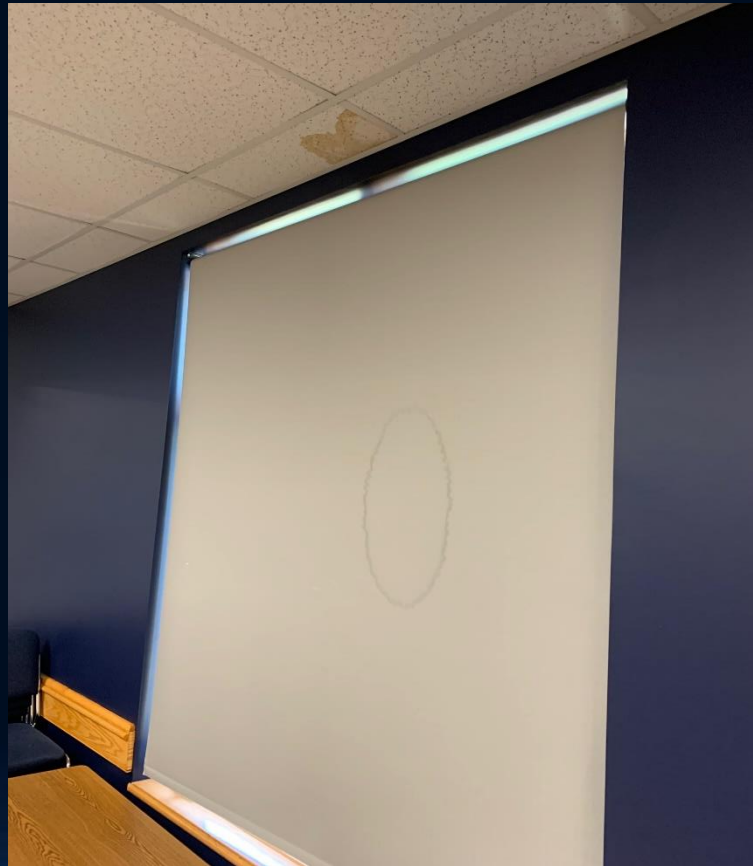
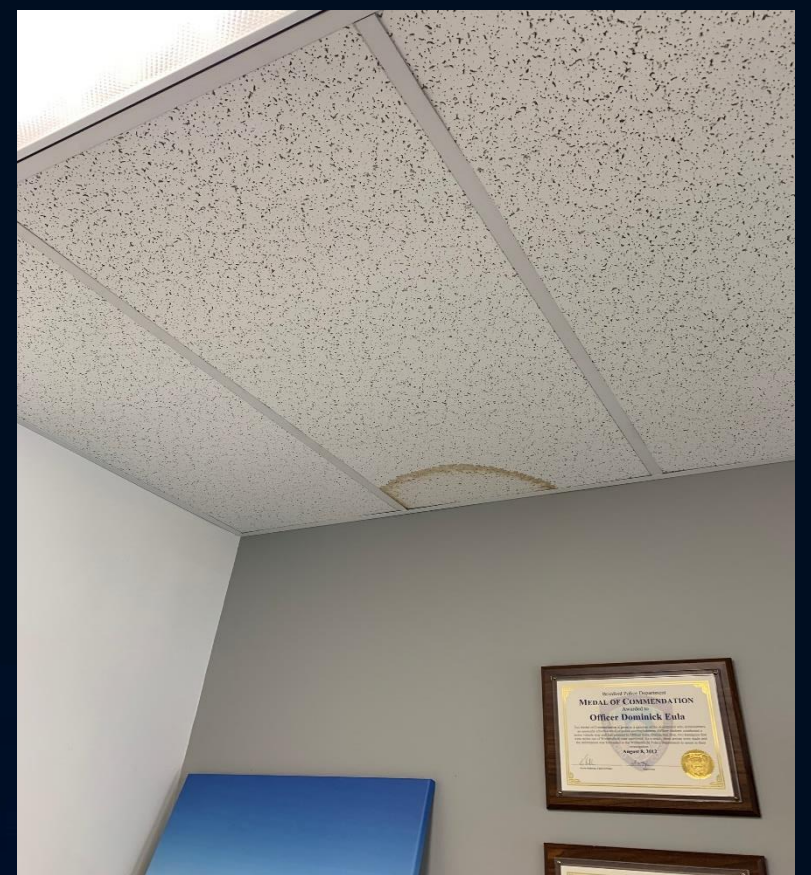
Exterior

- Roof – water leaks observed throughout the building

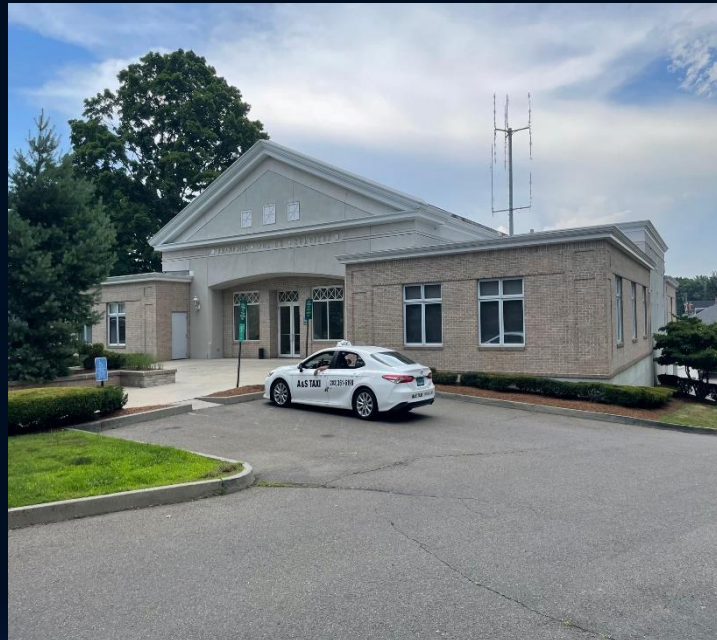
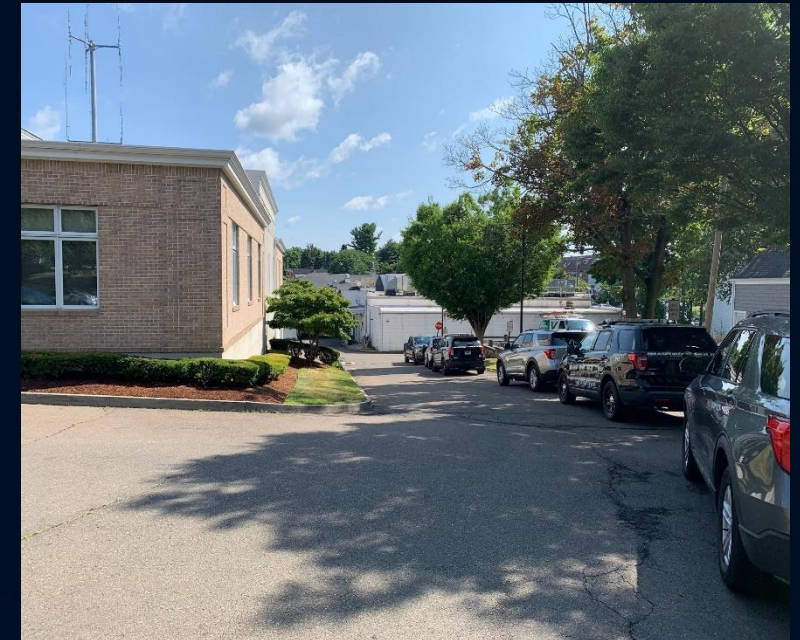
Exterior

- Public Parking – currently limited three spaces / one handicapped – forces public to park in back lot and walk up the side hill
- Lack of security (stalking, 1st amendment audits, damage to private vehicles, mental health issues)
- Lack of police parking
- Risk mitigation

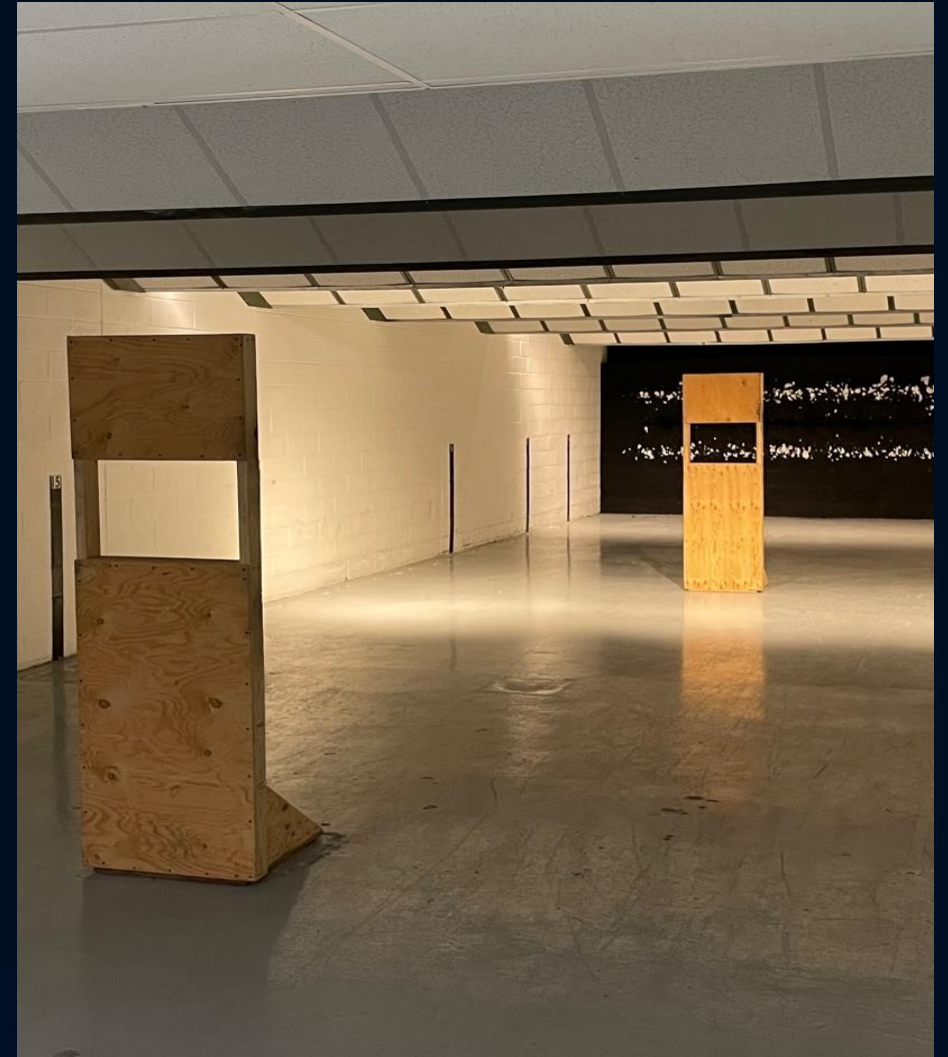
Firearms Range

- Located at garage of building – 45 Harrison Ave
- Extensive use – Officers mandated annual recertification training
- Range time is becoming more expensive/ less available to find off sight
- In-door facility can be used regardless of weather
- Unlimited access in the event an officer needs remedial training
- Current equipment – 5-8 years will reach its useful life expectancy
