## **Wetland Delineation Inventory, Functional Analysis and Impact Assessment**

East Industrial Road, Leetes Island Road, and East Main Street  
Branford, Connecticut

Costco Wholesale Corporation

September 9, 2015

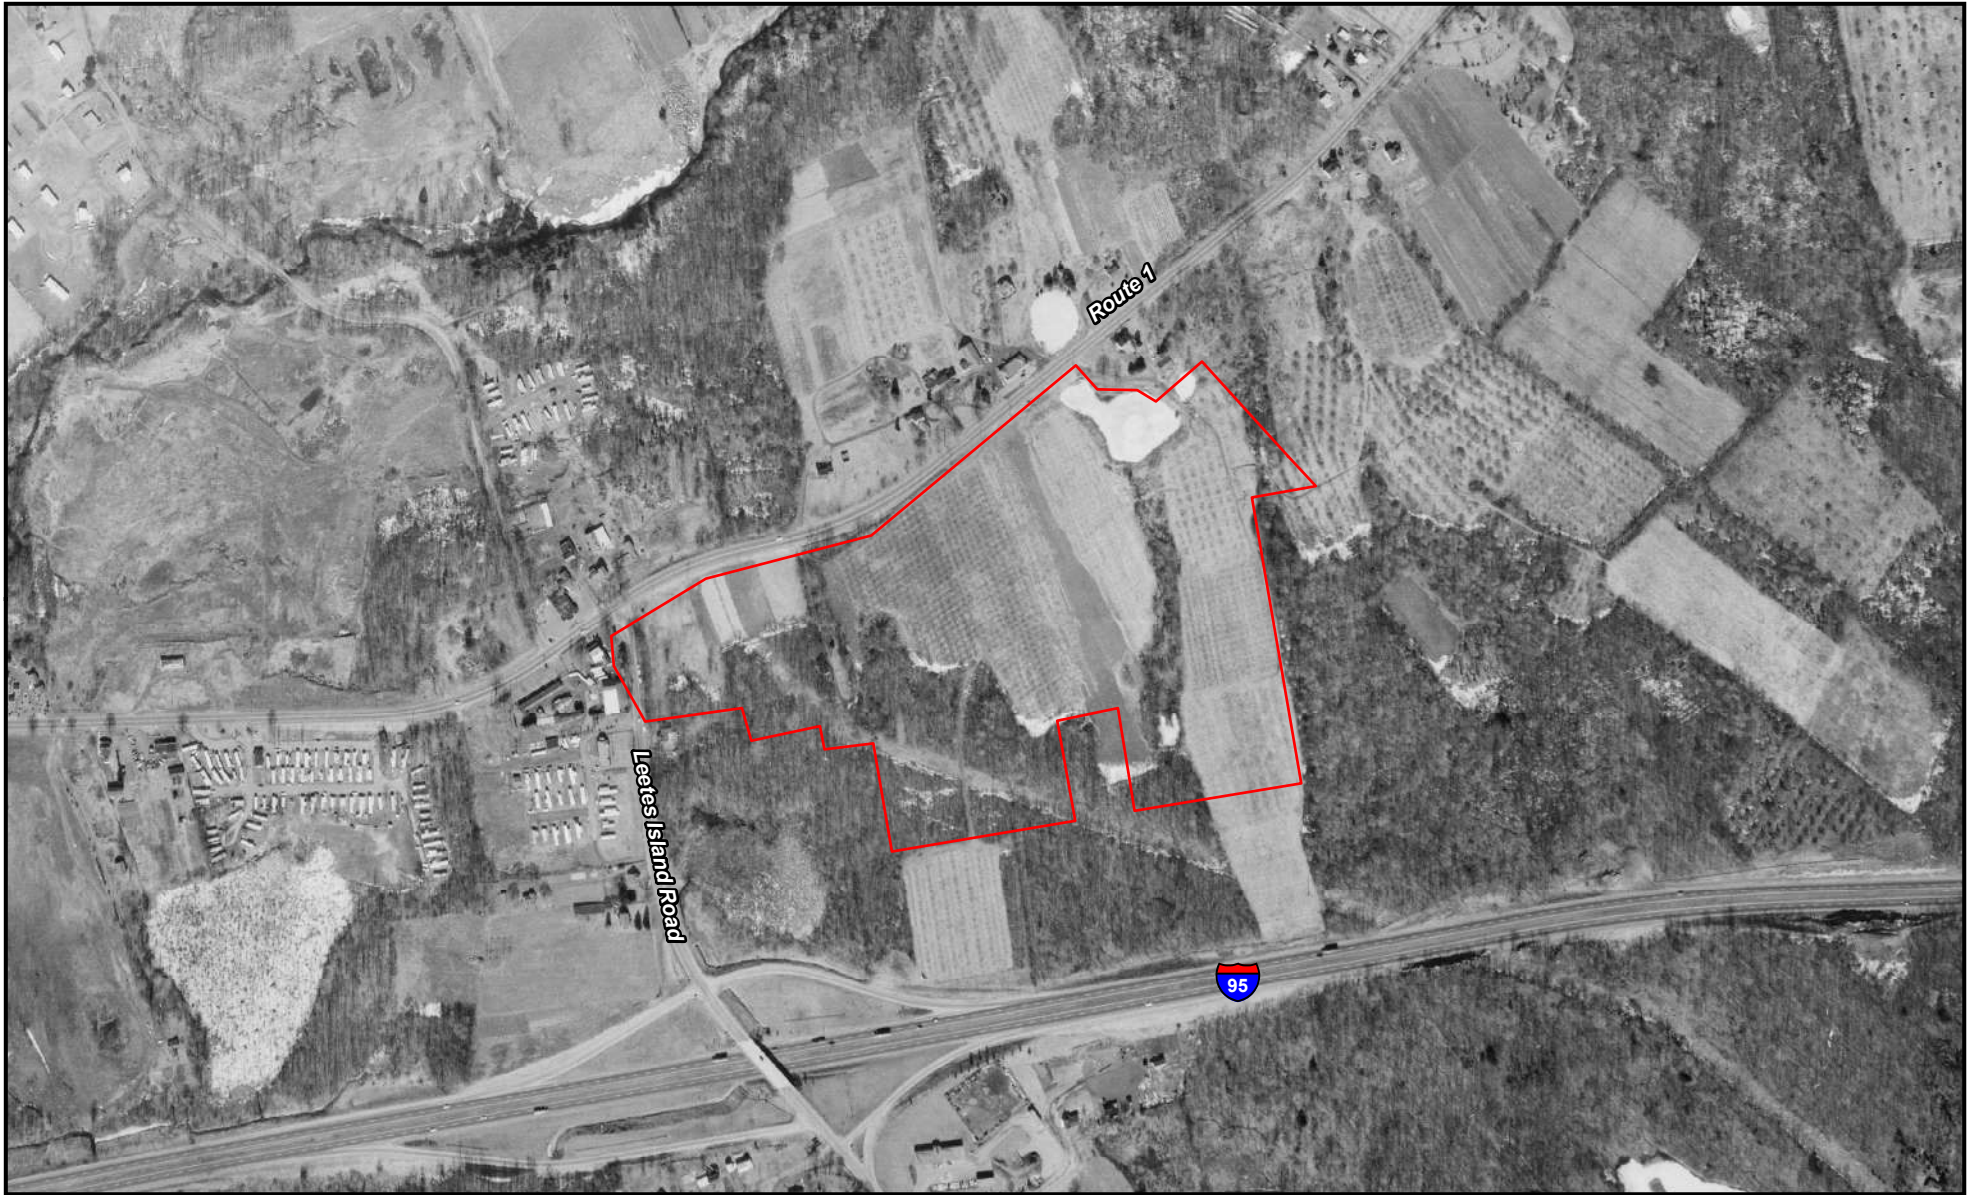
HISTORIC AERIAL  
1965  
East Industrial Road  
Branford

In 1934, the Site was active farmland, dominated by orchards, indicated by the evenly spaced rows and dotting pattern visible on the aerial photograph. In 1951 the Site conditions remained largely the same, with orchards being the dominant land-use. Maturation of forest from 1934 to 1951 is notable in the southern portions of the Site. In 1965 the land-use remained dominated

by orchards. This is the first historic aerial in which Interstate-95 is visible, and while the overall landscape is still dominated by farmland, an increase in commercial/industrial land use is notable in the surrounding landscape. 1965 is the first year in which the three man-made ponds in the northeast corner of the Site are visible (Ponds A, B and C). From 1965 to 1970 the Site conditions appear to be unchanged. By 1986, while orchards still dominate the Site, the amount of active farmland decreases and forest cover increases. By 1990, more fallow farmland is visible, but the large central orchard remains active. By 2004, the active orchards are completely gone. Active agriculture is confined to the central, 5 acre field. The balance of the former agricultural area is increasingly dominated by invasive, non-native vegetation. A more detailed description of the current conditions is given below.

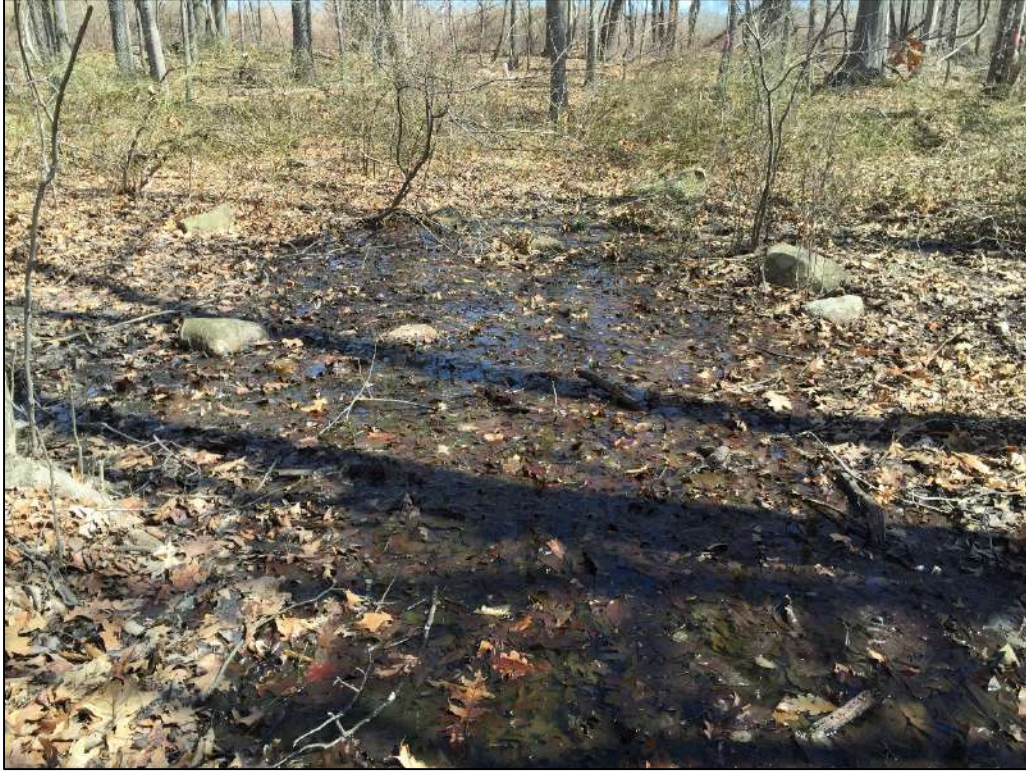
Photo 7: Wetland 2 in early spring prior to leaf-out, looking west.

Wetland 2 is a ±0.39 acre wooded swamp with a saturated to seasonally flooded hydrology. The wetland is situated on gently sloping terrace just north of, and bordering, the cut slope described above. The majority of the wetland maintained a saturated hydrology throughout the spring. Two small, separated depressions held standing water throughout the spring and would be classified as having a seasonally-flooded hydrology.

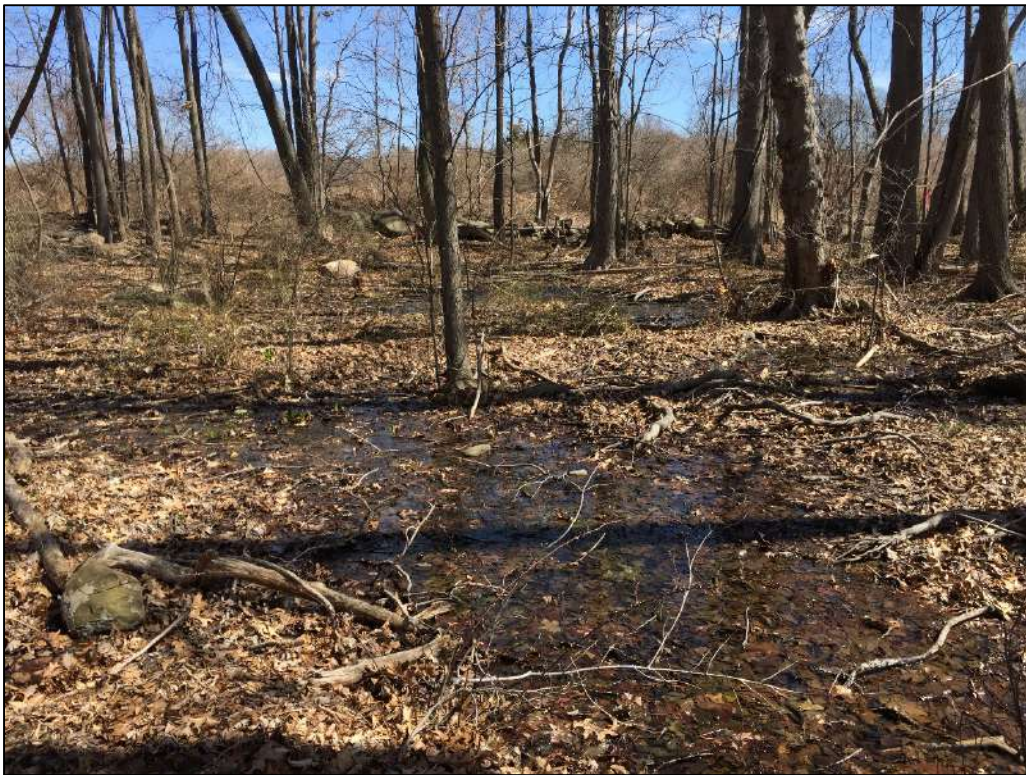
Photo 8: Wetland 2 in early spring prior to leaf-out, looking east.

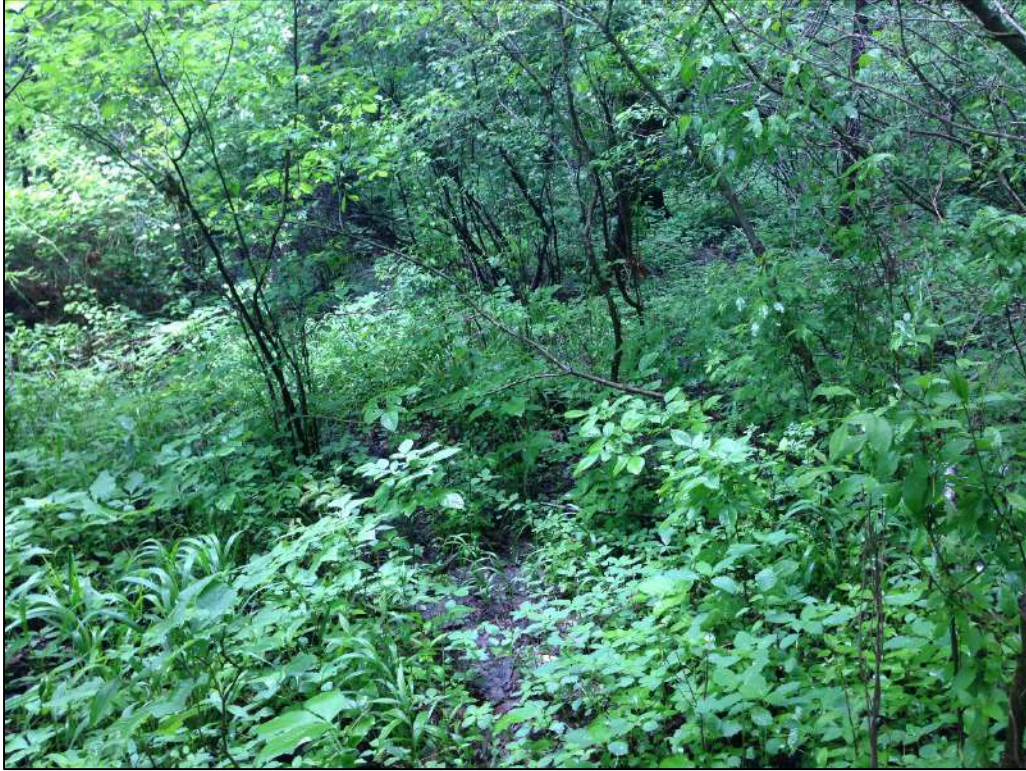
Photo 13: northeast portion of Wetland 1 showing dense ground and shrub cover vegetation.

Wetland 1 is the largest wetland at the site ( $\pm 3.83$  acres). It bisects the site in a north-south direction in the eastern portion of the site. The wetland is hydrologically connected to an offsite pond on the north side of Route 1 via a culvert, and discharges off-site to the south via a closed drainage system. Two man-made ponds are embedded within Wetland 1. The larger pond (Pond A) has a forested edge from the adjacent upland slopes. Scattered shrubs also grow along the shore including Silky Dogwood, Buttonbush (*Cephalanthus occidentalis*), and Multiflora Rose\* with Sensitive Fern. Within the pond there is a patch of Common Reed\* (*Phragmites australis*) and White Waterlily (*Nymphaea odorata*). Filamentous green algae are also present. The smaller pond (Pond B) is located a short distance east of Pond A. It has a dense edge of Silky Dogwood with Soft Rush (*Juncus effusus*) and Reed Canarygrass\* (*Phalaris arundinacea*). Patches of aquatic vegetation include waterweed (*Elodea spp.*) and smartweed (*Polygonum sp.*).

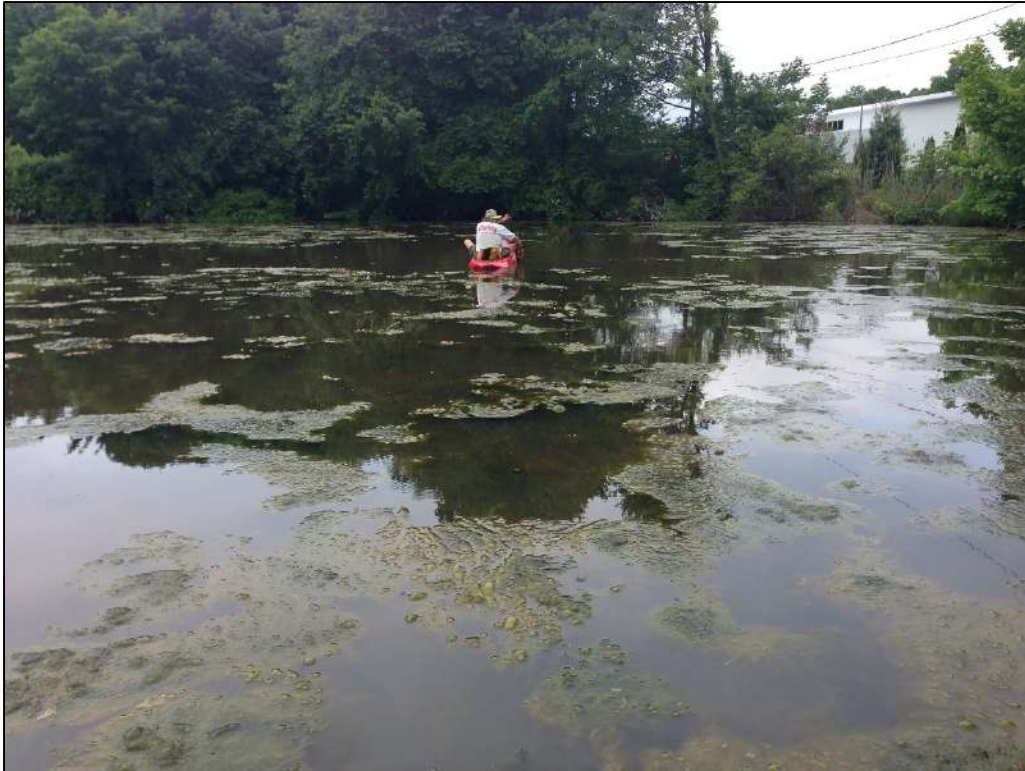
Photo 17: Pond C looking north.

Pond C is located north of Route 1. The Pond is shallow and the shore is partially wooded with Red Maple, Sugar Maple, Green Ash, Black Willow, and American Elm. The shrub layer varies from open to dense thickets and consists mostly of Arrowwood Viburnum, Silky Dogwood, Multiflora Rose\*, and Buttonbush. Minimal aquatic vegetation was observed and was mostly Duckweed (*Lemna minor*) and watermeal (*Wolffia sp.*). On the east side of the pond there is a water quality swale which is vegetated mostly with Common Reed\*. The vine layer includes Virginia Creeper and Asiatic Bittersweet\*.

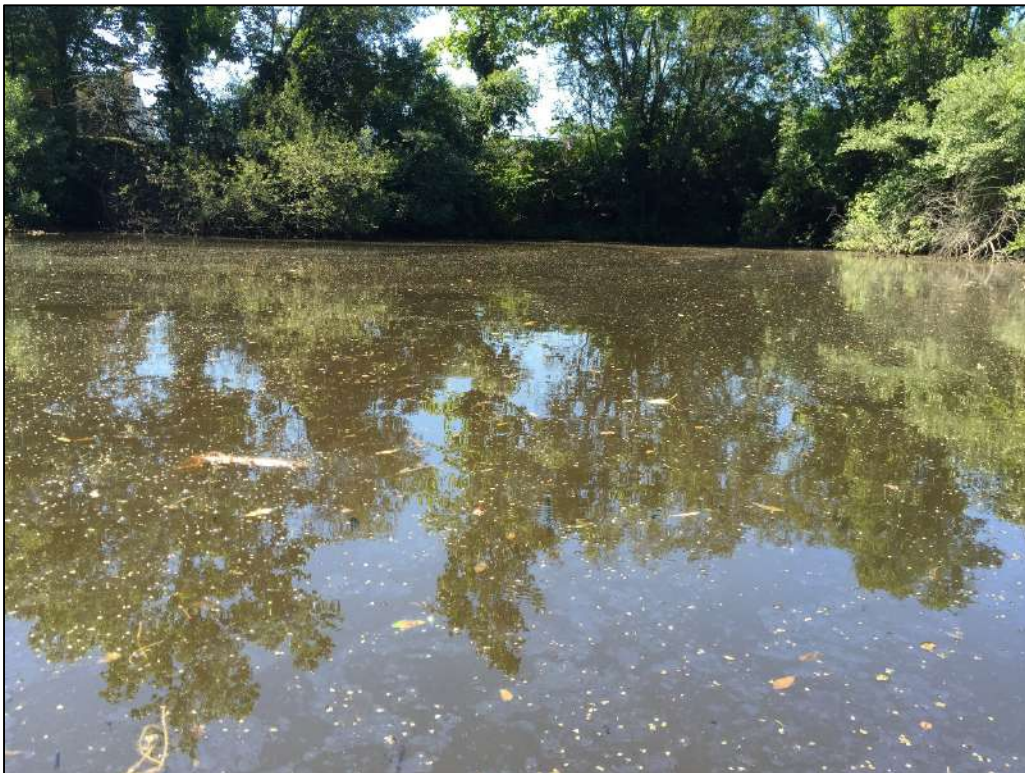
Photo 18: Pond D (Wetland 4) looking south towards Stop & Shop Supermarket.

Wetland 4 is a ±0.26 acre excavation that intercepts to the water table. It discharges to the stormwater management system of the commercial development at the corner of Leetes Island Road and East Industrial Road. The steep-sided basin is ponded and the water level fluctuates in response to seasonal and storm events. There is a narrow band of with wooded swamp vegetation growing along the shore, consisting primarily of Red Maple, Common Cottonwood (*Populus deltoides*), Pussy Willow (*Salix discolor*), and Multiflora Rose\* (*Rosa multiflora*).

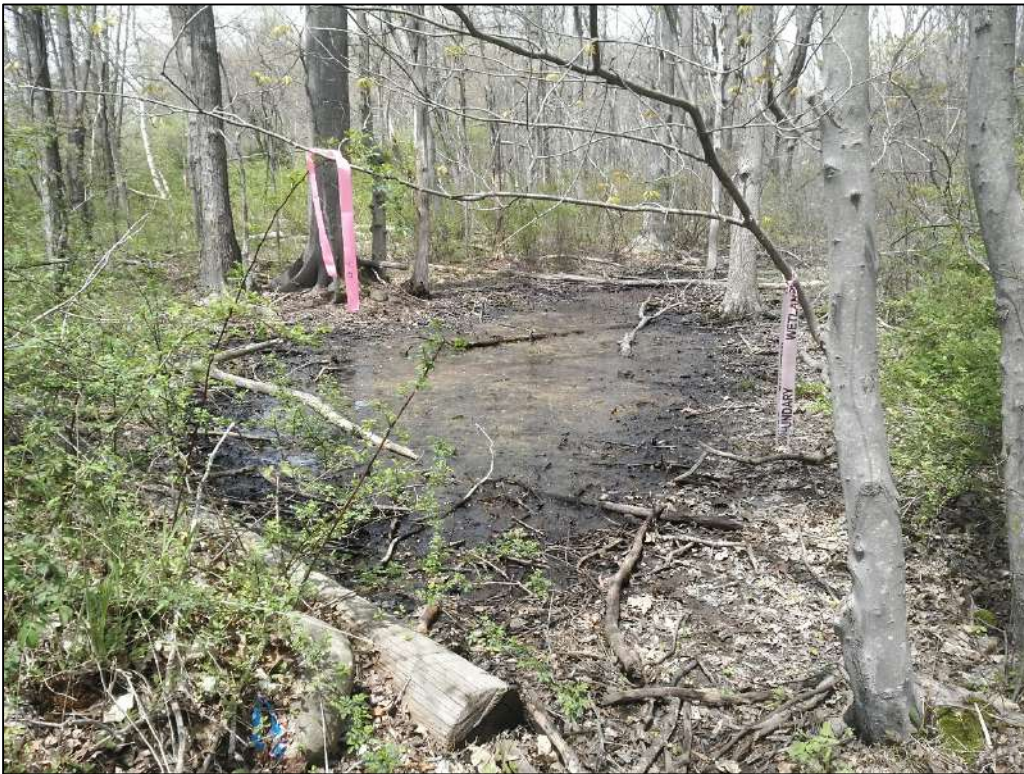
Photo 20: Area of Wetland 1 where wood frog were observed breeding in 2014.

Wetland areas with seasonally flooded and permanently flooded hydrology were surveyed for amphibians from April to June of 2014 and 2015. Survey methods included visual searches for egg masses and adults, cover searching (i.e., turning rocks, logs and debris) for adults, auditory surveys for calling frogs and toads, and dip-netting for larval amphibians. One vernal pool indicator species, the wood frog (*Rana sylvatica*), was observed on the site in 2014. One (or possibly two) adults were heard calling and a single egg mass was found in the southeast corner of Wetland 1, in a flooded depression adjacent to flag #21. During the spring 2015

The presence of one or two wood frogs (and a single egg mass) is not unusual, as wood frogs are capable of migrating distances of 3000 feet (or more), and often seek out new breeding pools in which to colonize. Wetland 1 is located in the southeast corner of the Site, within the migratory distance of other potential breeding pools located within a large forest block east of the Site adjacent to Towner Swamp Road. It is likely that individuals observed on the Site in 2014 originated from this area. The lack of mating or breeding activity in 2015 suggests that there was no survivorship in 2014. A major factor precluding the presence of robust populations of vernal pool wildlife is the lack of mature forest cover on as well as immediately adjacent to the site, as vernal pool species utilize forested habitat during the non-breeding season. The presence of high-density development and high-traffic roads adjacent to the site also severely limit the ability of amphibians to move into and out of site wetlands during migration.
