Wetland Delineation Inventory, Functional Analysis and Impact Assessment

East Industrial Road, Leetes Island Road, and East Main Street
Branford, Connecticut

Submitted To:
Costco Wholesale Corporation
In support of applications for inland wetlands permits
Town of Branford, Inland Wetlands Commission

September 9, 2015

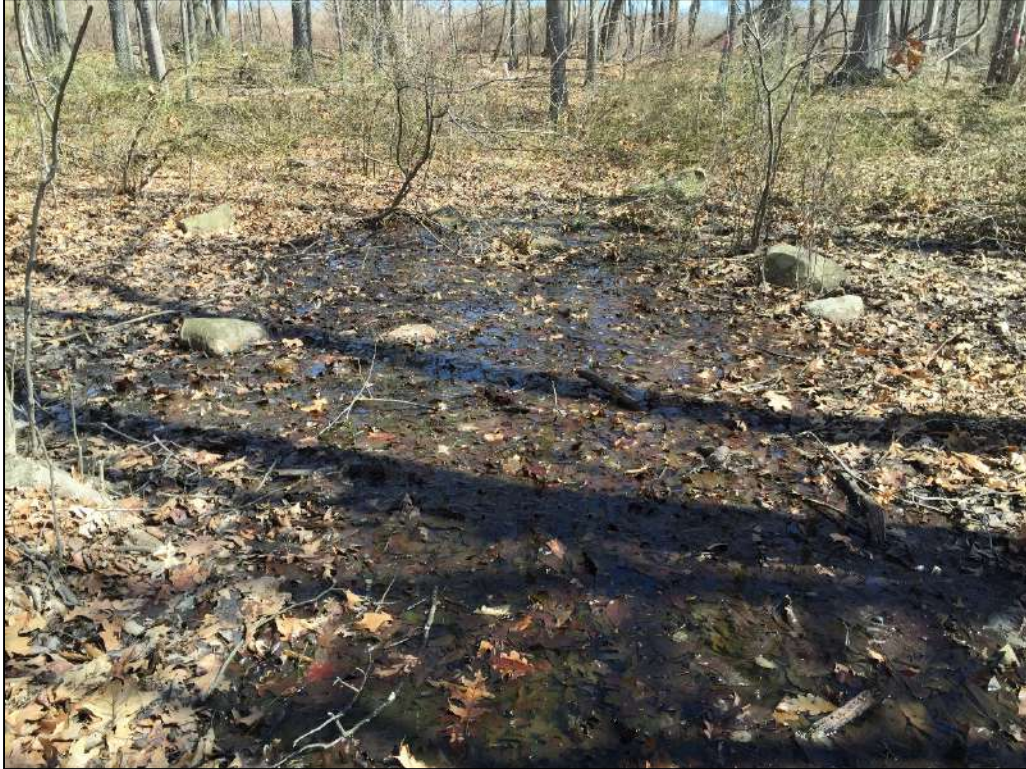
Photo 7: Wetland 2 in early spring prior to leaf-out, looking west.

Wetland 2 is a ±0.39 acre wooded swamp with a saturated to seasonally flooded hydrology. The wetland is situated on gently sloping terrace just north of, and bordering, the cut slope described above. The majority of the wetland maintained a saturated hydrology throughout the spring. Two small, separated depressions held standing water throughout the spring and would be classified as having a seasonally-flooded hydrology.

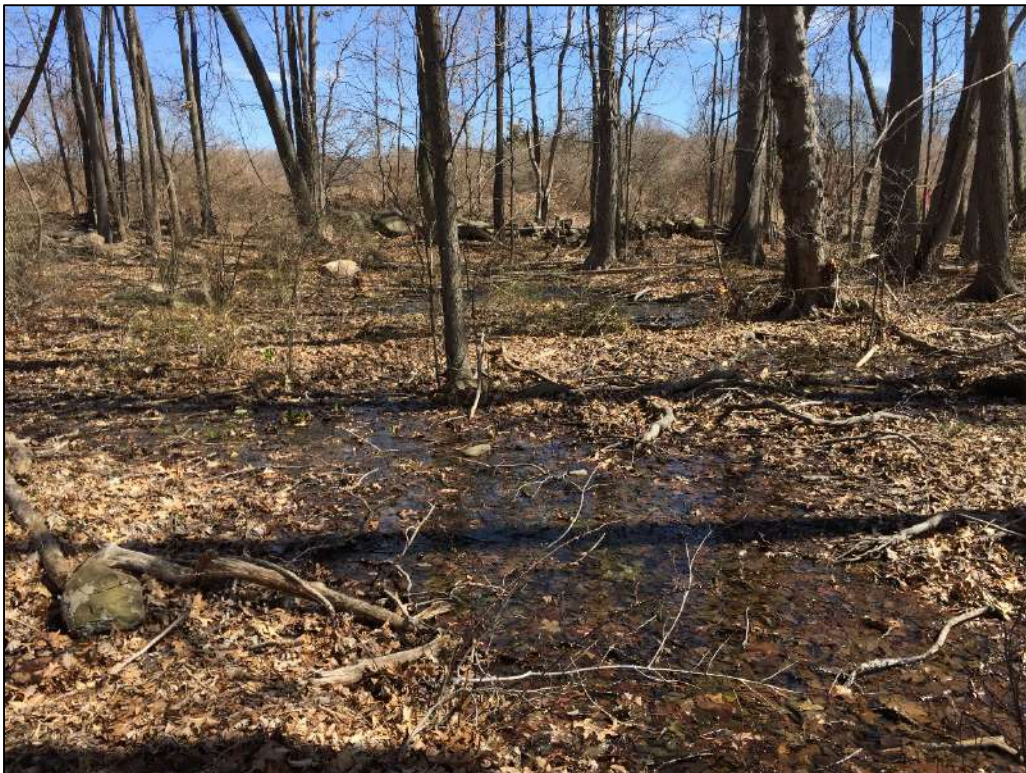
Photo 8: Wetland 2 in early spring prior to leaf-out, looking east.

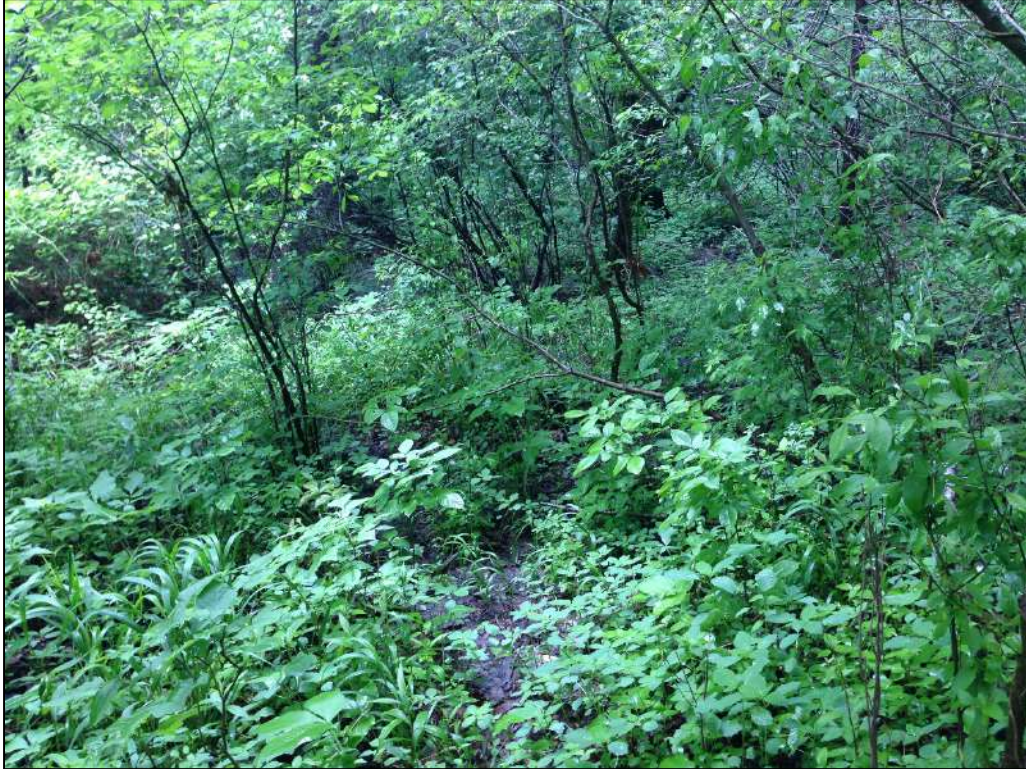
Photo 13: northeast portion of Wetland 1 showing dense ground and shrub cover vegetation.

Wetland 1 is the largest wetland at the site (± 3.83 acres). It bisects the site in a north-south direction in the eastern portion of the site. The wetland is hydrologically connected to an offsite pond on the north side of Route 1 via a culvert, and discharges off-site to the south via a closed drainage system. Two man-made ponds are embedded within Wetland 1. The larger pond (Pond A) has a forested edge from the adjacent upland slopes. Scattered shrubs also grow along the shore including Silky Dogwood, Buttonbush (*Cephalanthus occidentalis*), and Multiflora Rose* with Sensitive Fern. Within the pond there is a patch of Common Reed* (*Phragmites australis*) and White Waterlily (*Nymphaea odorata*). Filamentous green algae are also present. The smaller pond (Pond B) is located a short distance east of Pond A. It has a dense edge of Silky Dogwood with Soft Rush (*Juncus effusus*) and Reed Canarygrass* (*Phalaris arundinacea*). Patches of aquatic vegetation include waterweed (*Elodea spp.*) and smartweed (*Polygonum sp.*).

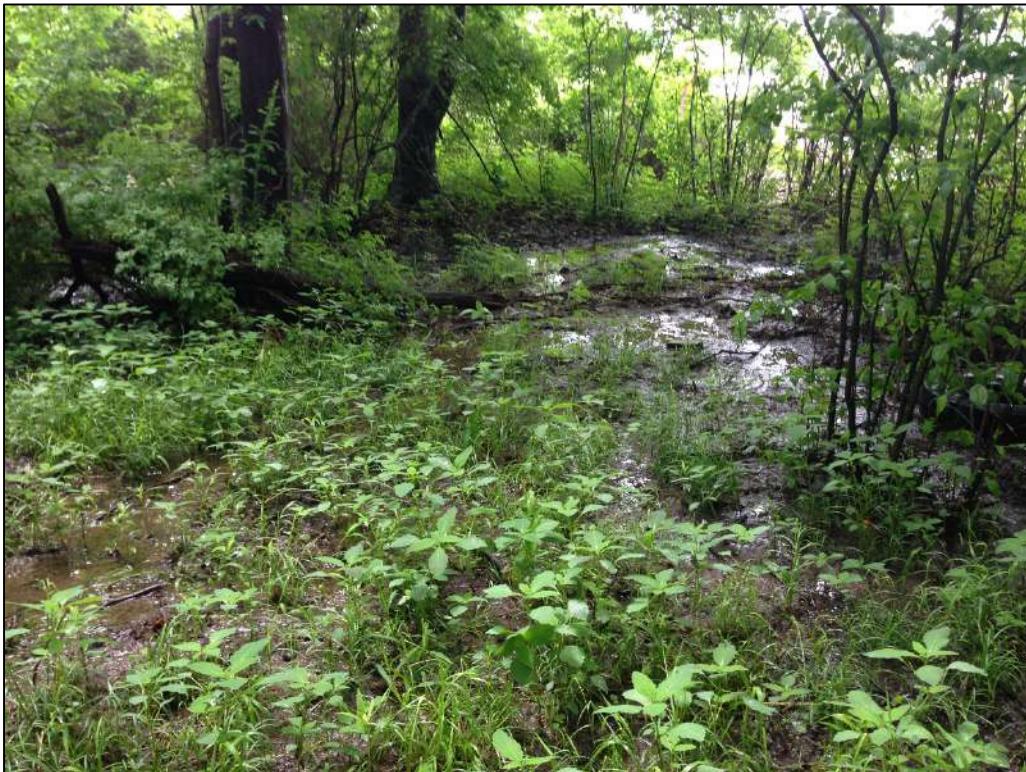
Photo 14: Southeast corner of Wetland 1.

The southern portions of Wetland 1 located below the cut slope are highly disturbed, and may be entirely anthropogenic in nature, having been created either as a result of the deep excavation of the slope that intercepted the water table, or from drainage that has been conveyed to it from other areas in closed or open systems.

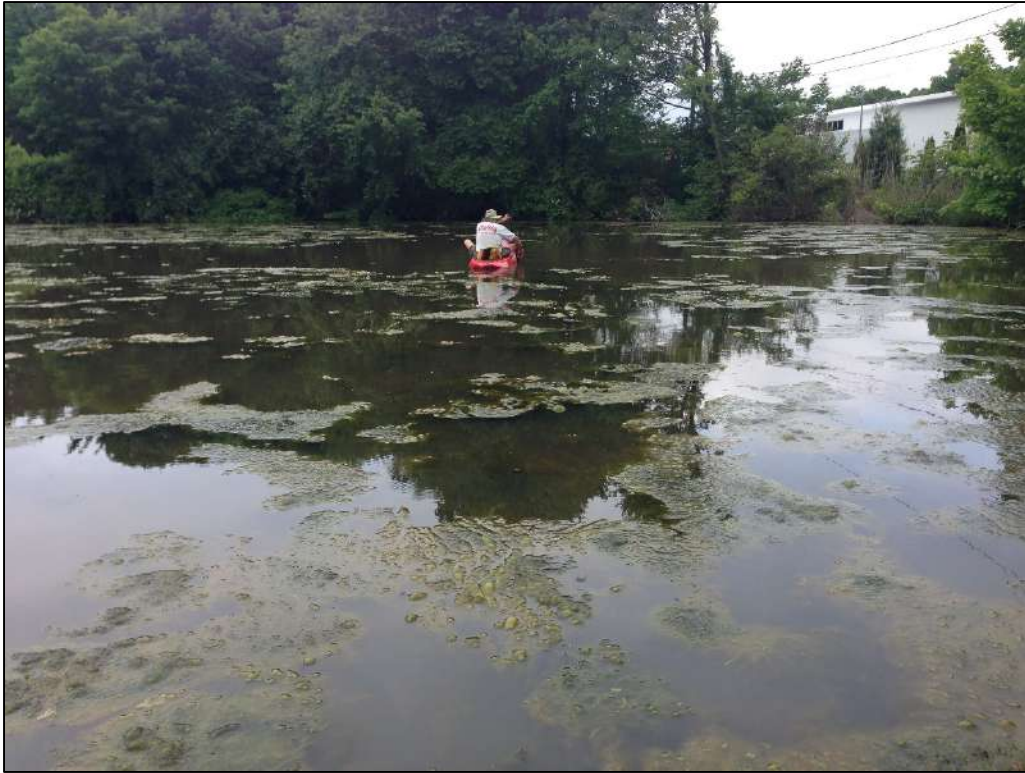
Photo 17: Pond C looking north.

Pond C is located north of Route 1. The Pond is shallow and the shore is partially wooded with Red Maple, Sugar Maple, Green Ash, Black Willow, and American Elm. The shrub layer varies from open to dense thickets and consists mostly of Arrowwood Viburnum, Silky Dogwood, Multiflora Rose*, and Buttonbush. Minimal aquatic vegetation was observed and was mostly Duckweed (*Lemna minor*) and watermeal (*Wolffia sp.*). On the east side of the pond there is a water quality swale which is vegetated mostly with Common Reed*. The vine layer includes Virginia Creeper and Asiatic Bittersweet*.
