Branford Police Department

REMEDICATION PROPOSAL

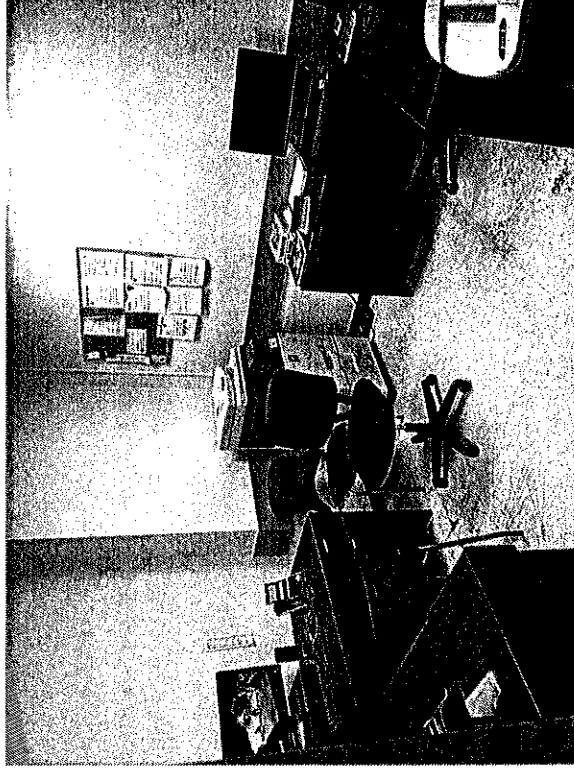
Report Writing –space needs

- Major increase in modern day policing in terms of reporting
- Small room with two stations serves the entire Patrol Division – 65% of Agency
- Often both stations are occupied

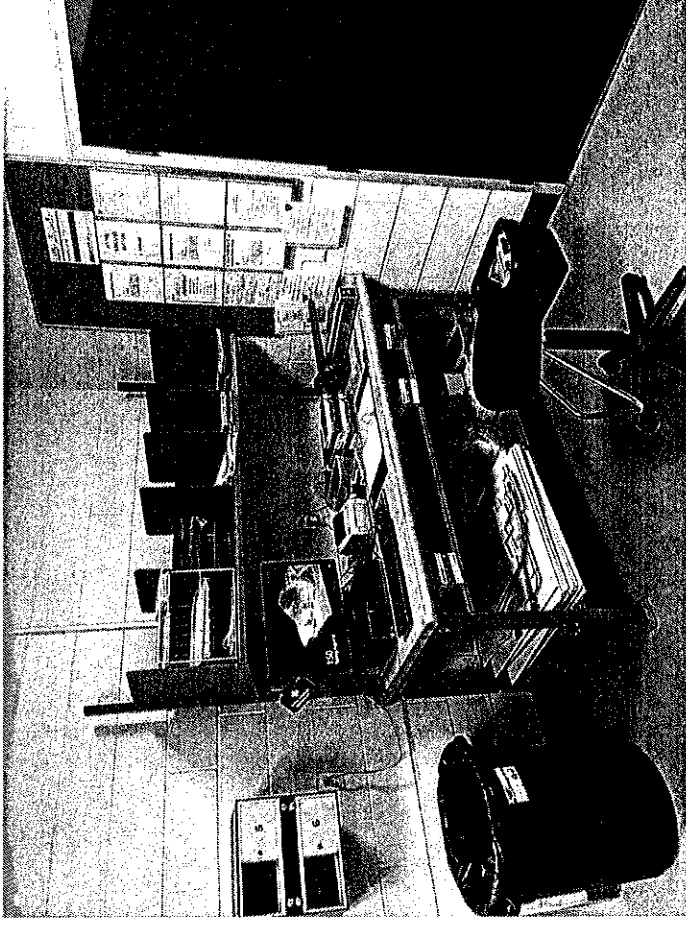
Evidence processing – space needs

- Area serves entire patrol division and detectives.
- Better utilization/ allocation of space in our proposal

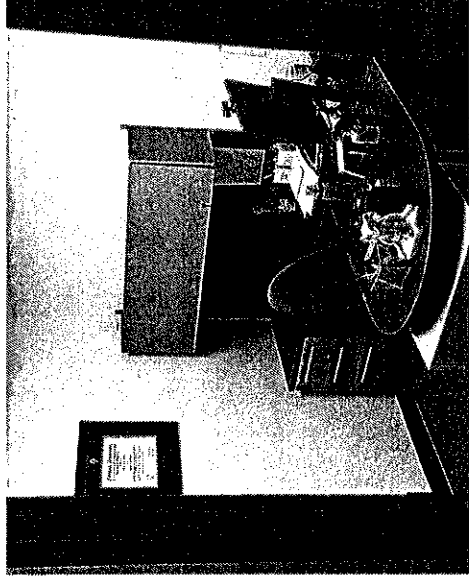
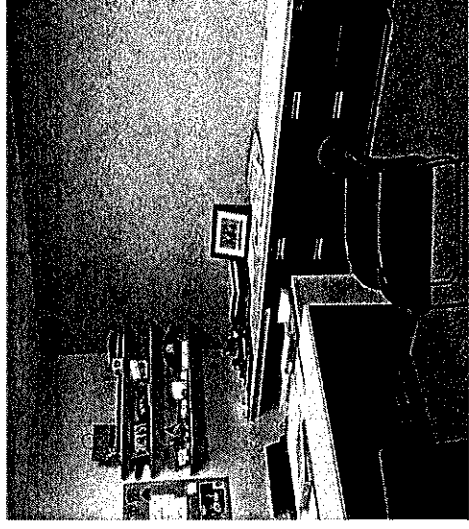
Offices - Main Floor – space needs

- Re-allocation (re-organization) of square footage is needed
- Over the years, closets have been built, offices/walls added – HVAC balance
- Growth -Police social worker = closet / 2 employees from I.T/ Crime Analyst
