BRANFORD

Community Facilities Evaluation

Phase 1 - February 2012

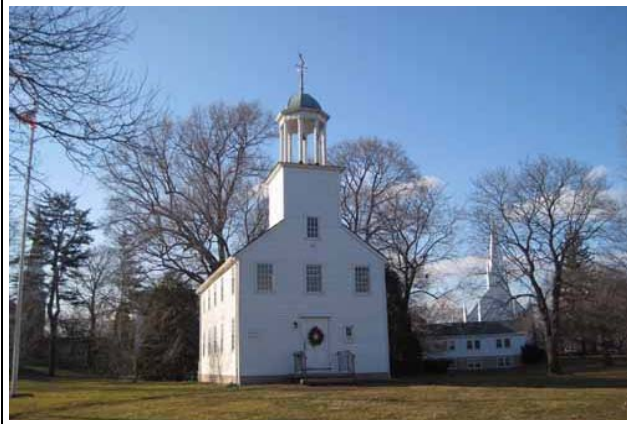
Photograph

Physical Condition	
Roof: Good	Replaced several years ago Bell tower needs renovation
Exterior Walls / Windows: Good	Needs painting
Interior Condition: Good	
Signs of Water Damage?	No

Building
<p>Bell tower on the roof needs renovation.</p> <p>BOF/RTM approved \$40,000 for FY 2012 for bell tower (requested \$65,000)</p> <p>Potential hazardous materials associated with building given its age such as potential for lead paint, asbestos.</p>

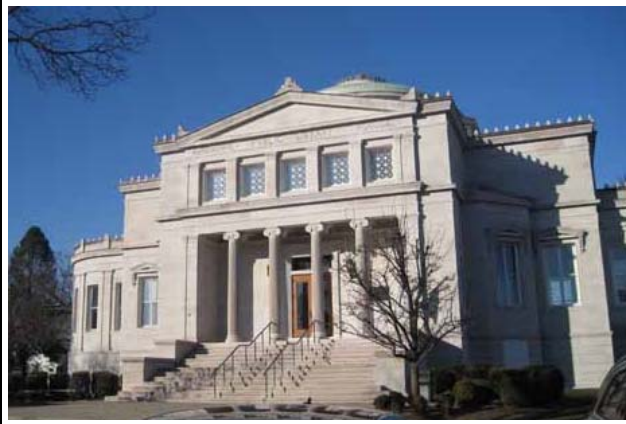
Photograph

Physical Condition	
Roof:	
Very Good	
Exterior Walls / Windows:	
Very Good	
Interior Condition:	
Very Good	
Signs of Water Damage?	No

Parking	
Availability:	
Fair	Not at all times, but generally yes
Drainage:	
Good	
Condition:	
Good	Handicapped spaces are not aligned with the handicap entrance. Spaces are tight for backing up. Driveway exit to Laurel Street ends with a large dip, (Crown of Laurel is somewhat high).

Building
<p>CIP - Requested \$100,000 for feasibility study but not funded by BOF</p> <p>Possible hazardous materials in building construction.</p> <p>Garage on property used for storage (1,564 gross SF, 948 effective SF)</p>

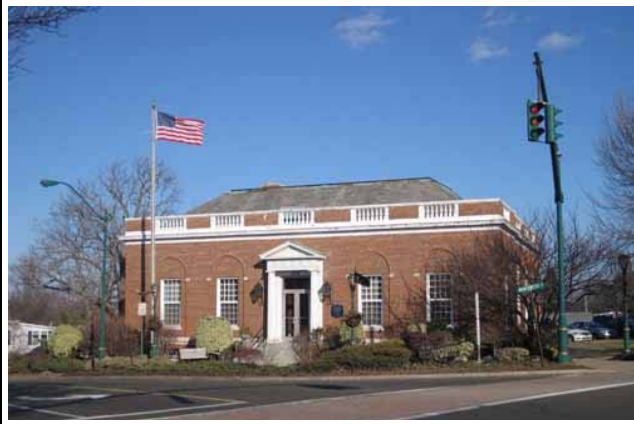
Photograph

Physical Condition	
Roof: Poor	Roof needs to be replaced
Exterior Walls / Windows: Poor	Walls are in poor condition from roofing leaks over the years, R-1 windows
Interior Condition: Fair	
Signs of Water Damage?	Yes

Building
<p>CIP – Requested \$4,800,000 for renovation / relocation to Canoe Brook – not funded by BOF</p> <p>BOE considering relocation to Walsh Intermediate School</p> <p>Hazardous materials survey shows presence of lead paint and asbestos.</p>

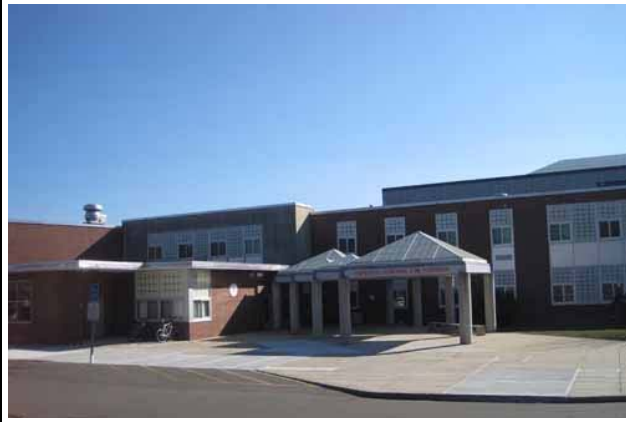
Photograph

Physical Condition	
Roof:	
Fair	
Exterior Walls / Windows:	
Good	
Interior Condition:	
Good	
Signs of Water Damage?	Yes

Building
<p>Property in flood plain but building is not.</p> <p>CIP - \$200,000 for carpet / floor work (2012-16)</p> <p>CIP - \$75,000 for brick wall / sidewalk work (2012-16)</p> <p>CIP - \$101,000 for door / entry replacements (2013-15)</p> <p>CIP - \$210,000 for energy management system (2014)</p> <p>CIP - \$130,000 for conversion to HW in Shop area (2014)</p> <p>CIP - \$125,000 for fire notification system (2014)</p>

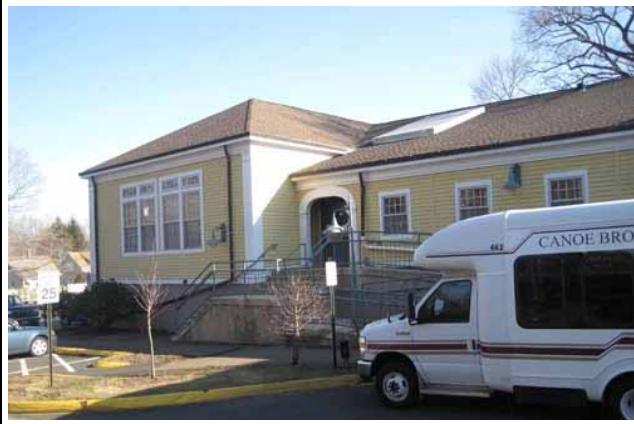
Photograph

Physical Condition	
Roof: Good	Roof replaced two years ago, occasional leaking in computer lab
Exterior Walls / Windows: Fair	Columns are rotting, paint peeling
Interior Condition: Fair	Finish worn off of wood floors, carpet buckling & stained, bathrooms need updating.
Signs of Water Damage?	Yes

Condition Of Grounds	
Overall: Good	Tree adjacent to Totokett room/Richlins should be removed.
Drainage: Good

Parking	
Availability: Poor	Parking is a challenge daily, fortunately Richlins allows overflow.
Drainage: Good	
Condition: Good

ADA Compliance	
Building Interior: Fair	May need elevator eventually fir Senior Center use
Building Access: Poor	Ramp not ADA compliant and pitch / length is very difficult for elderly. Cement cracks and crumbles constantly on ramp & stairs
Route To Parking Area: Poor	Via long walkway & steep lengthy pre-ADA ramp. Cement cracking and ice accumulatin are major ongoing issues
Parking Area: Fair	Limited handicapped parking

Building
<p>CIP – Requested \$4,800,000 for renovation / use as BOE offices with Senior Center relocation elsewhere – not funded by BOF</p> <p>Some part of the building may be connected to a septic tank</p> <p>Possible hazardous materials in building.</p>

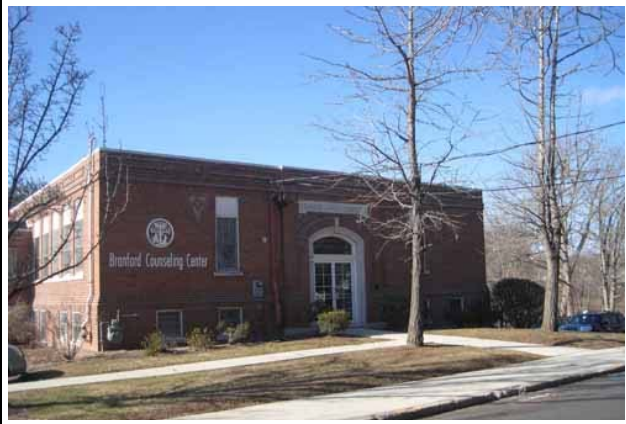
Photograph

Physical Condition	
Roof: Fair	Roofing screws are starting to come through the roof.
Exterior Walls / Windows: Fair	Building recently repointed. Need windows replaced
Interior Condition: Good	
Signs of Water Damage?	Yes

Condition Of Grounds	
Overall: Fair	Well cared for by the Rec.Dept.
Drainage: Good

Parking	
Availability: Fair	Most of the time some days it is tight
Drainage: Good	
Condition: Good	Curbs need to be replaced

Building
Part of property in Flood Zone but Building is not.
Old renovated building that may have hazardous building materials.

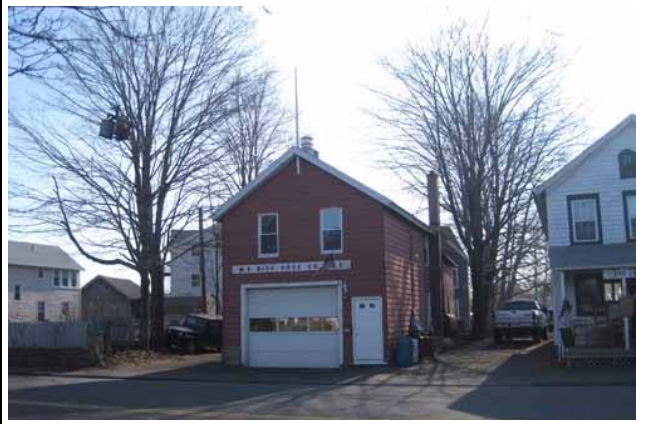
Photograph

Physical Condition	
Roof: Poor	Roof needs repair / replacement
Exterior Walls / Windows: Fair	Siding needs repair / replacement
Interior Condition: Good	
Signs of Water Damage?	Yes

Condition Of Grounds	
Overall:	
Good	
Drainage:	Basement gets continuous water
Poor

Building
May have hazardous materials present in building.
Oil tank in basement that floated during storm. Tank is obsolete.
Have expressed interest in an additional bay for equipment.

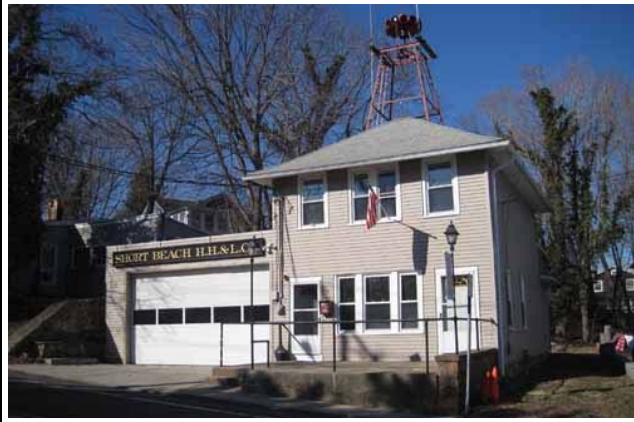
Photograph

Physical Condition	
Roof:	
Good	
Exterior Walls / Windows:	
Good	
Interior Condition:	
Signs of Water Damage?

Parking	
Availability:	On-street
Poor	
Drainage:	
Condition:

Building
<p>Non-conforming structure</p> <p>Old building - possible hazardous materials.</p> <p>No evidence of sewer connection but must be connected to sewers.</p>

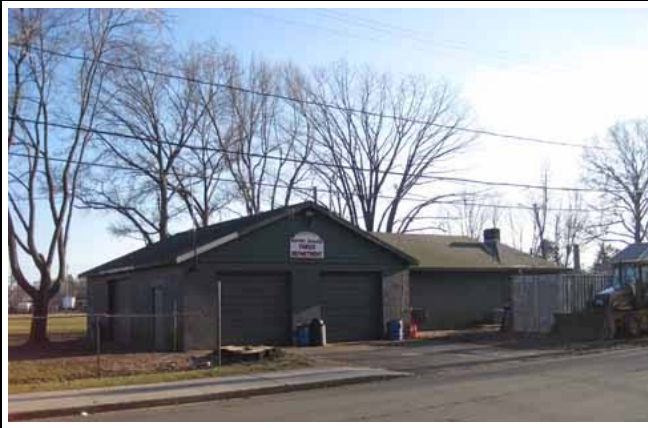
Photograph

Physical Condition	
Roof: Fair	Needs new roof
Exterior Walls / Windows: Good	
Interior Condition: Good	
Signs of Water Damage?	Yes

HVAC Systems	
Heating: Poor	Needs boiler replacement
Ventilation:	
Cooling: Fair	New split system installed
Est. Annual Utility Costs:	\$1,052

Parking	
Availability:	
Good	
Drainage:	
Good	
Condition:	large pot hole in front of rescue 5 bay door
Good

Building
Old building may have hazardous materials.

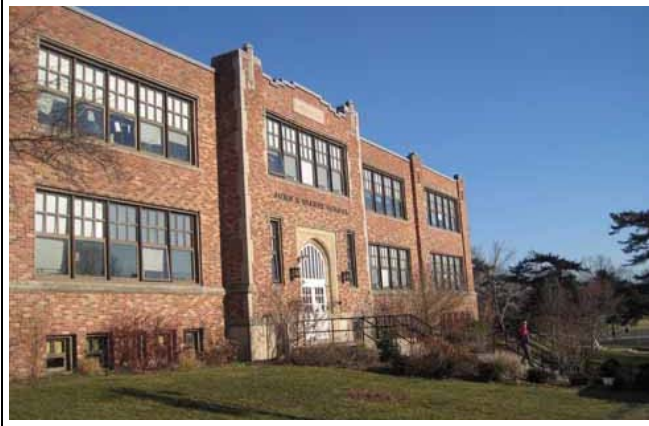
Photograph

Parking	
Availability:	
No	
Drainage:	
Good	
Condition:	
Poor

Building
<p>CIP –\$27,000 for outdoor lighting (2013)</p> <p>CIP –\$160,000 for flooring replacement (2014-15)</p> <p>CIP –\$200,000 for AC system (2016)</p> <p>CIP –\$57,000 requested for driveway / parking – not approved by BOF</p> <p>Hazardous building materials.</p>

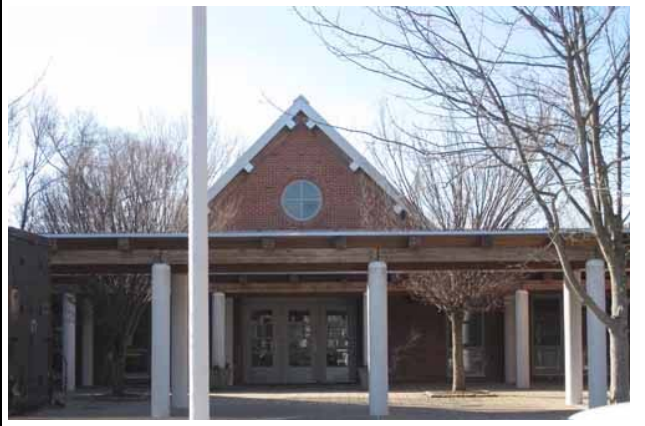
Photograph

Physical Condition	
Roof: Poor	Roofs are leaking
Exterior Walls / Windows: Good	
Interior Condition: Good	
Signs of Water Damage?	Yes

Building
CIP –\$650,000 for roof replacement (2014)
CIP –\$70,000 for boiler replacement (2015)

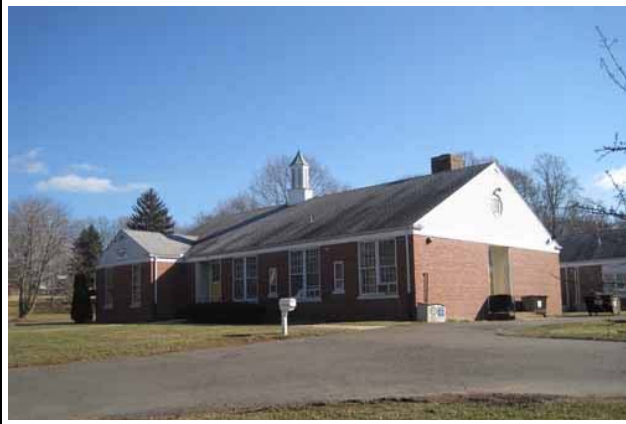
Photograph

Physical Condition	
Roof: Poor	Roofs leaking
Exterior Walls / Windows: Good	
Interior Condition: Good	
Signs of Water Damage?	Yes

Building
CIP –\$650,000 for roof replacement (2014)
CIP –\$70,000 for boiler replacement (2015)

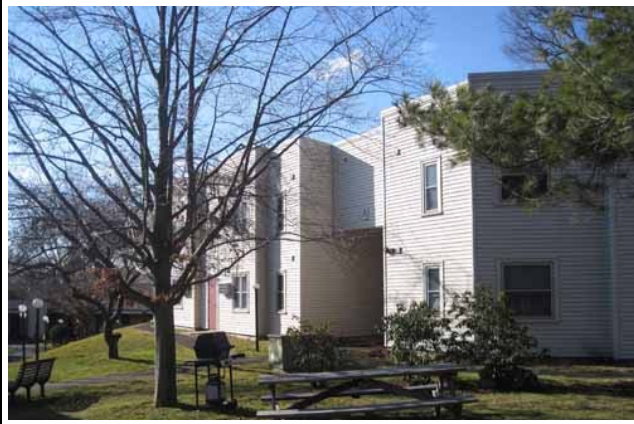
Photograph

Physical Condition	
Roof: Poor	Flat section of roof needs to be redone properly. Various leaks throughout
Exterior Walls / Windows: Fair	
Interior Condition: Good	
Signs of Water Damage?	Yes

HVAC Systems	
Heating: Good	Converted from steam to hot water this year
Ventilation:	
Cooling: Fair	Portions of the building not air conditioned. System not balanced
Est. Annual Utility Costs:	\$13,865

Condition Of Grounds	
Overall: Fair	Lower parking area and front lawn are not maintained well.
Drainage: Good

Parking	
Availability: Fair	With the exception of polling and special events. Could use a better layout
Drainage: Fair	
Condition: Poor*

Building
<p>CIP –\$135,000 for windows / ceilings (2014)</p> <p>Received grant (2012) for improvements to roof, windows, doors, etc.</p> <p>Part of property in Flood zone but building is not.</p> <p>Building probably contains hazardous materials</p>

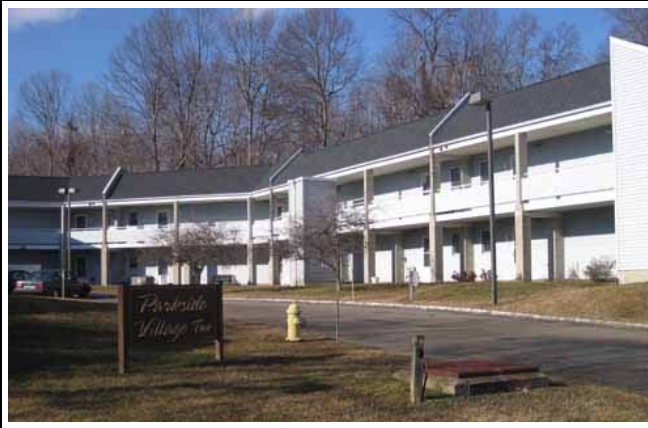
Photograph

Physical Condition	
Roof: Very Good	New roofs in 2000
Exterior Walls / Windows: Poor	Ext. walls rotting, second floor walkways failing
Interior Condition: Good	As units vacate a fit up is completed as needed.
Signs of Water Damage?	Yes

HVAC Systems	
Heating: Fair	Electric baseboard heat
Ventilation:	
Cooling: Good	Sleeve models tenant owned air conditioners
Est. Annual Utility Costs:	101572

Condition Of Grounds	
Overall: Fair	Tree roots. Ledge and lot line configuration limits building potential
Drainage: Poor	Pitched areas

Parking	
Availability: Poor	Limited parking and are too far from the units
Drainage: Poor	
Condition: Poor	Cracks and pot holes

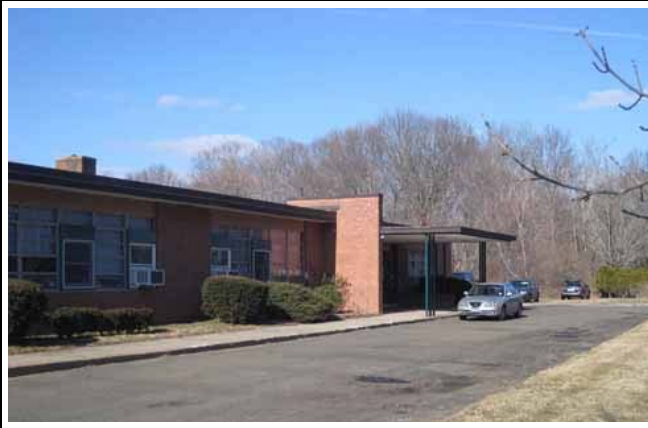
Photograph

Physical Condition	
Roof: Very Good	New roofs 2010 and 2011
Exterior Walls / Windows: Poor	Ext Walls rotting, second floor walkways failing
Interior Condition: Good	When vacant units fit up as needed.
Signs of Water Damage?	Yes

HVAC Systems	
Heating: Fair	Tenants pay for electric baseboard heat
Ventilation:	
Cooling: Good	Tenants own air conditioner units
Est. Annual Utility Costs:	\$14,180

Condition Of Grounds	
Overall: Fair	Old trees need to be removed
Drainage: Poor

Lighting	
Availability: Fair	Dim for elderly residents
Condition: Good

Parking	
Availability: Fair	
Drainage: Fair	
Condition: Fair	Pot holes and cracks

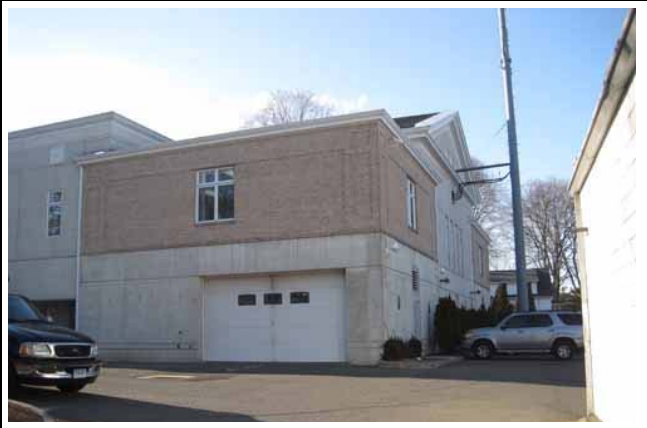
Photograph

Physical Condition	
Roof: Fair	Shows signs of needing roof replaced. The roof leaks occasionally and needs work
Exterior Walls / Windows: Fair	Needs stucco repair on sides of building
Interior Condition: Fair	Regular painting schedule has been discontinued and walls are starting to show wear, cell block floor is chipping, some carpet showing wear
Signs of Water Damage?	Yes

HVAC Systems	
Heating: Fair	Zones don't regulate very well.
Ventilation:	
Cooling: Fair	Humidity issues in the lower level of the building
Est. Annual Utility Costs:

Condition Of Grounds	
Overall: Good*	
Drainage: Good	Rain garden for water quality is not maintained properly

Lighting	
Availability: Fair	Rear parking lot lighting is inadequate. We have had thefts from employees vehicles in the past.
Condition: Good

Parking	
Availability: Fair	Compete with Volunteer Service Center and residents on Harrison Ave in lower parking lot. There is only a couple of spots in the front of the building.
Drainage: Good	
Condition: Fair	Driveway has cracks

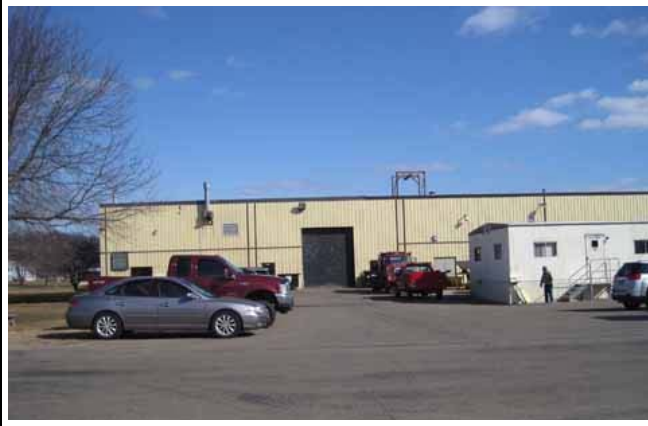
Photograph

Physical Condition	
Roof: Fair	Leaks in garage and firearms range
Exterior Walls / Windows: Fair	Cracks in the building exterior , needs painting
Interior Condition: Fair	The interior was painted to encapsulate lead when the firearms range was built. The paint is chipped
Signs of Water Damage?	Yes

HVAC Systems	
Heating: Fair	Old system and it leaks a fluid
Ventilation:	
Cooling: N/A	
Est. Annual Utility Costs:

Condition Of Grounds	
Overall: Fair	There is no landscaping
Drainage: Poor	Downspouts overflow

Parking	
Availability: Fair	Competing with volunteer services and residents in the area
Drainage: Fair	
Condition: Fair	Cracks in pavement
